Date: 30 August 2023
Project No: LTC21220-A
Revision: B

**RE: SHALLOW SOIL TEST REPORT
FUTURE RESIDENTIAL FOUNDATIONS
LOT 10, 115 EUREKA STREET, ARANUI**

Test Location Plan
 Lot 10, 115 Eureka Street,
 ARANUI, CHRISTCHURCH

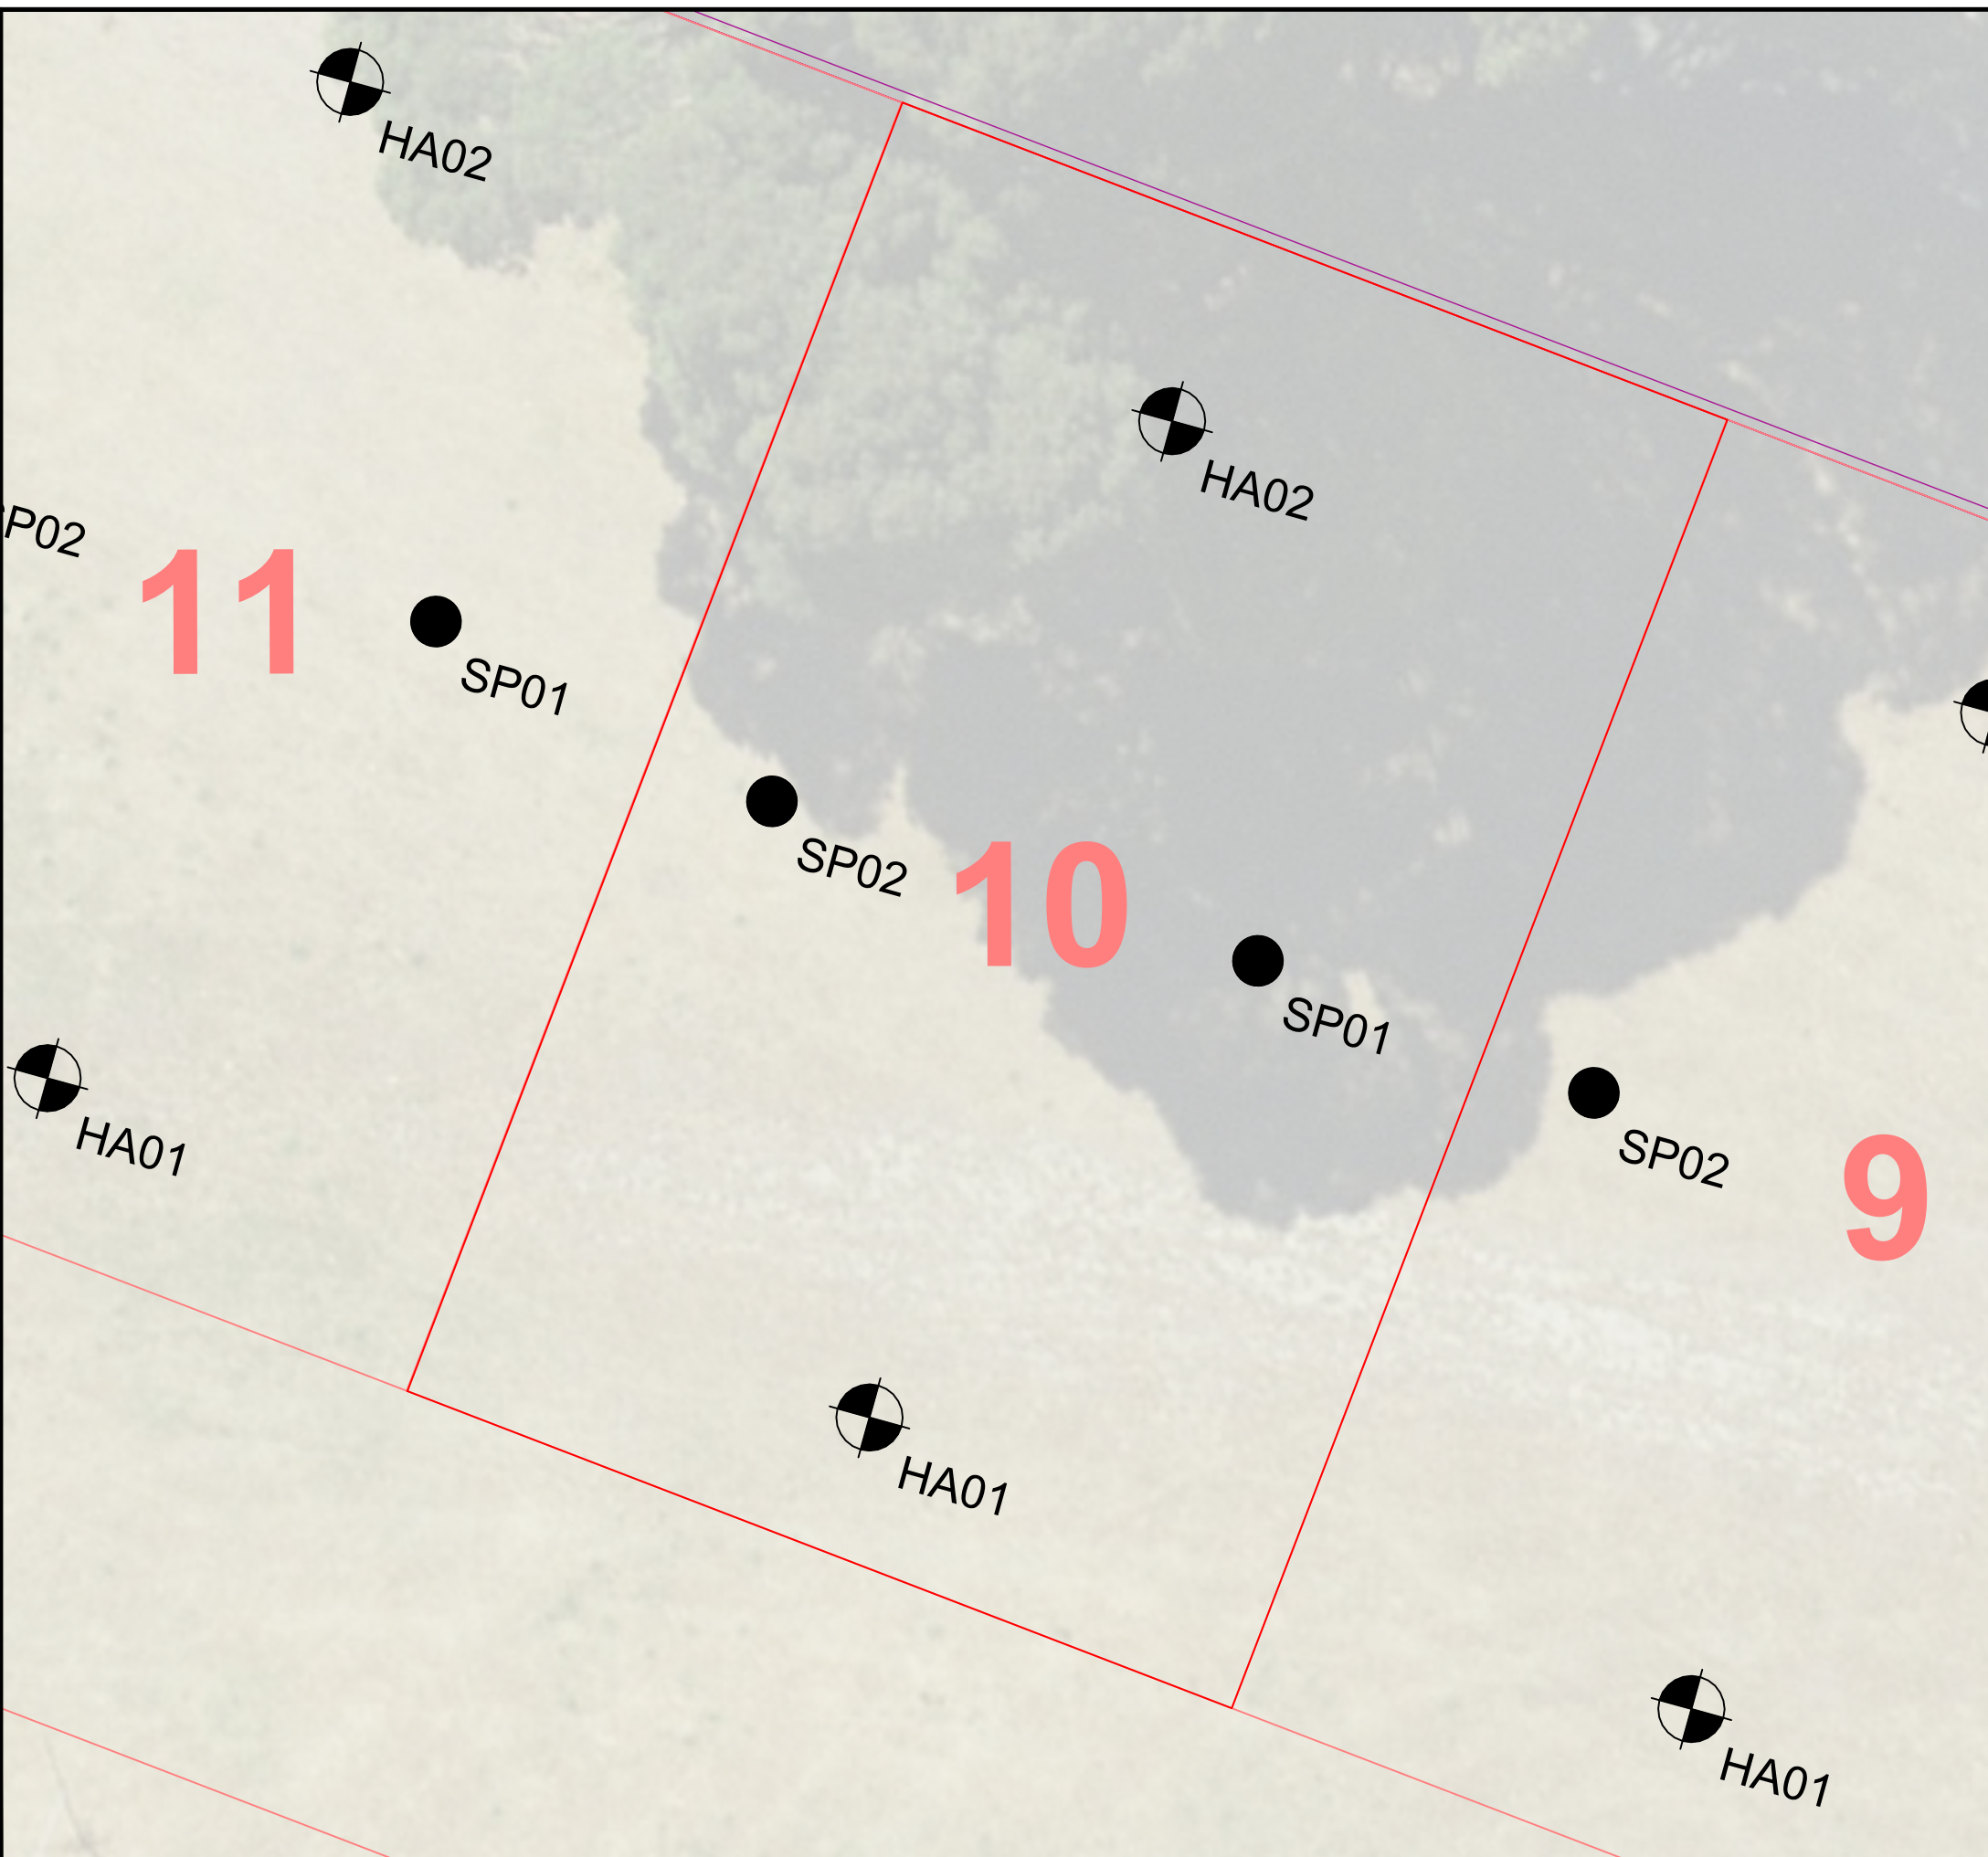
LandTech investigated the site on 1 June 2023, conducting two hand augers with corresponding Scala Penetrometer tests (SPs) and two additional SPs. The locations of the hand auger and SPs were measured using inferred lot boundaries and are approximate only. The test locations are shown on our LandTech *Test Location Plan*, Drawing No. Lot 10/ TLP, attached to this report.

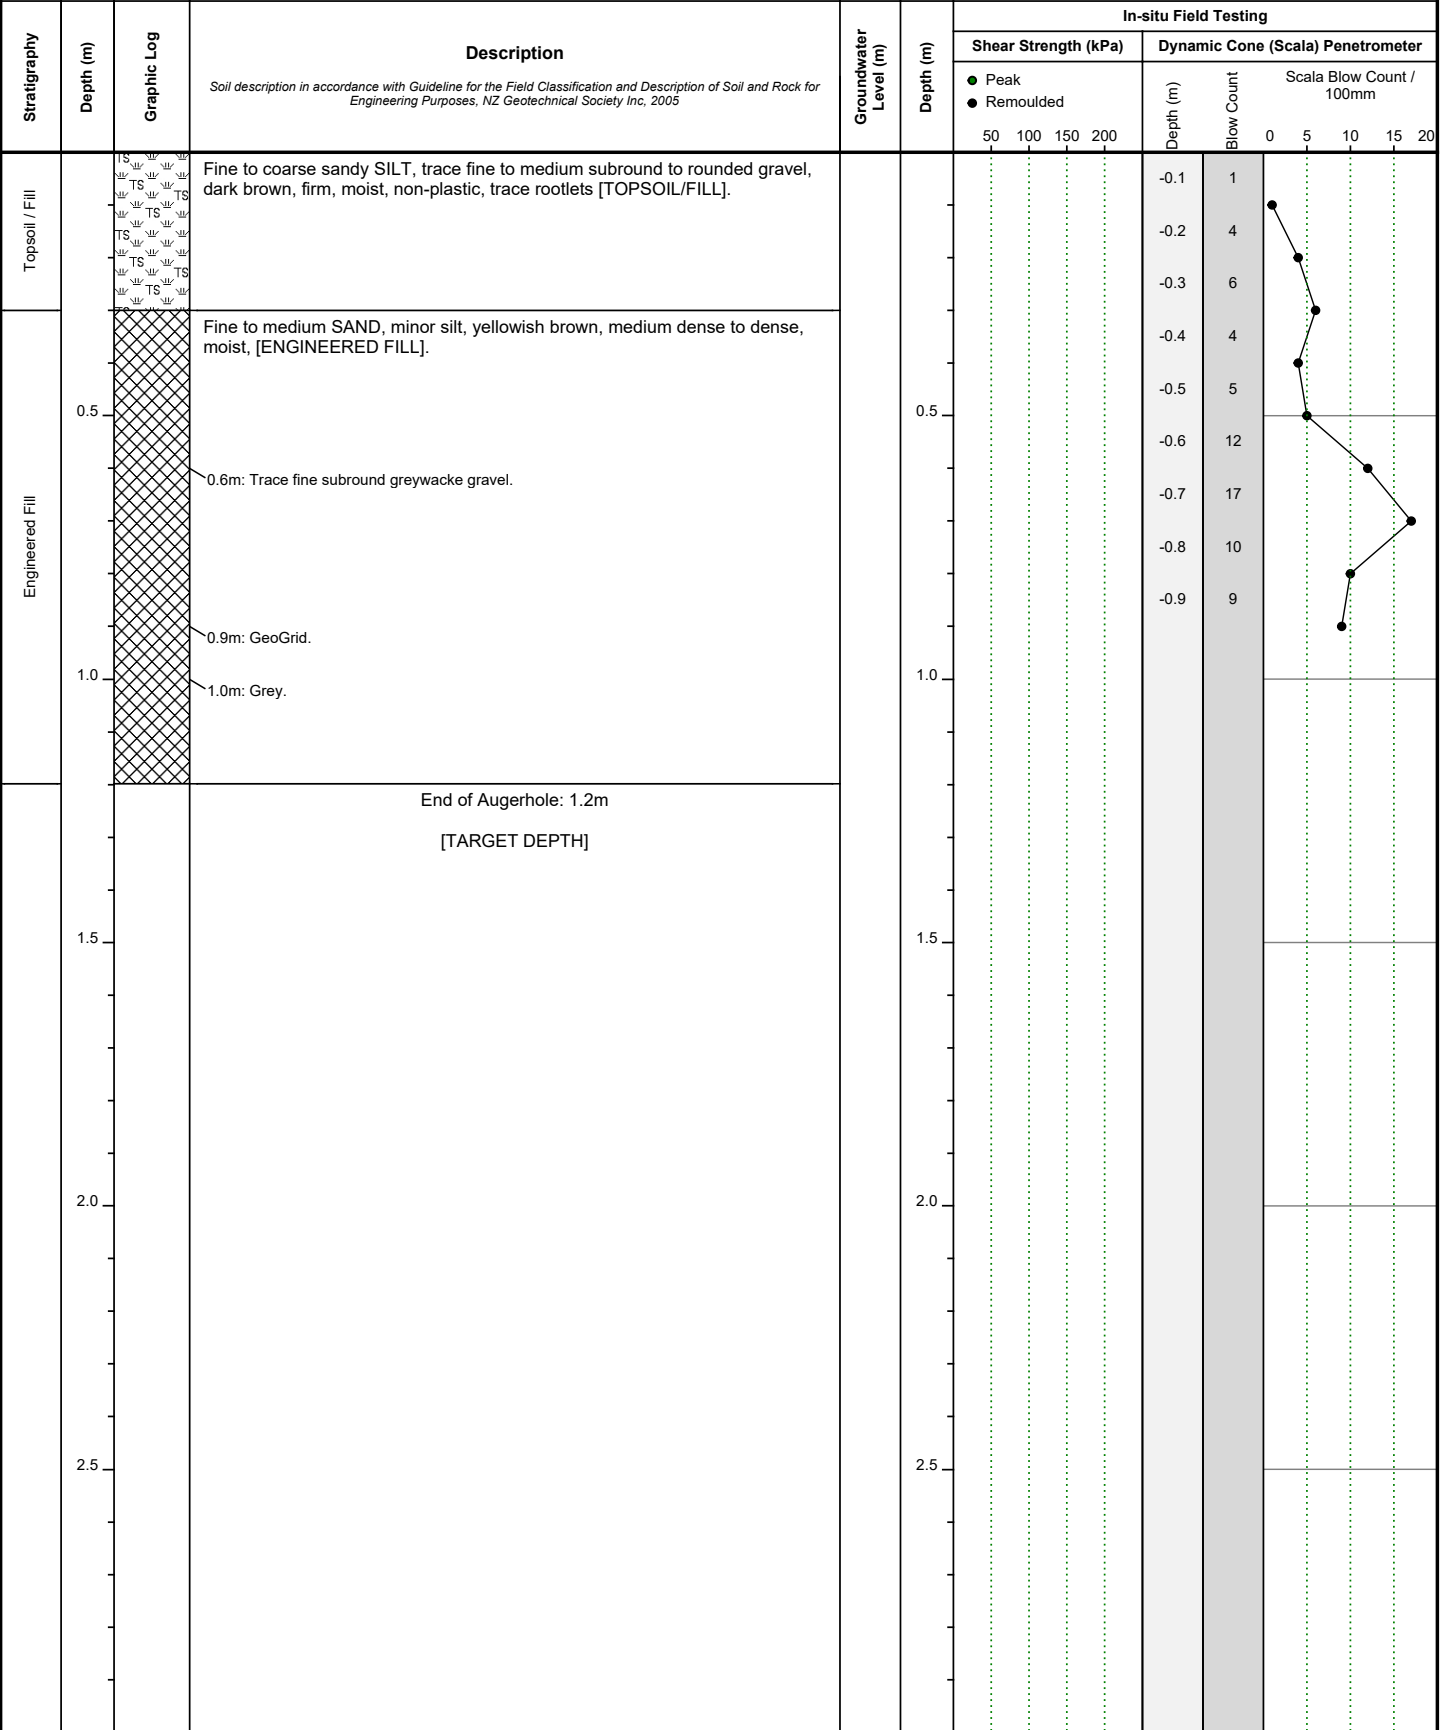
Augerhole No.: Lot 10 - HA01

Topsoil was encountered within the hand augers from the ground surface to 0.3m depth, which was typically a dark brown sandy silt material. Engineered fill was encountered below the topsoil to the base of auger holes, which was a compacted yellowish brown sand material with minor silt. The hand augers were terminated at 1.2m depth below ground level to avoid damage to the geotextile layer which was installed at 1.5m depth below ground level. Groundwater was not encountered during testing.

Target depth achieved. In-situ testing in accordance with the following standards:
 Scala Penetrometer Testing: NZS 4402:1988, Test 6.5.2, Dynamic Cone Penetrometer
 Shear Vane Testing: Guideline for Hand Held Shear Vane Test, NZGS, August 2001

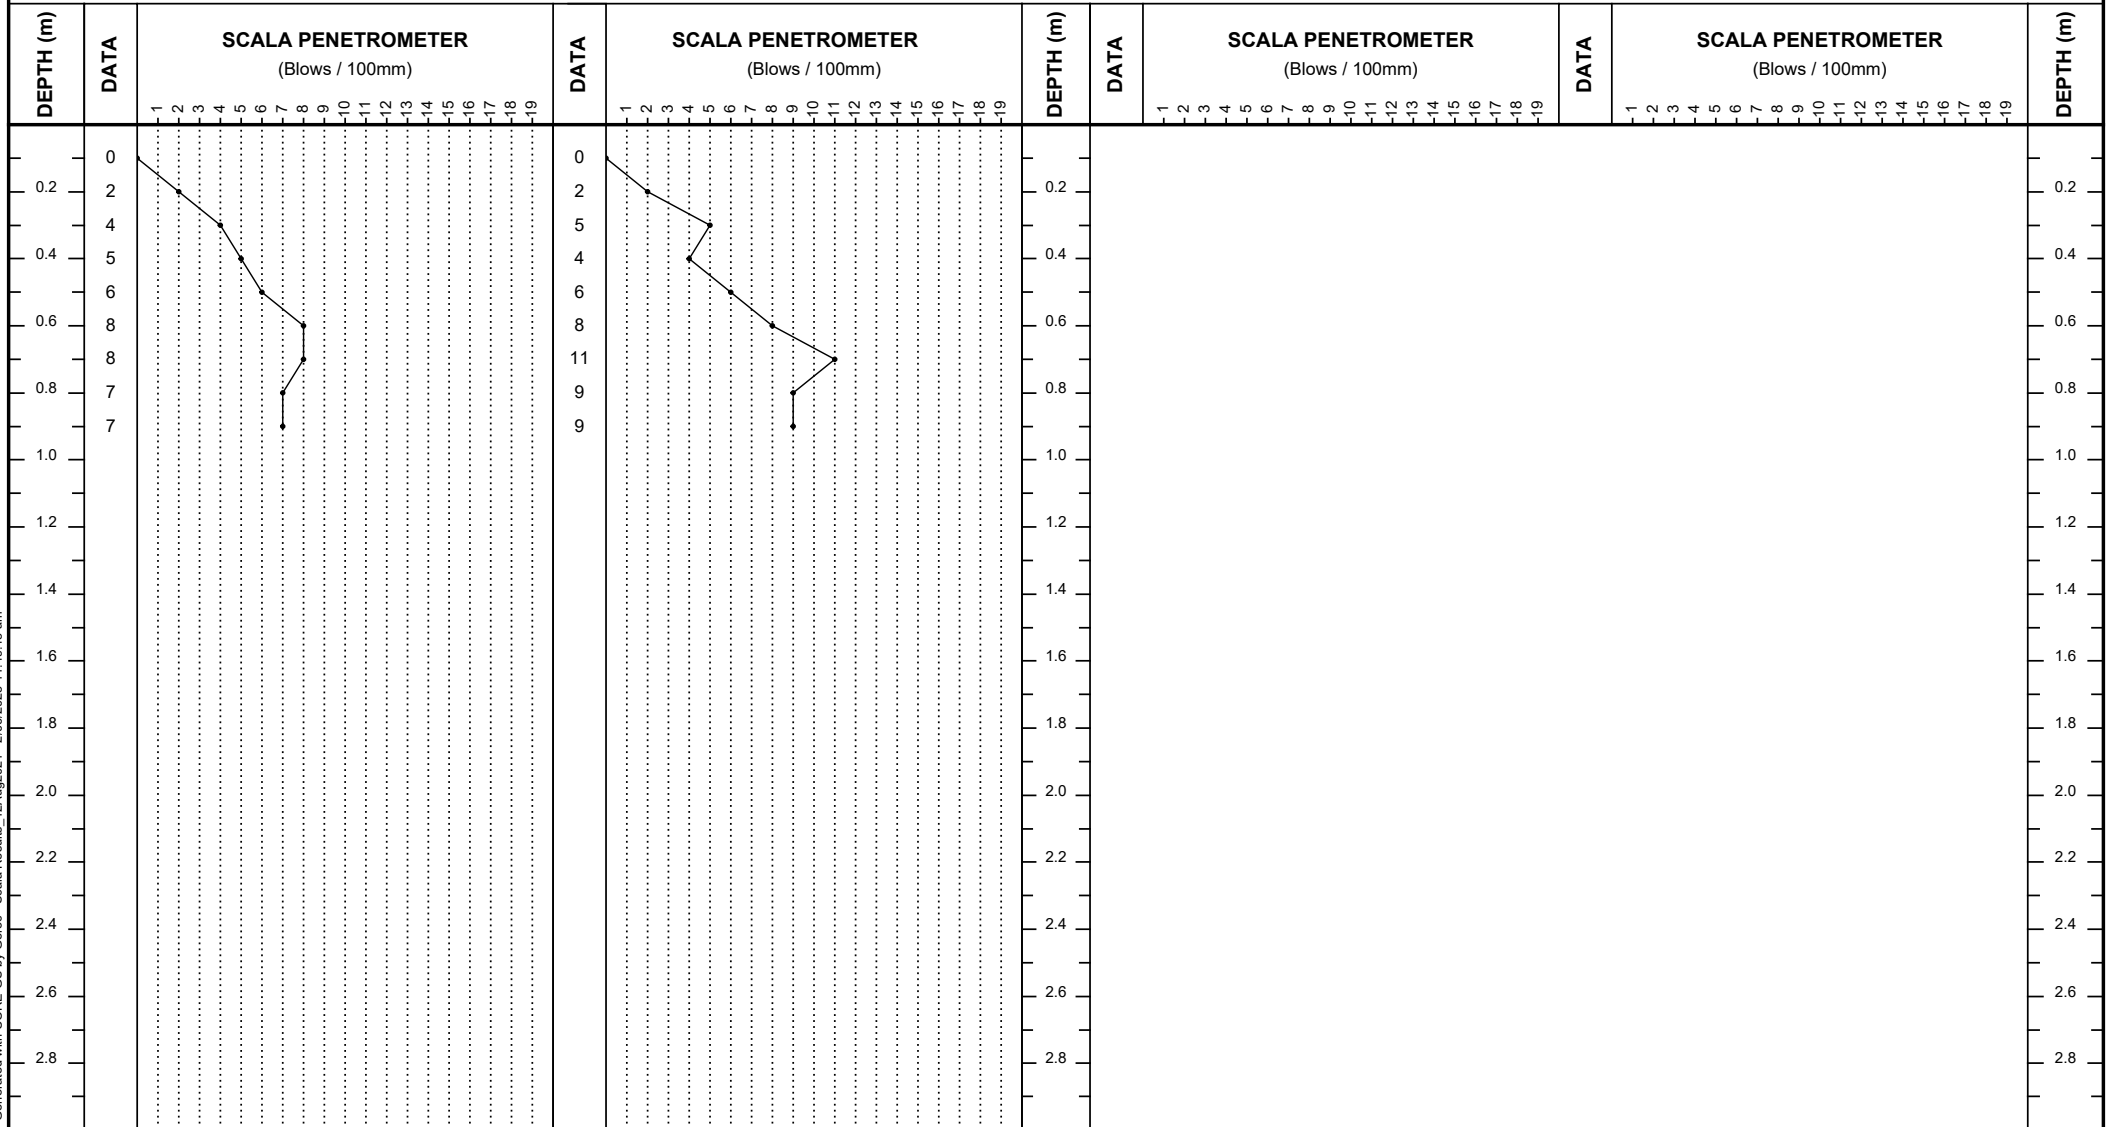
LOT 10- SP01

SPs at each of the four locations returned results between 3 and 17 blows per 100mm penetration below the topsoil and within the engineered fill layer. SPs were terminated at 0.9m depth to confirm near surface bearing capacities, and to avoid damage to the geogrids and geotextile. In addition, the density of the engineered fill and bearing capacity of its underlying subgrade have been confirmed via extensive geotechnical inspection and fill compaction testing during subdivision earthworks.
