Date: 30 August 2023
Project No: LTC21220-A
Revision: B

**RE: SHALLOW SOIL TEST REPORT
FUTURE RESIDENTIAL FOUNDATIONS
LOT 24, 115 EUREKA STREET, ARANUI**

Test Location Plan
 Lot 24, 115 Eureka Street,
 ARANUI, CHRISTCHURCH

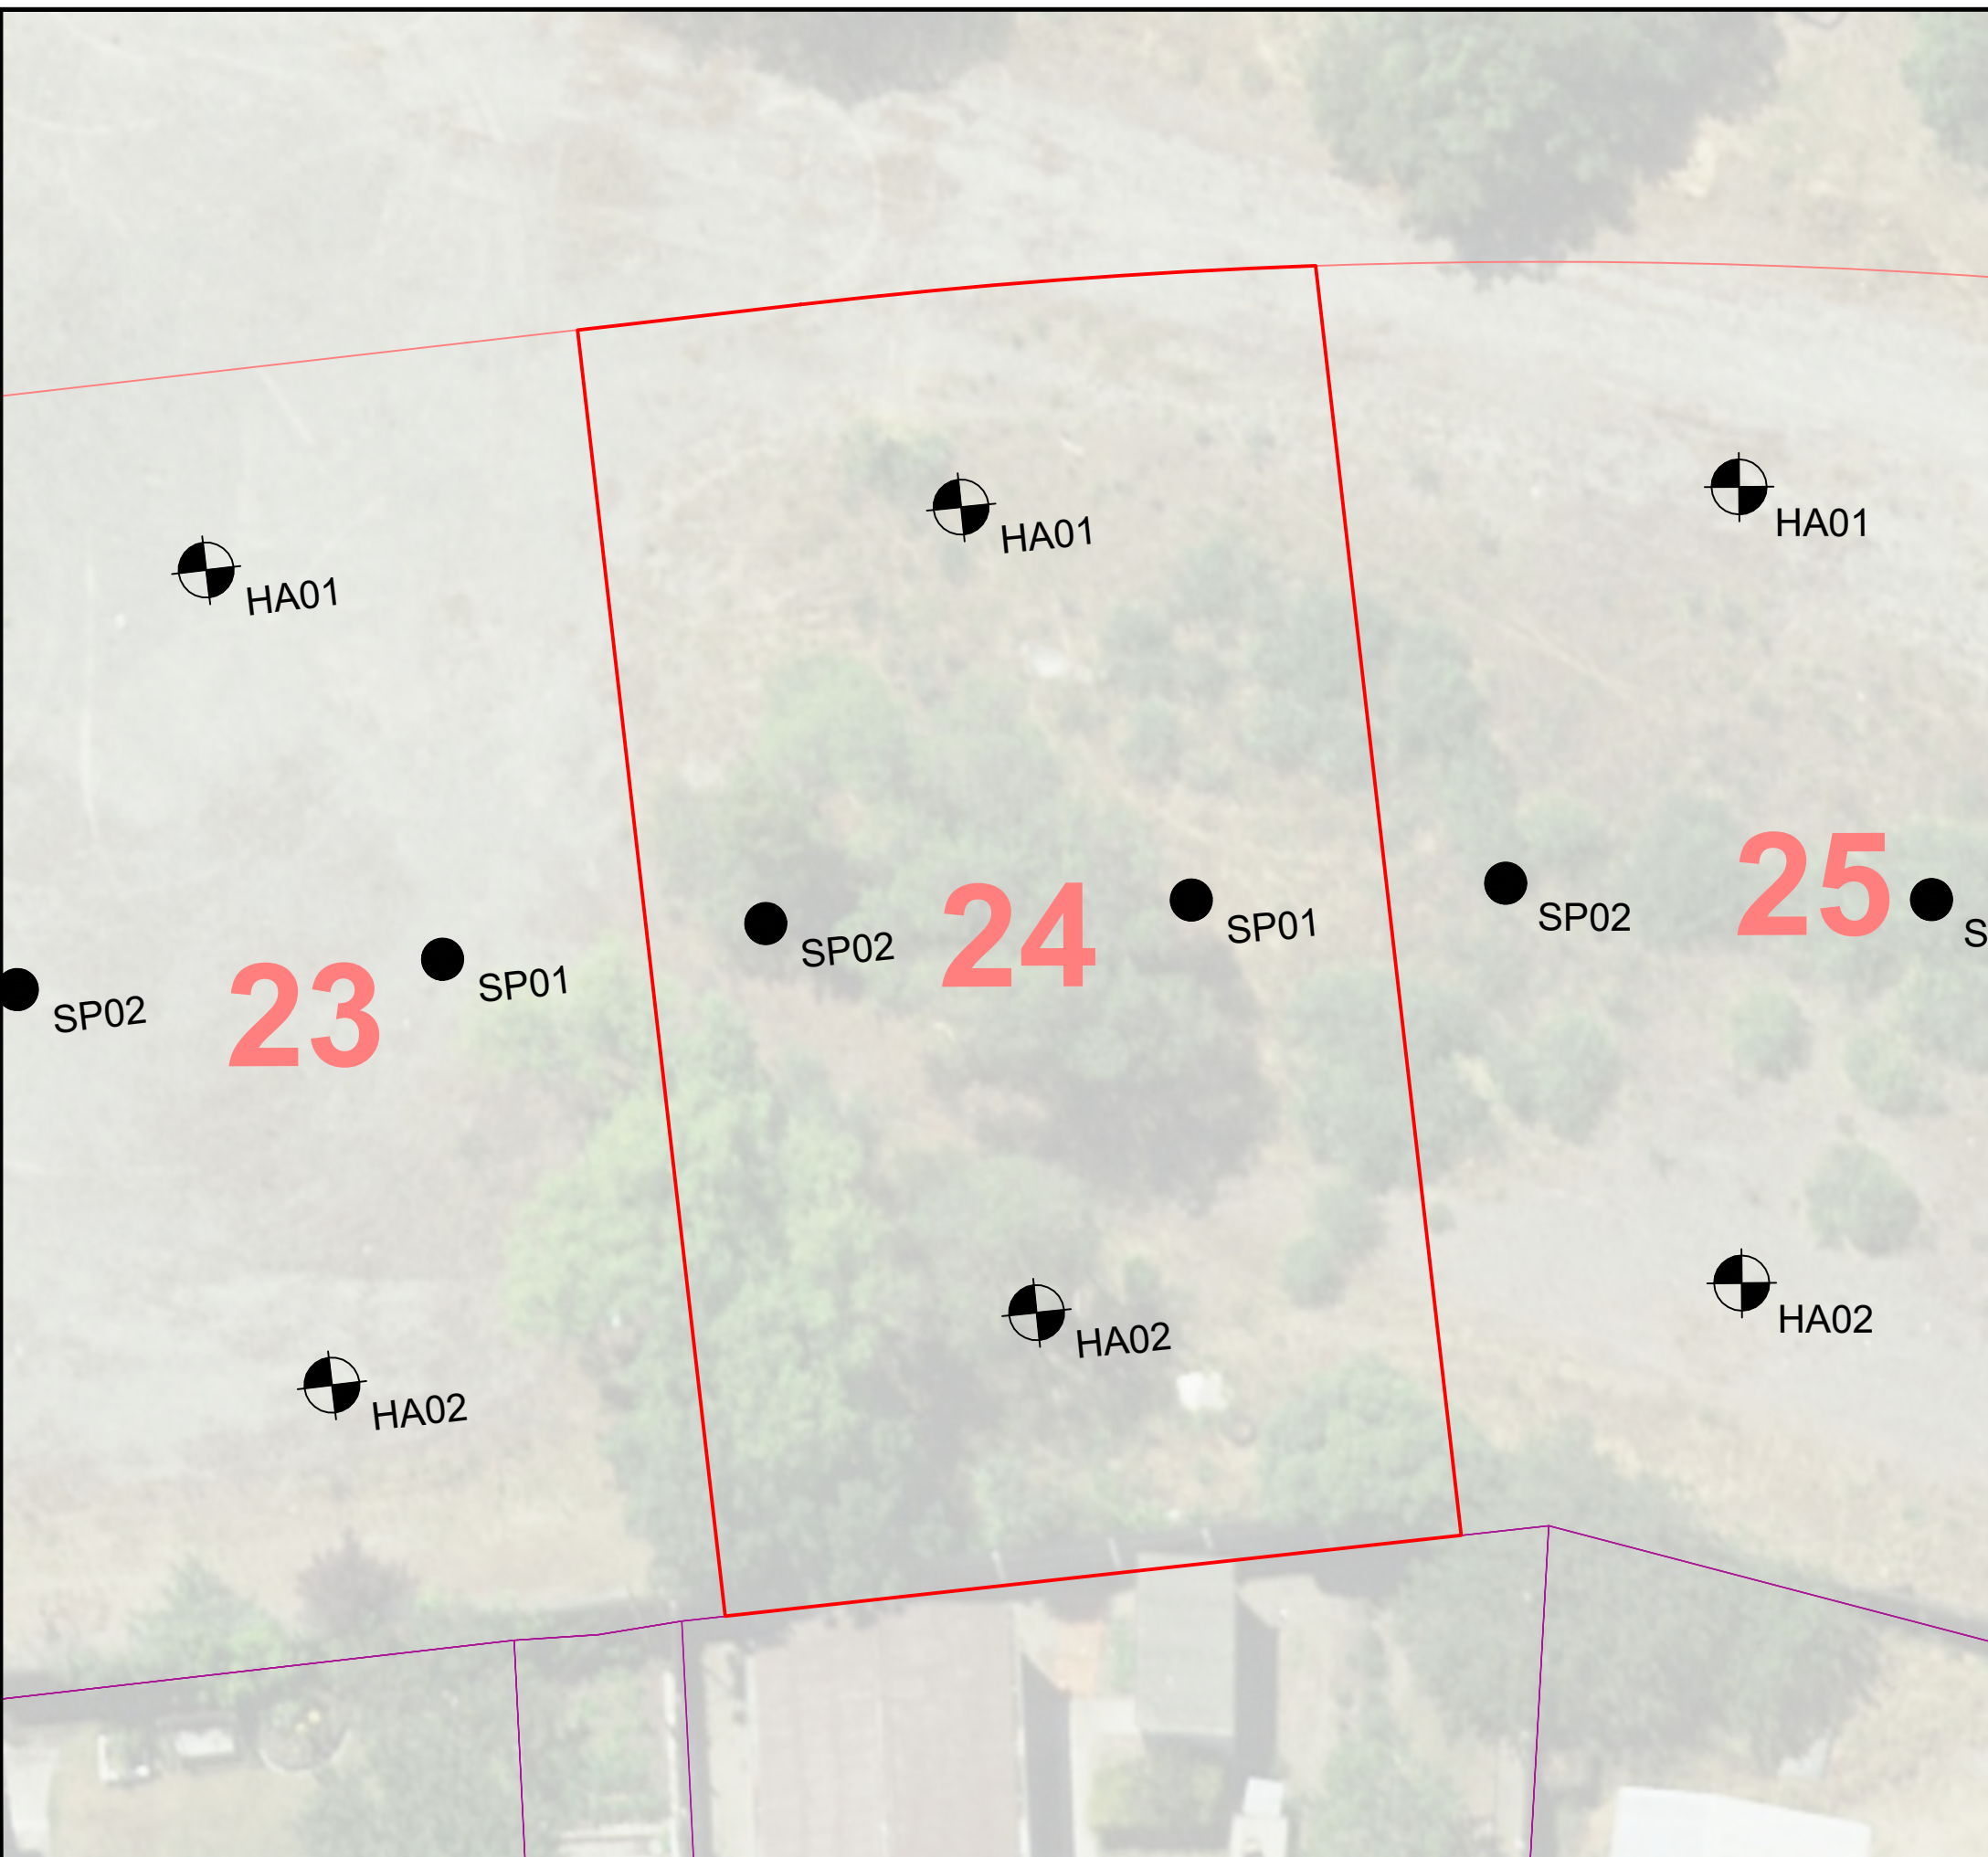
Drawing No: Lot 24/TLP	Drawn by: RM	Date: 30 August 2023
Scale: 1: 150 (A3) 1: 2000 (A3)	Checked by: D Wilson	Revision: B
Filename: LTC21220 - A - Drawings.dwg

LandTech investigated the site on 23 March 2023, conducting two hand augers with corresponding Scala Penetrometer tests (SPs) and two additional SPs. The locations of the hand auger and SPs were measured using inferred lot boundaries and are approximate only. The test locations are shown on our LandTech *Test Location Plan*, Drawing No. Lot 24/ TLP, attached to this report.

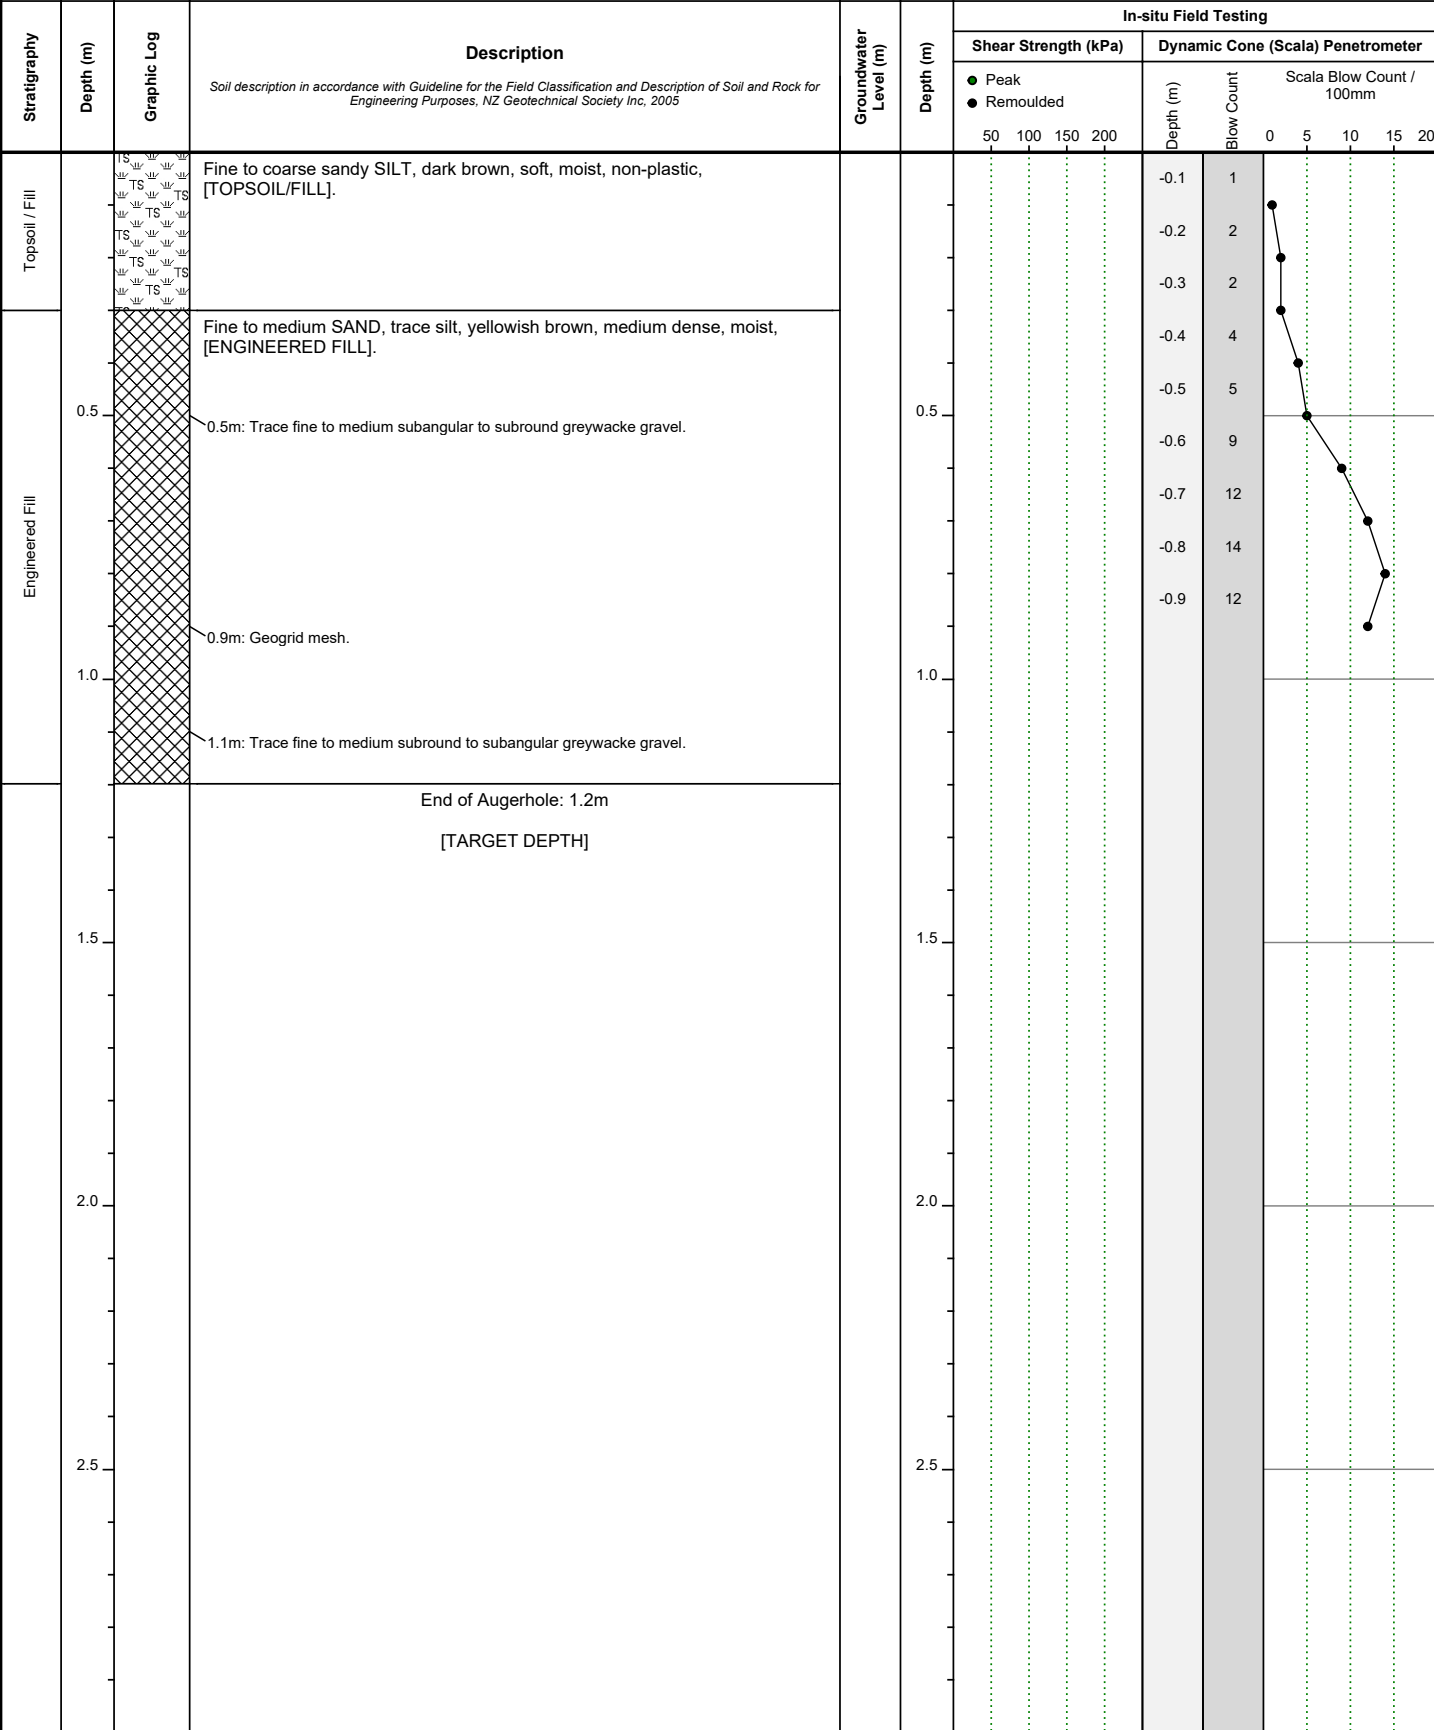
Augerhole No.: LOT 24- HA01

Topsoil was encountered within the hand augers from the ground surface to 0.3m depth, which was typically a dark brown sandy silt material. Engineered fill was encountered below the topsoil to the base of auger holes, which was a compacted yellowish brown sand material with a trace of silt. The hand augers were terminated at 1.2m depth below ground level to avoid damage to the geotextile layer which was installed at 1.5m depth below ground level. Groundwater was not encountered during testing.

Target depth achieved. In-situ testing in accordance with the following standards:
 Scala Penetrometer Testing: NZS 4402:1988, Test 6.5.2, Dynamic Cone Penetrometer
 Shear Vane Testing: Guideline for Hand Held Shear Vane Test, NZGS, August 2001

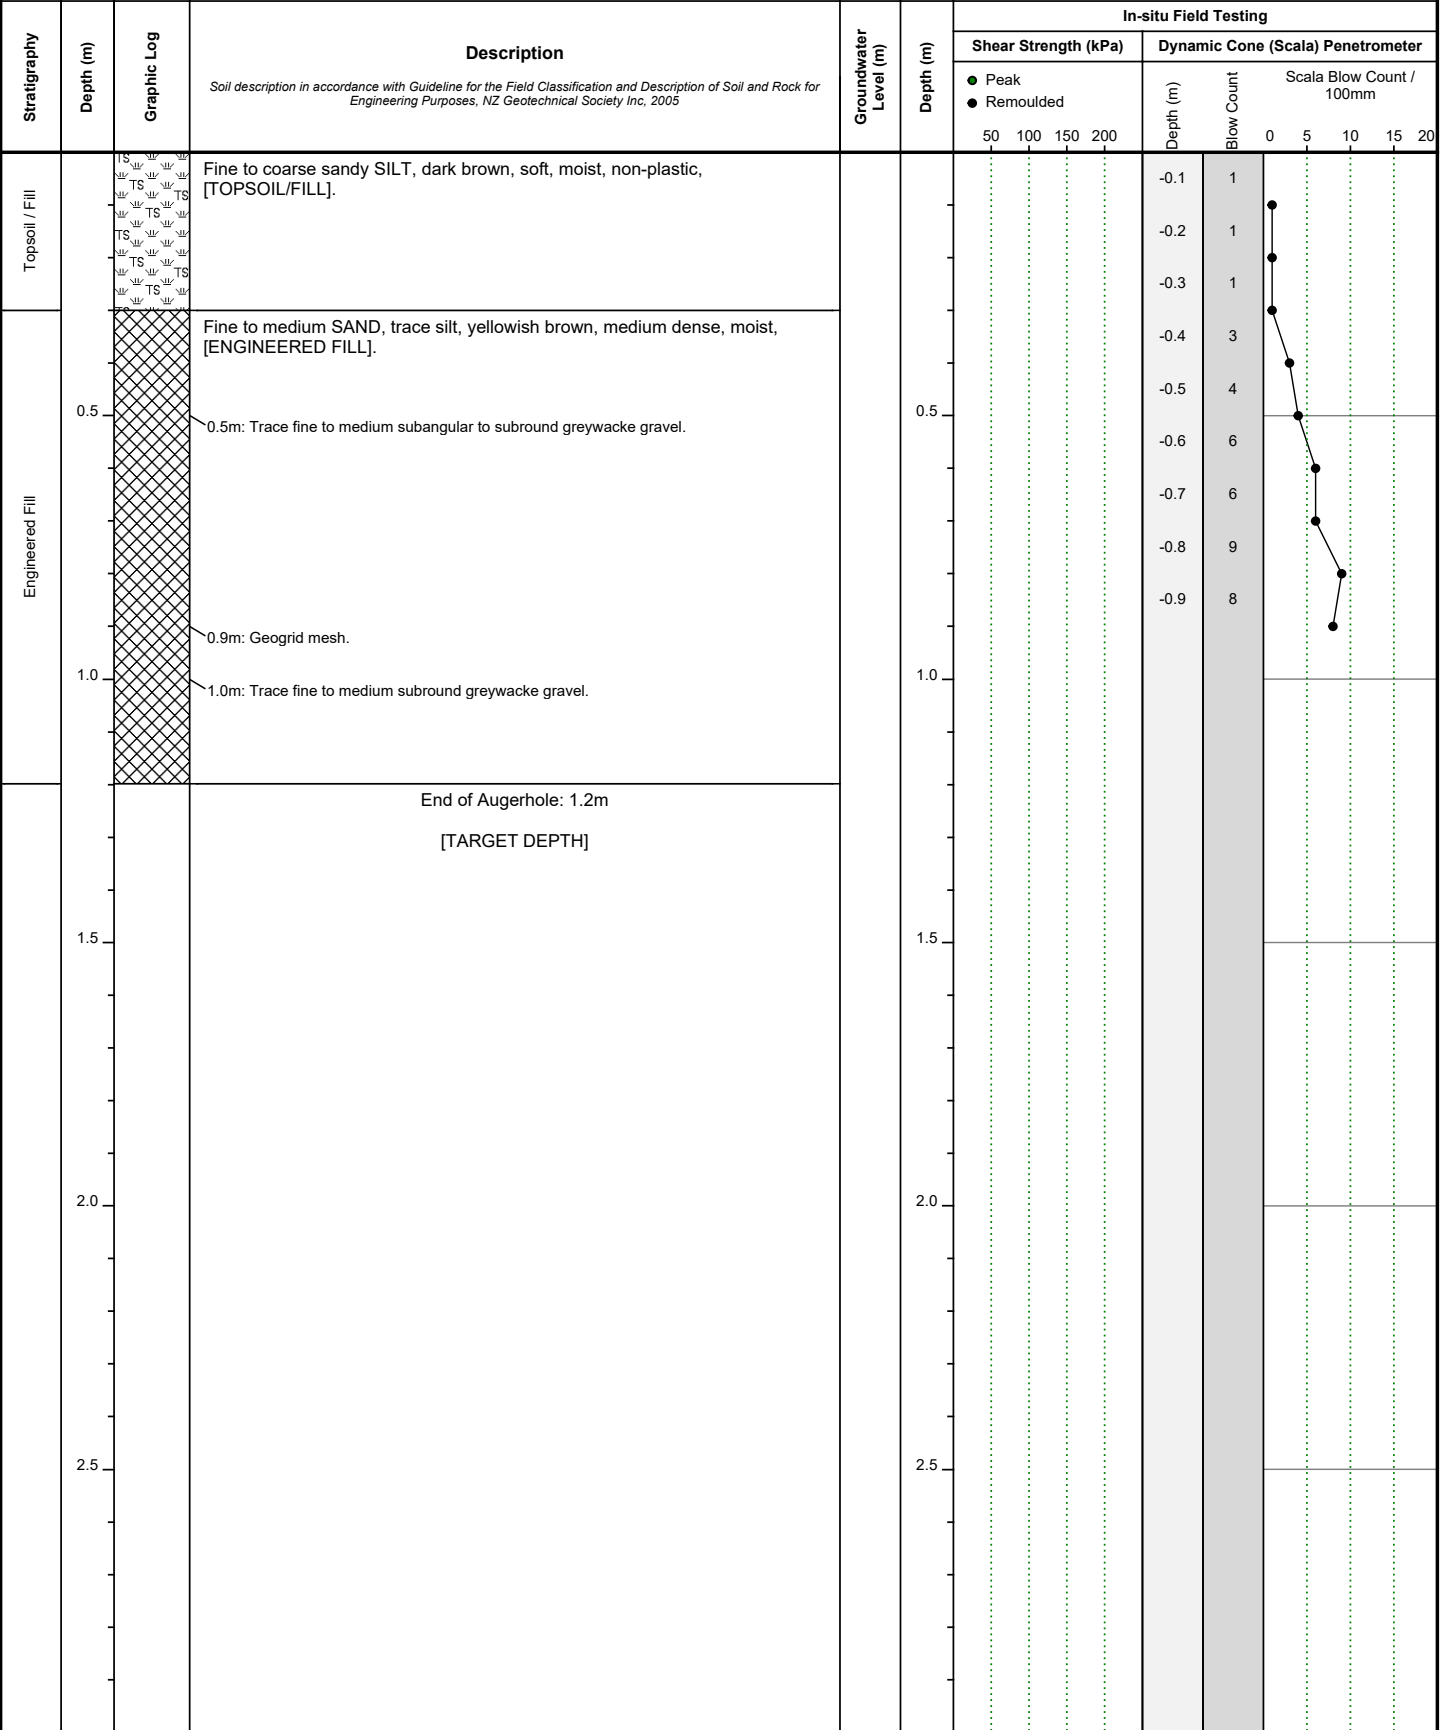
Augerhole No.: LOT 24- HA02

Target depth achieved. In-situ testing in accordance with the following standards:
 Scala Penetrometer Testing: NZS 4402:1988, Test 6.5.2, Dynamic Cone Penetrometer
 Shear Vane Testing: Guideline for Hand Held Shear Vane Test, NZGS, August 2001

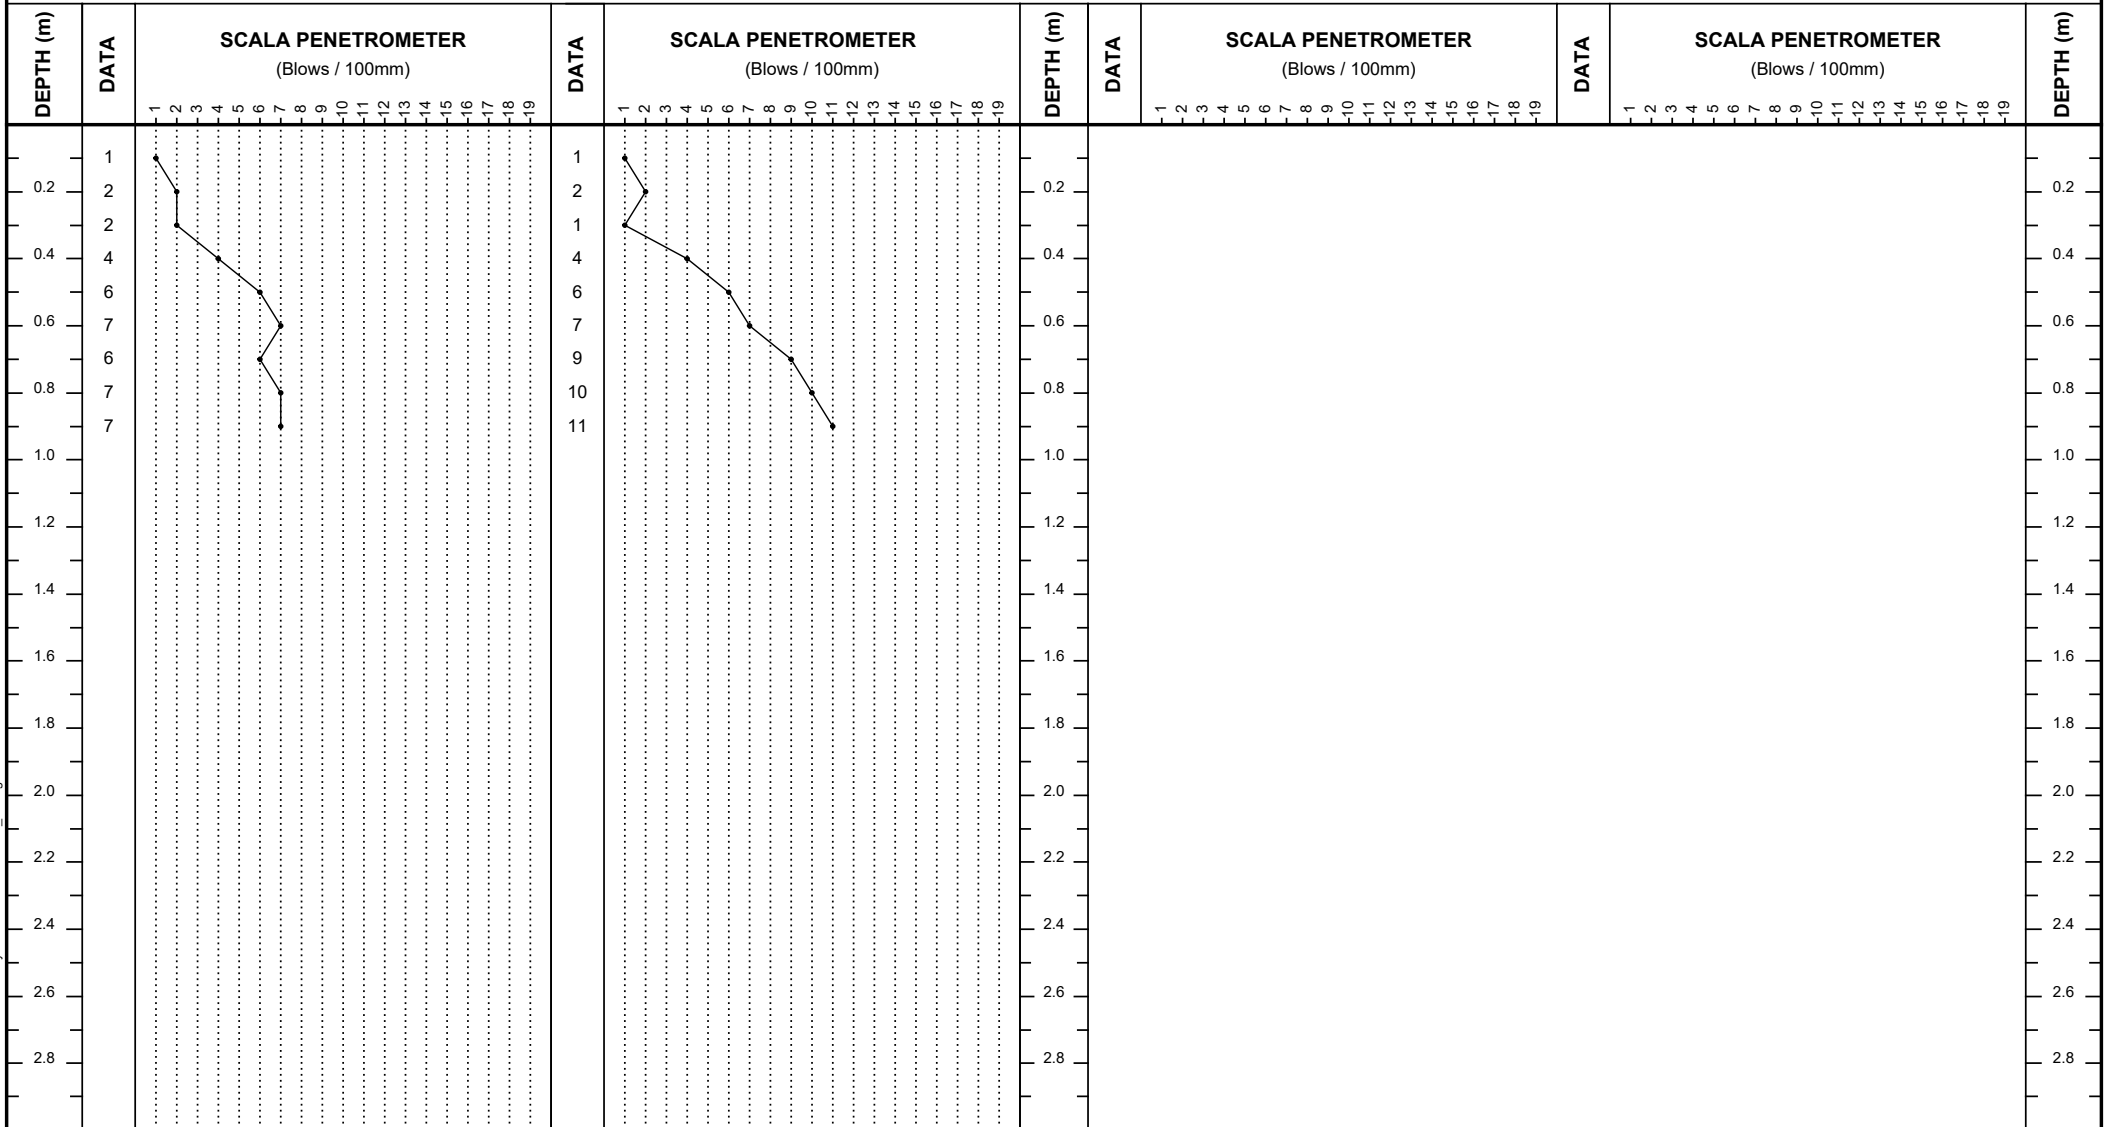
SPs at each of the four locations returned results between 3 and 14 blows per 100mm penetration below the topsoil and within the engineered fill layer. SPs were terminated at 0.9m depth to confirm near surface bearing capacities, and to avoid damage to the geogrids and geotextile. In addition, the density of the engineered fill and bearing capacity of its underlying subgrade have been confirmed via extensive geotechnical inspection and fill compaction testing during subdivision earthworks.
