Date: 30 August 2023  
Project No: LTC21220-A  
Revision: B

Ngai Tahu Property  
115 Eureka Street, Aranui  
Attention: Simon Tucker

**RE: SHALLOW SOIL TEST REPORT  
FUTURE RESIDENTIAL FOUNDATIONS  
LOT 28, 115 EUREKA STREET, ARANUI**

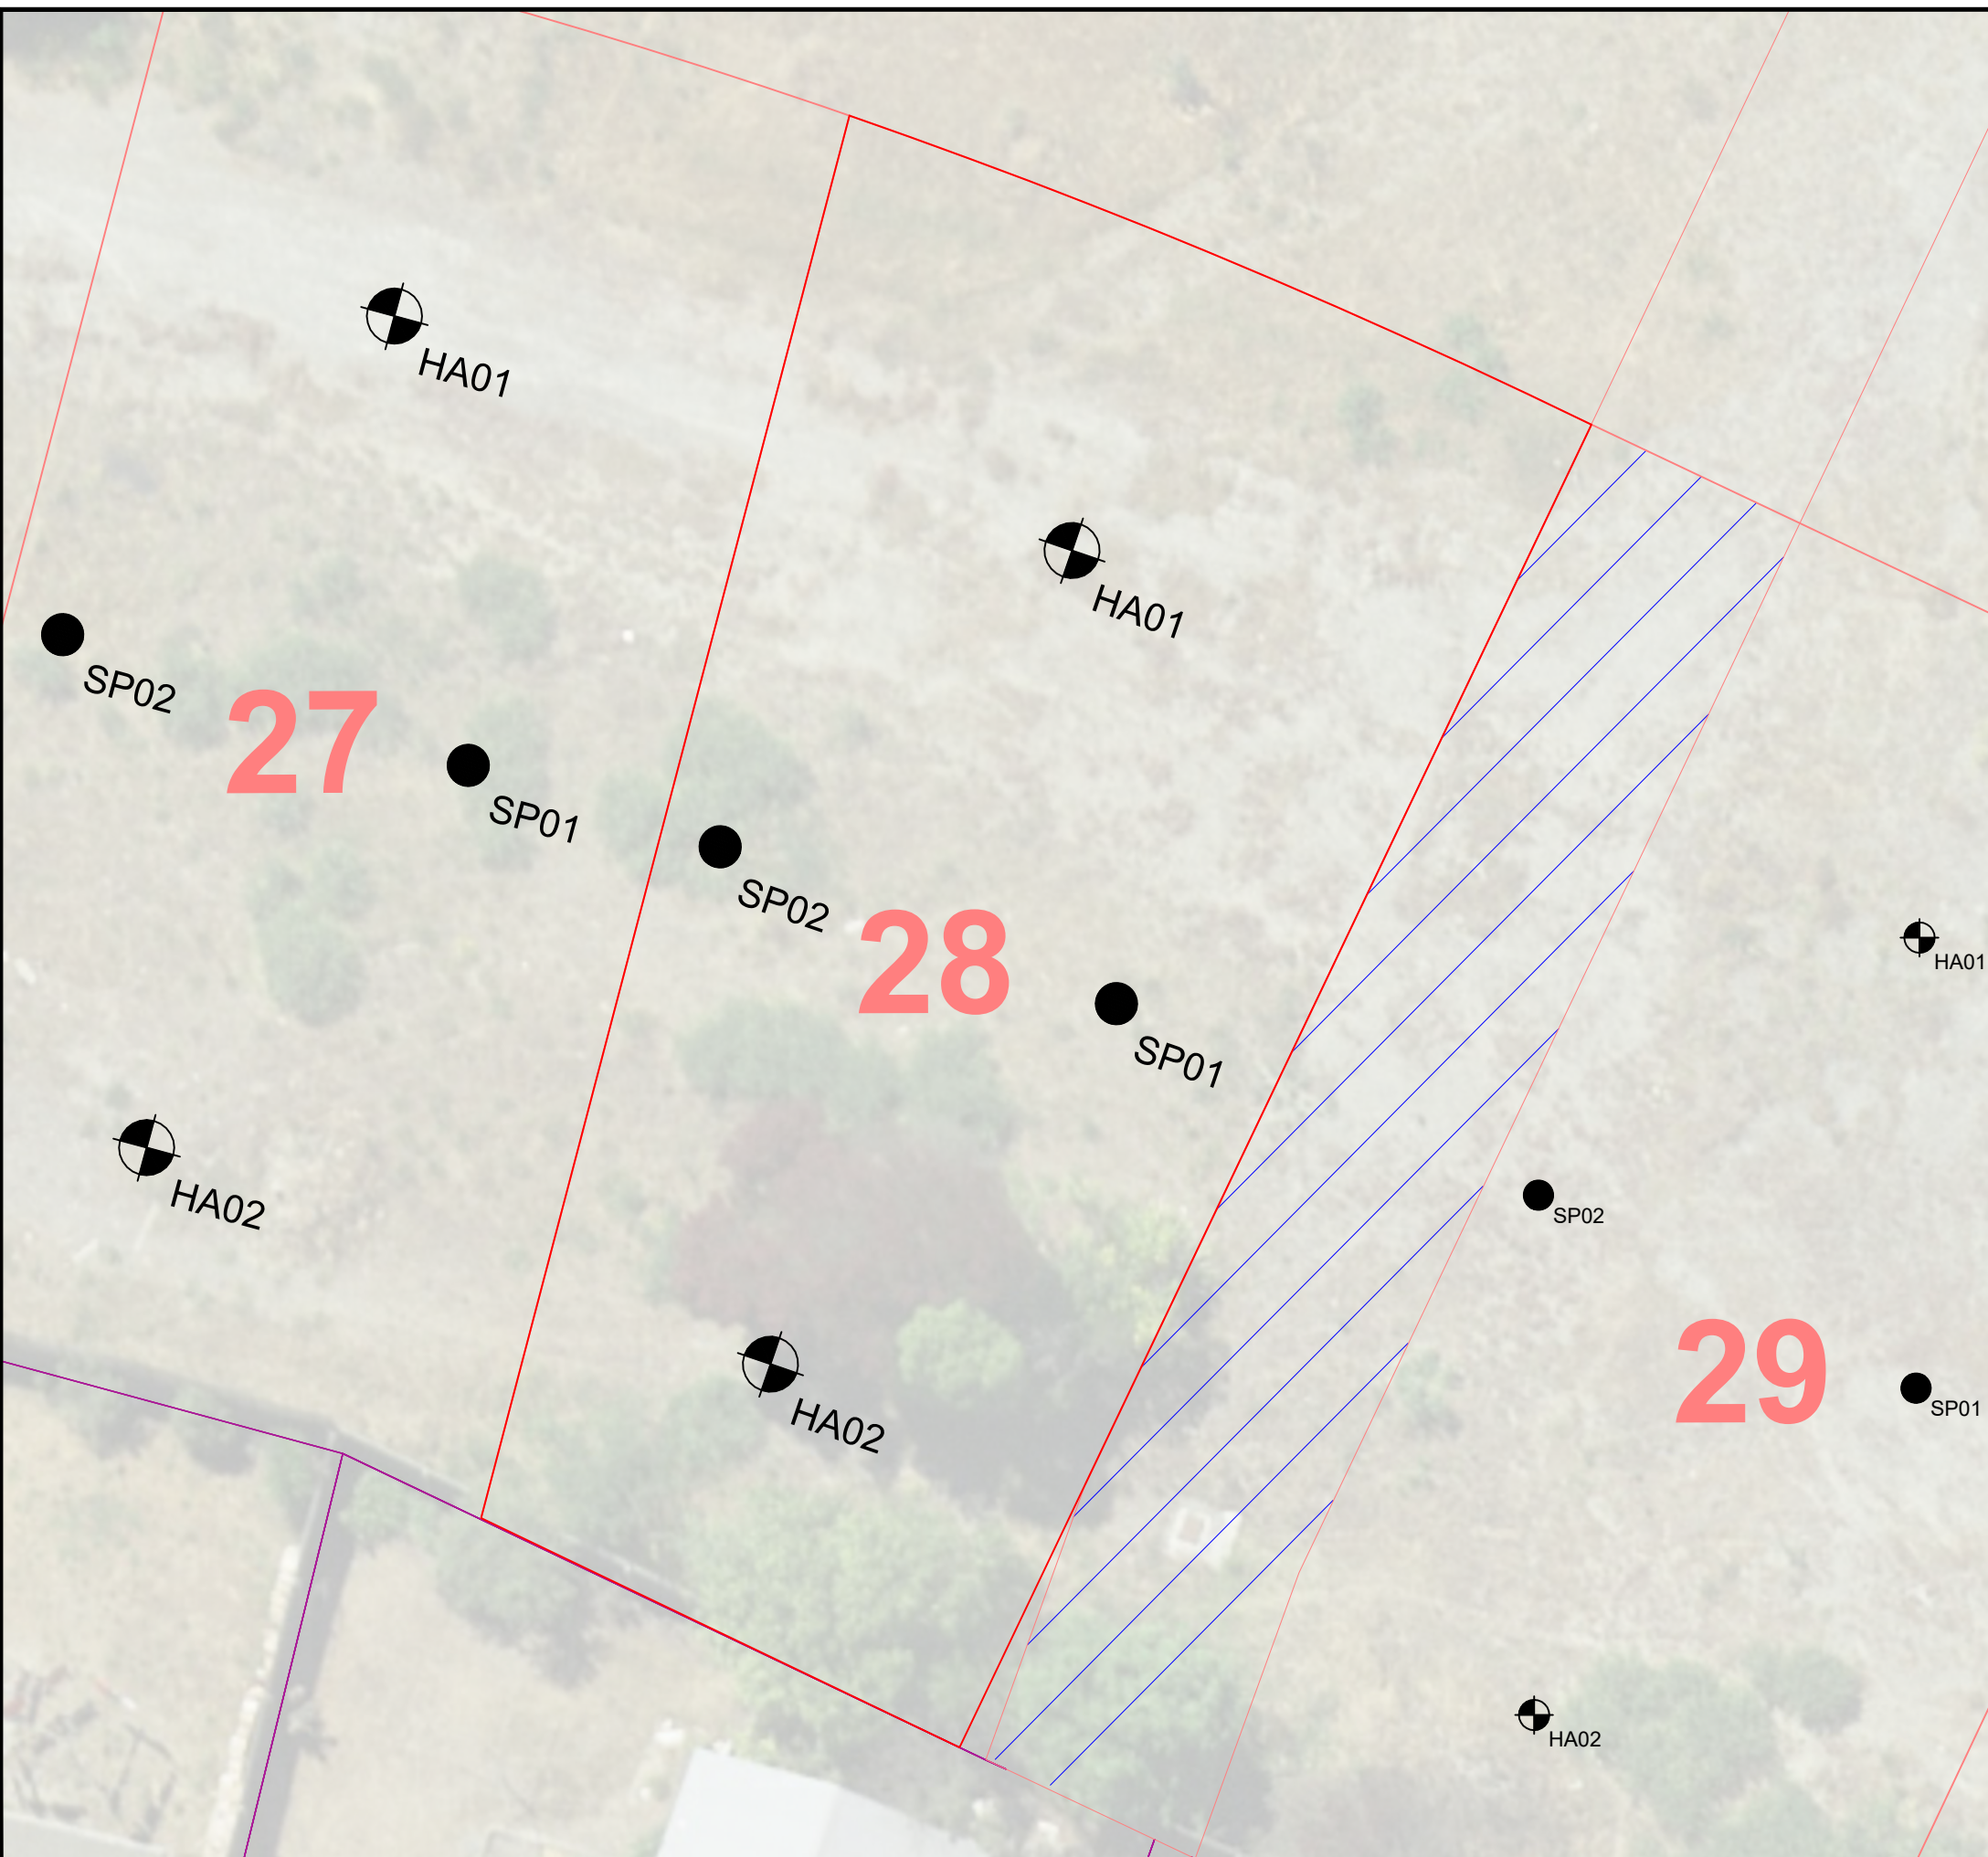
**Test Location Plan**

LandTech investigated the site on 23 March 2023, conducting two hand augers with corresponding Scala Penetrometer tests (SPs) and two additional SPs. The locations of the hand auger and SPs were measured using inferred lot boundaries and are approximate only. The test locations are shown on our LandTech *Test Location Plan*, Drawing No. Lot 28/ TLP, attached to this report.

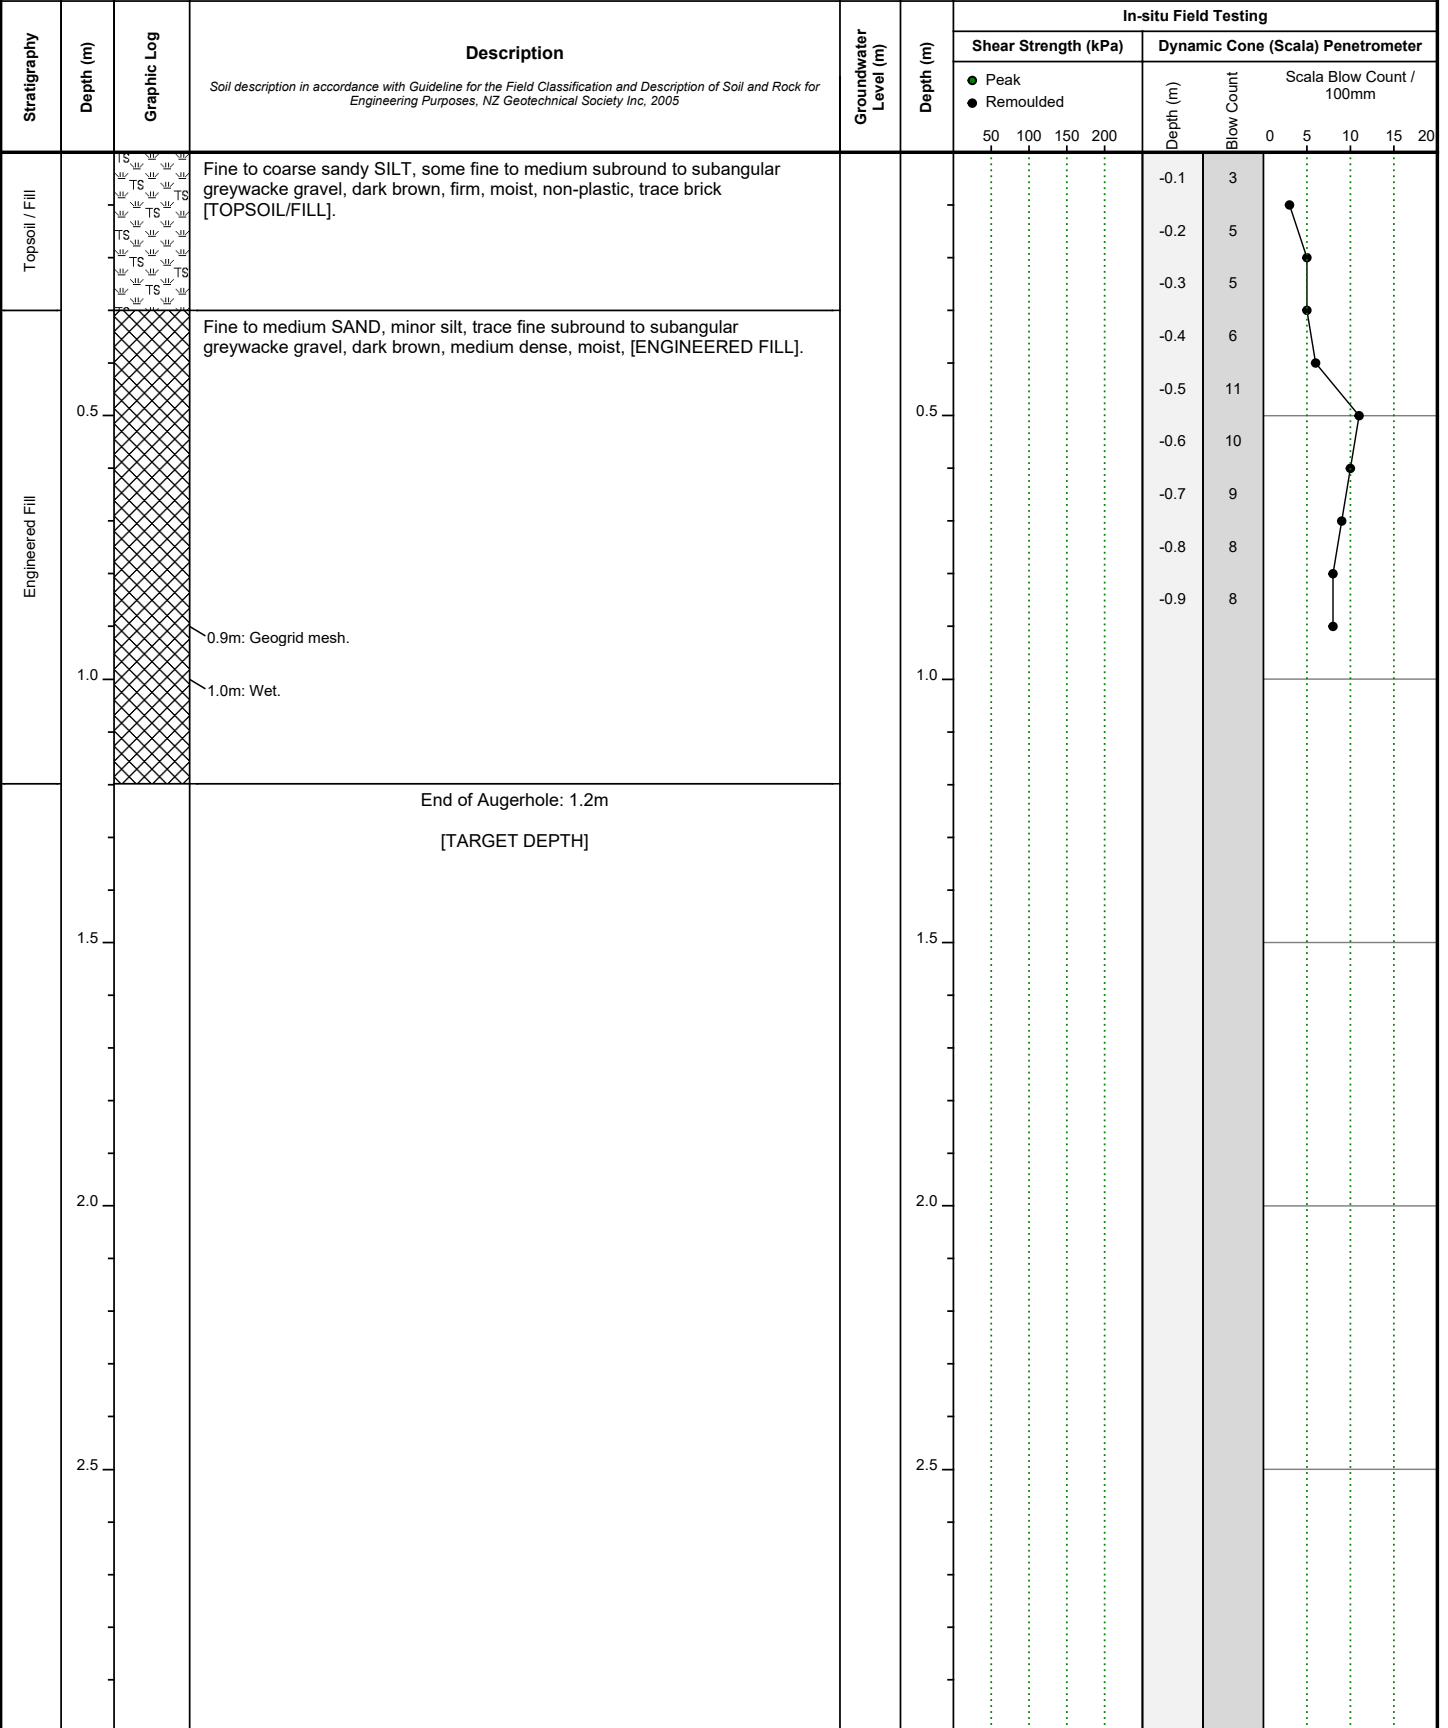
**Augerhole No.:** LOT 28- HA01

Topsoil was encountered within the hand augers from the ground surface to 0.3m depth, which was typically a dark brown sandy silt material with some gravel. Engineered fill was encountered below the topsoil to the base of auger holes, which was a compacted brown sand material with a trace of silt and gravel. The hand augers were terminated at 1.2m depth below ground level to avoid damage to the geotextile layer which was installed at 1.5m depth below ground level. Groundwater was not encountered during testing.

Target depth achieved.      In-situ testing in accordance with the following standards:  
 Scala Penetrometer Testing: NZS 4402:1988, Test 6.5.2, Dynamic Cone Penetrometer  
 Shear Vane Testing: Guideline for Hand Held Shear Vane Test, NZGS, August 2001

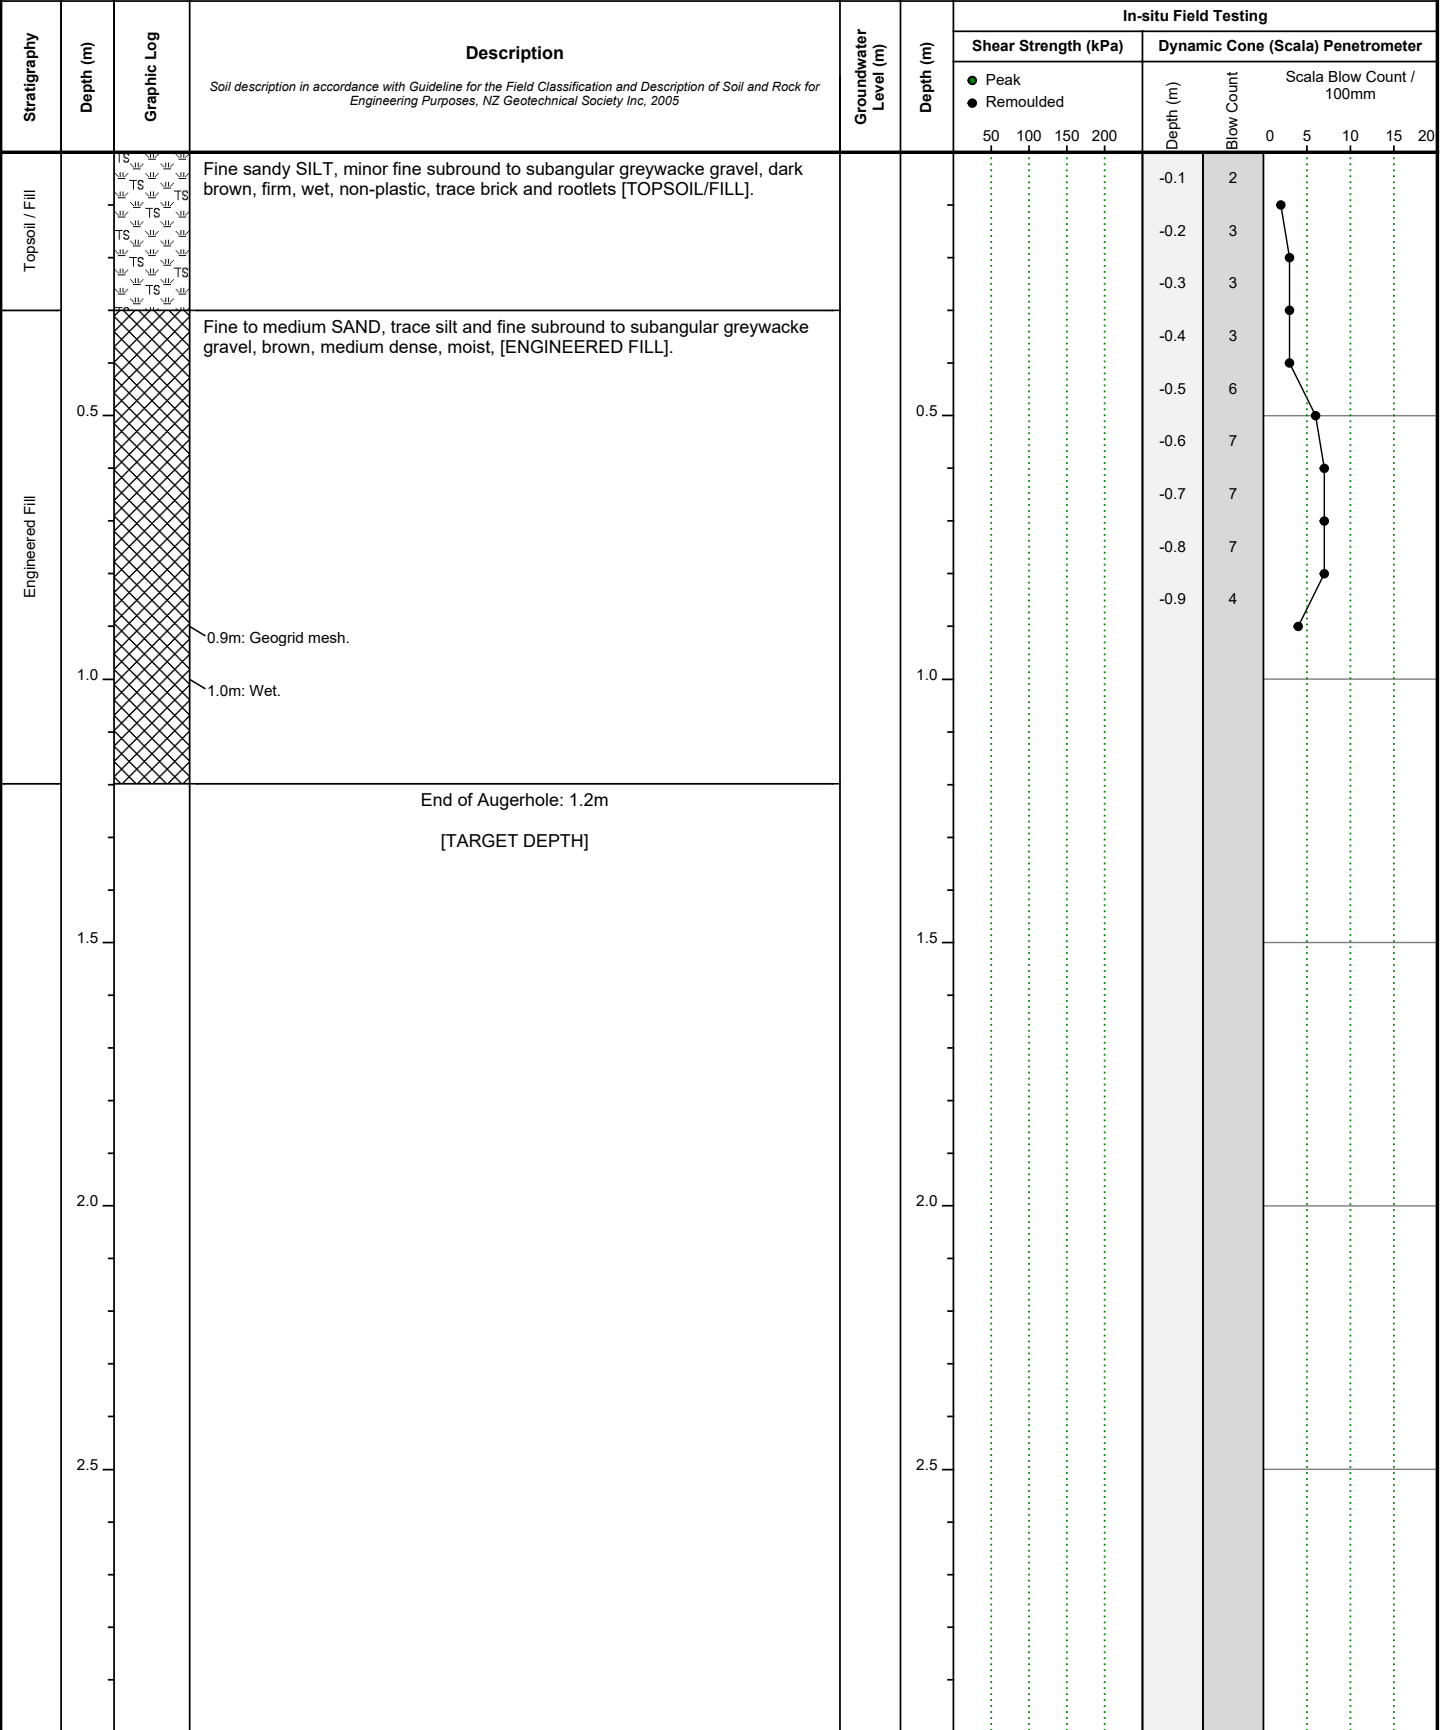
Augerhole No.: LOT 28- HA02

Target depth achieved.      In-situ testing in accordance with the following standards:  
 Scala Penetrometer Testing: NZS 4402:1988, Test 6.5.2, Dynamic Cone Penetrometer  
 Shear Vane Testing: Guideline for Hand Held Shear Vane Test, NZGS, August 2001

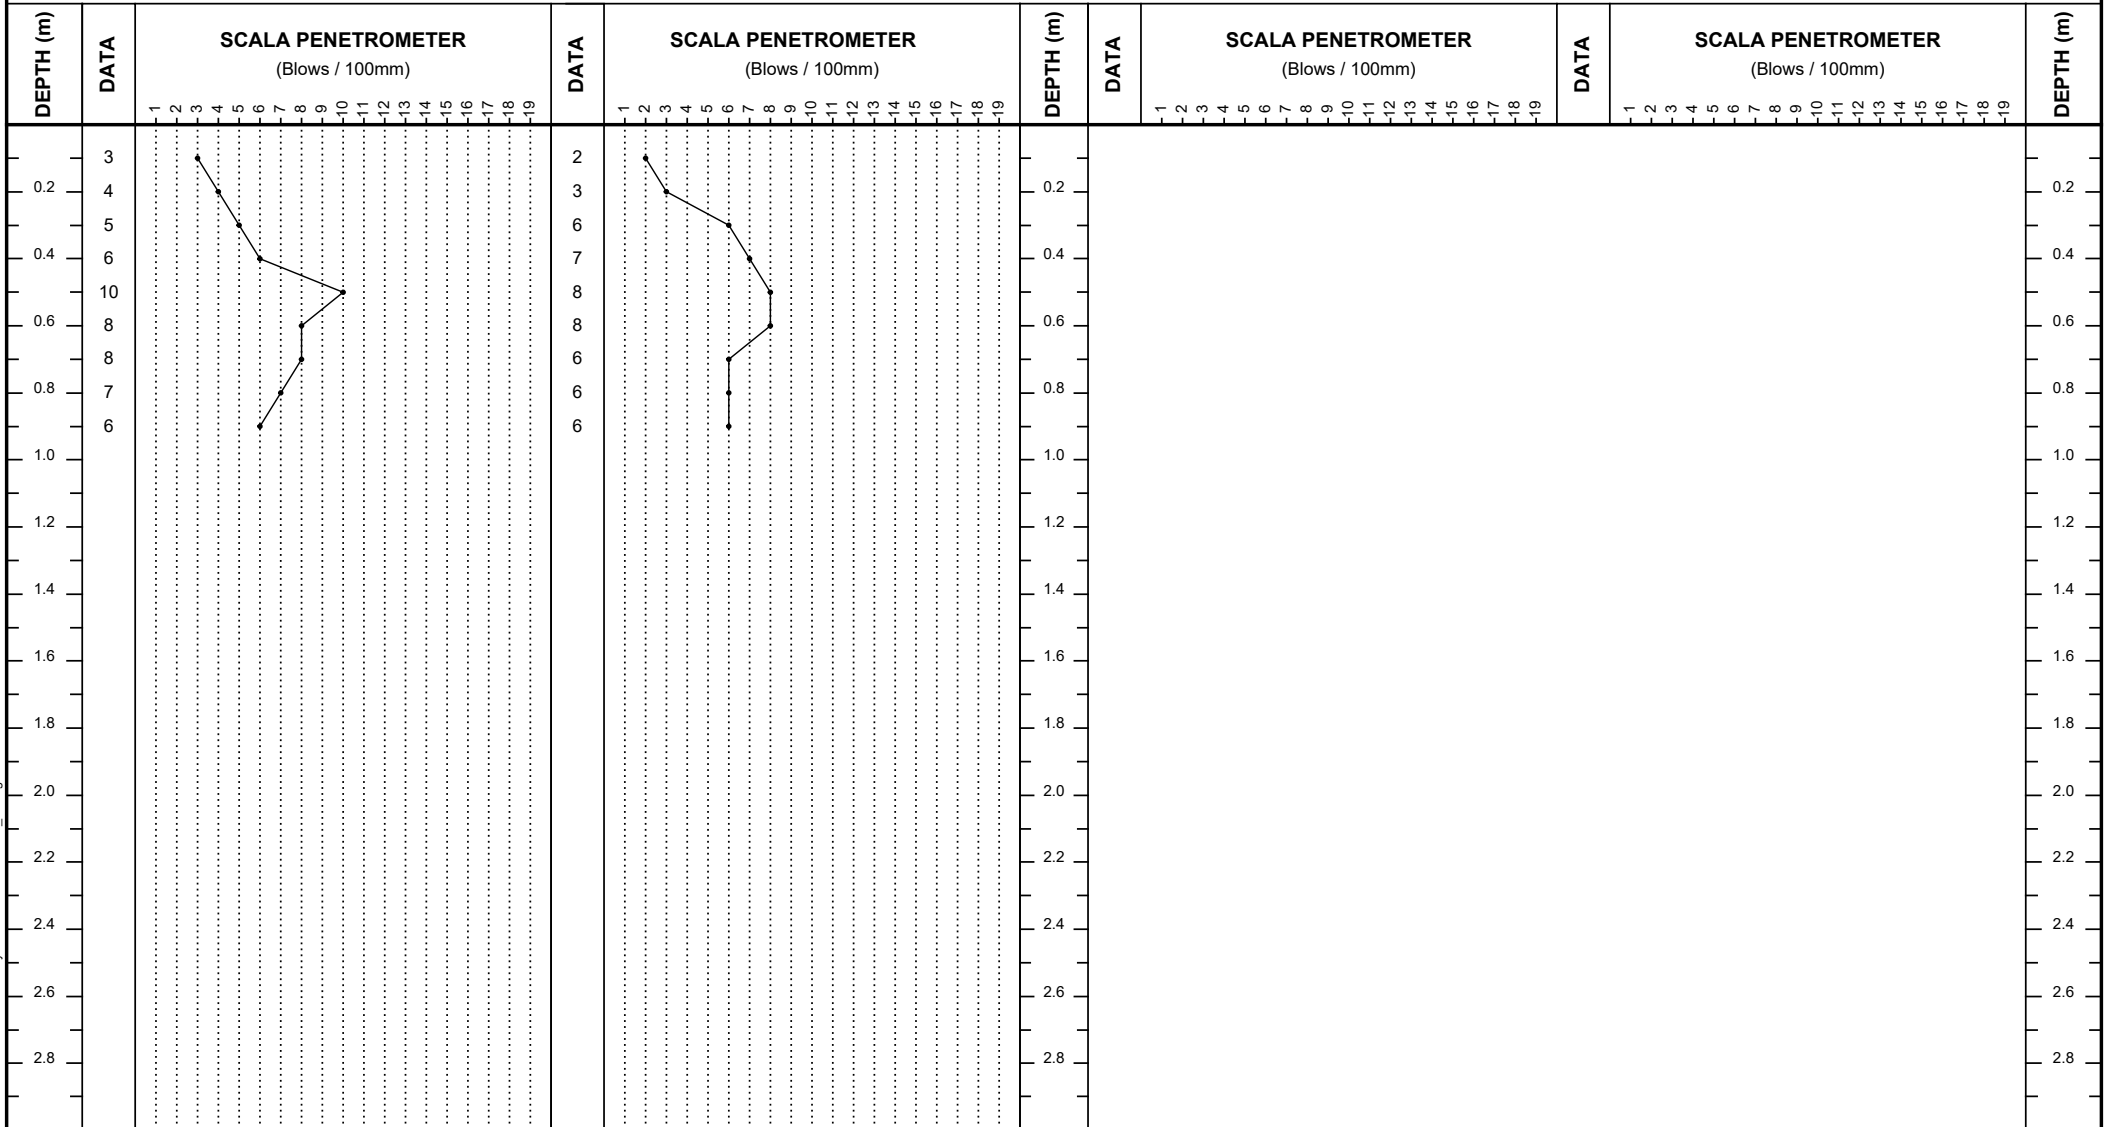
SPs at each of the four locations returned results between 3 and 11 blows per 100mm penetration below the topsoil and within the engineered fill layer. SPs were terminated at 0.9m depth to confirm near surface bearing capacities, and to avoid damage to the geogrids and geotextile. In addition, the density of the engineered fill and bearing capacity of its underlying subgrade have been confirmed via extensive geotechnical inspection and fill compaction testing during subdivision earthworks.
