Date: 30 August 2023  
Project No: LTC21220-A  
Revision: B

**RE: SHALLOW SOIL TEST REPORT  
FUTURE RESIDENTIAL FOUNDATIONS  
LOT 11, 115 EUREKA STREET, ARANUI**

**Test Location Plan**  
 Lot 11, 115 Eureka Street,  
 ARANUI, CHRISTCHURCH

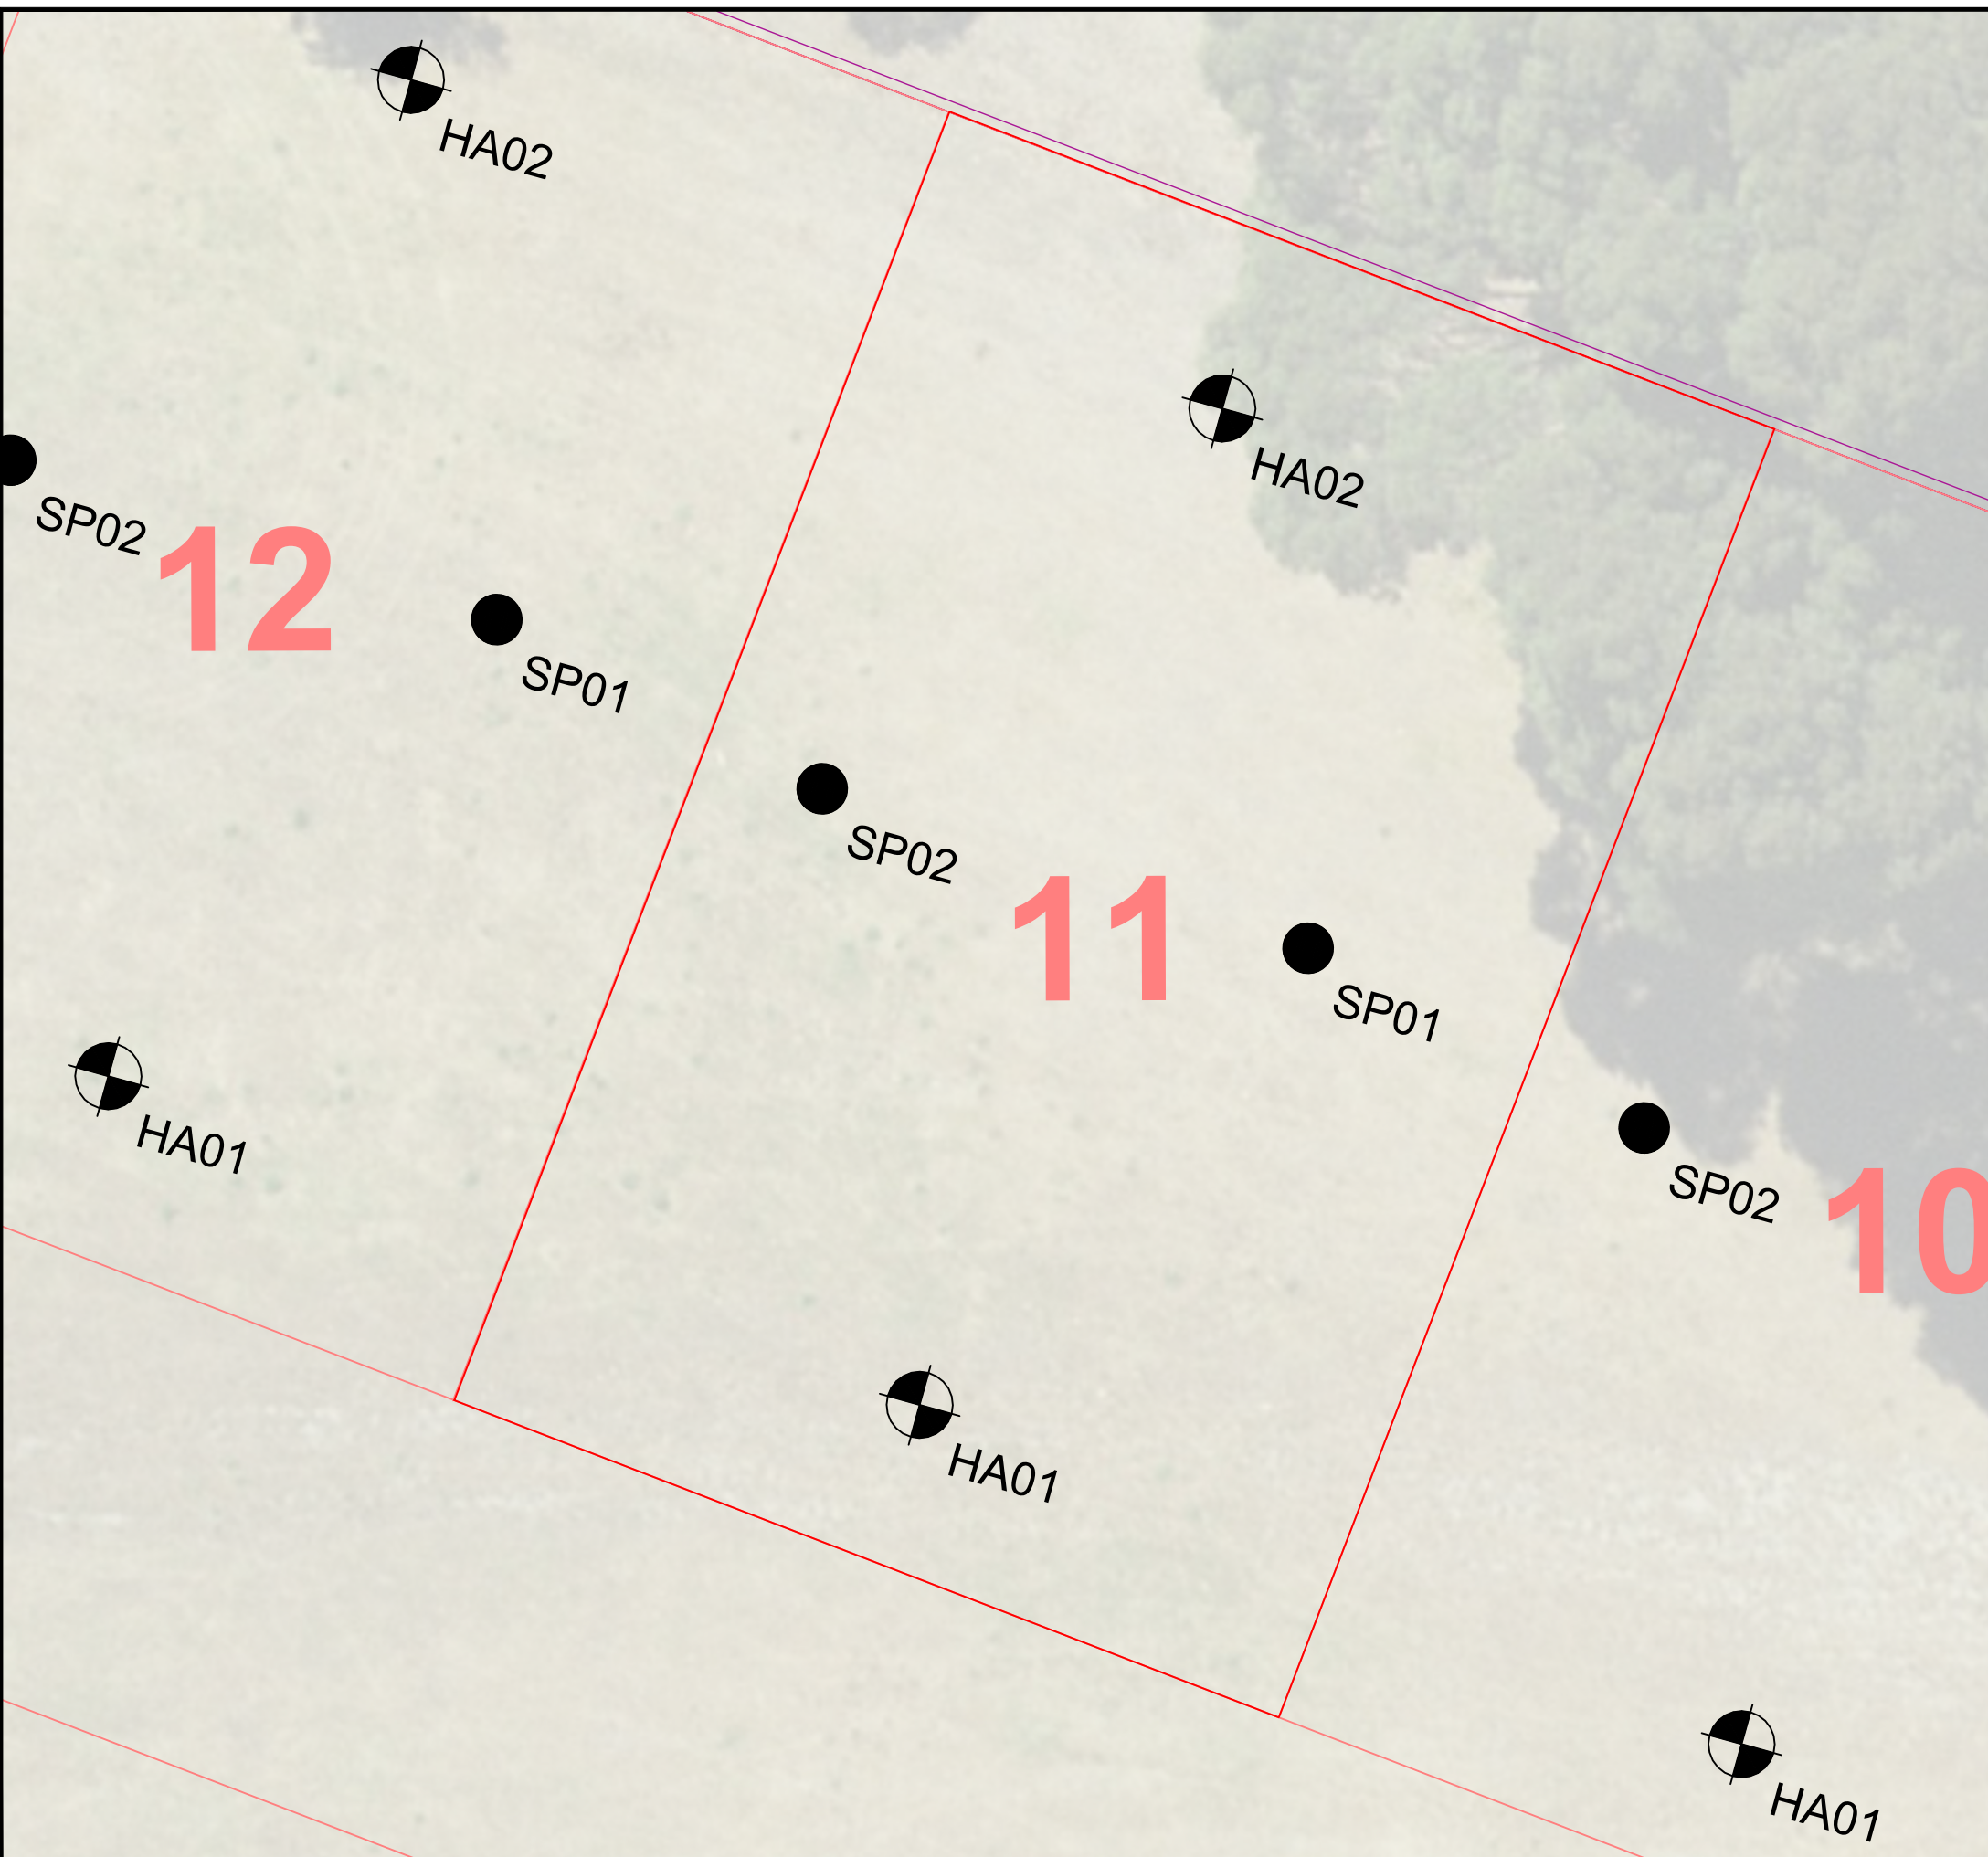
Drawing No: Lot 11/TLP	Drawn by: RM	Date: 30 August 2023
Scale: 1: 125 (A3) 1: 2000 (A3)	Checked by: D Wilson	Revision: B
Filename: LTC21220 - A - Drawings.dwg

LandTech investigated the site on 1 June 2023, conducting two hand augers with corresponding Scala Penetrometer tests (SPs) and two additional SPs. The locations of the hand auger and SPs were measured using inferred lot boundaries and are approximate only. The test locations are shown on our LandTech *Test Location Plan*, Drawing No. Lot 11/ TLP, attached to this report.

HA01 LandTech Consulting Ltd. augerhole locations, drilled 01 June 2023
-

SP01 LandTech Consulting Ltd. DCP test location, tested 01 June 2023
-

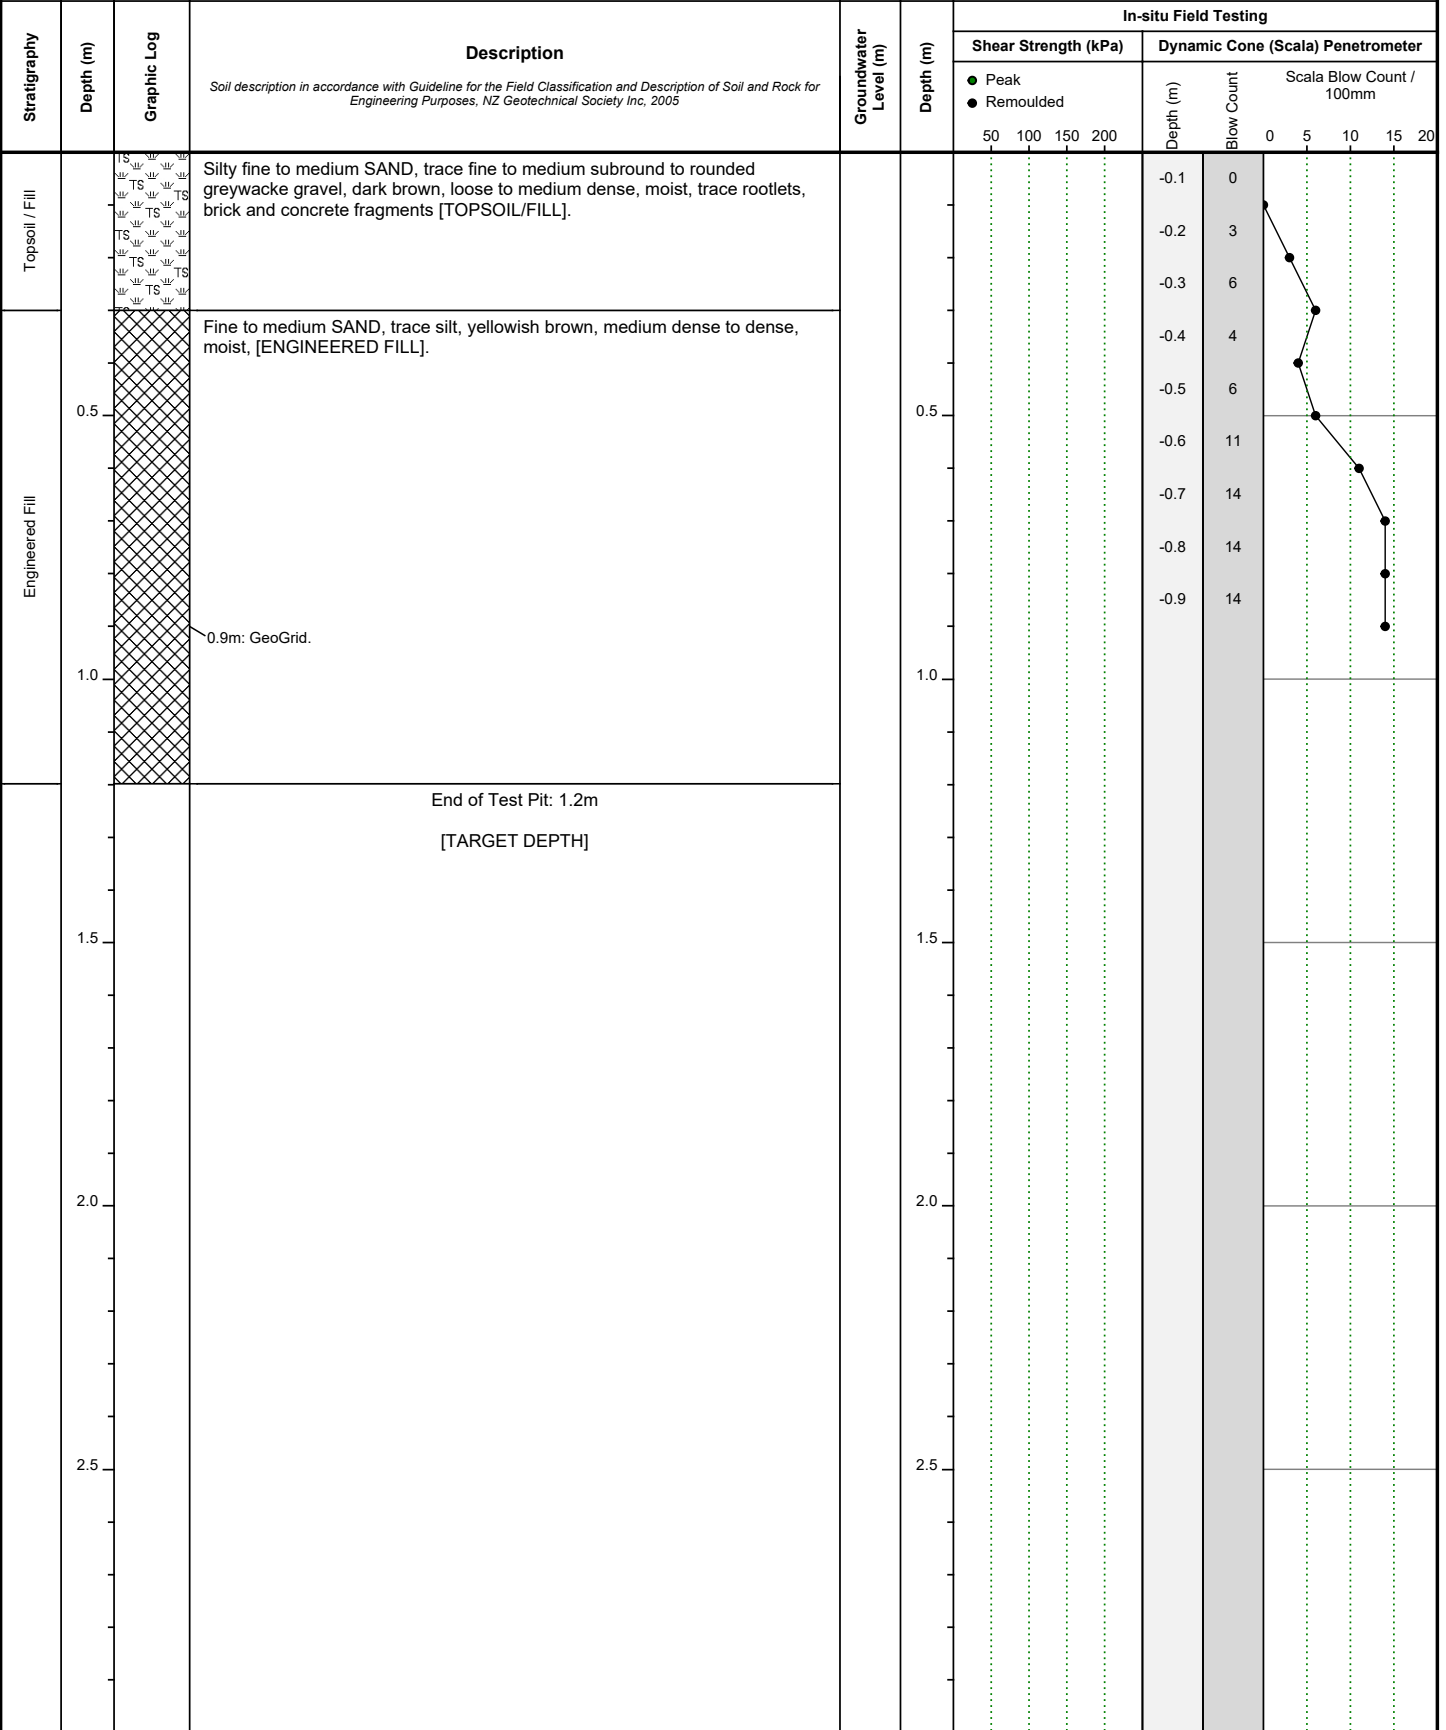
Test Pit No.: Lot 11 - HA01

Topsoil was encountered within the hand augers from the ground surface to 0.3m depth, which was typically a dark brown silty sand material. Engineered fill was encountered below the topsoil to the base of auger holes, which was a compacted yellowish brown sand material with a trace of silt. The hand augers were terminated at 1.2m depth below ground level to avoid damage to the geotextile layer which was installed at 1.5m depth below ground level. Groundwater was not encountered during testing.

Target depth achieved.

Soil types and conditions within the hand augers were logged by LandTech technical staff in accordance with New Zealand Geotechnical Society *Guideline for the Description of Soil and Rock for Engineering Purposes* (2005). The hand auger logs for each hole are attached.

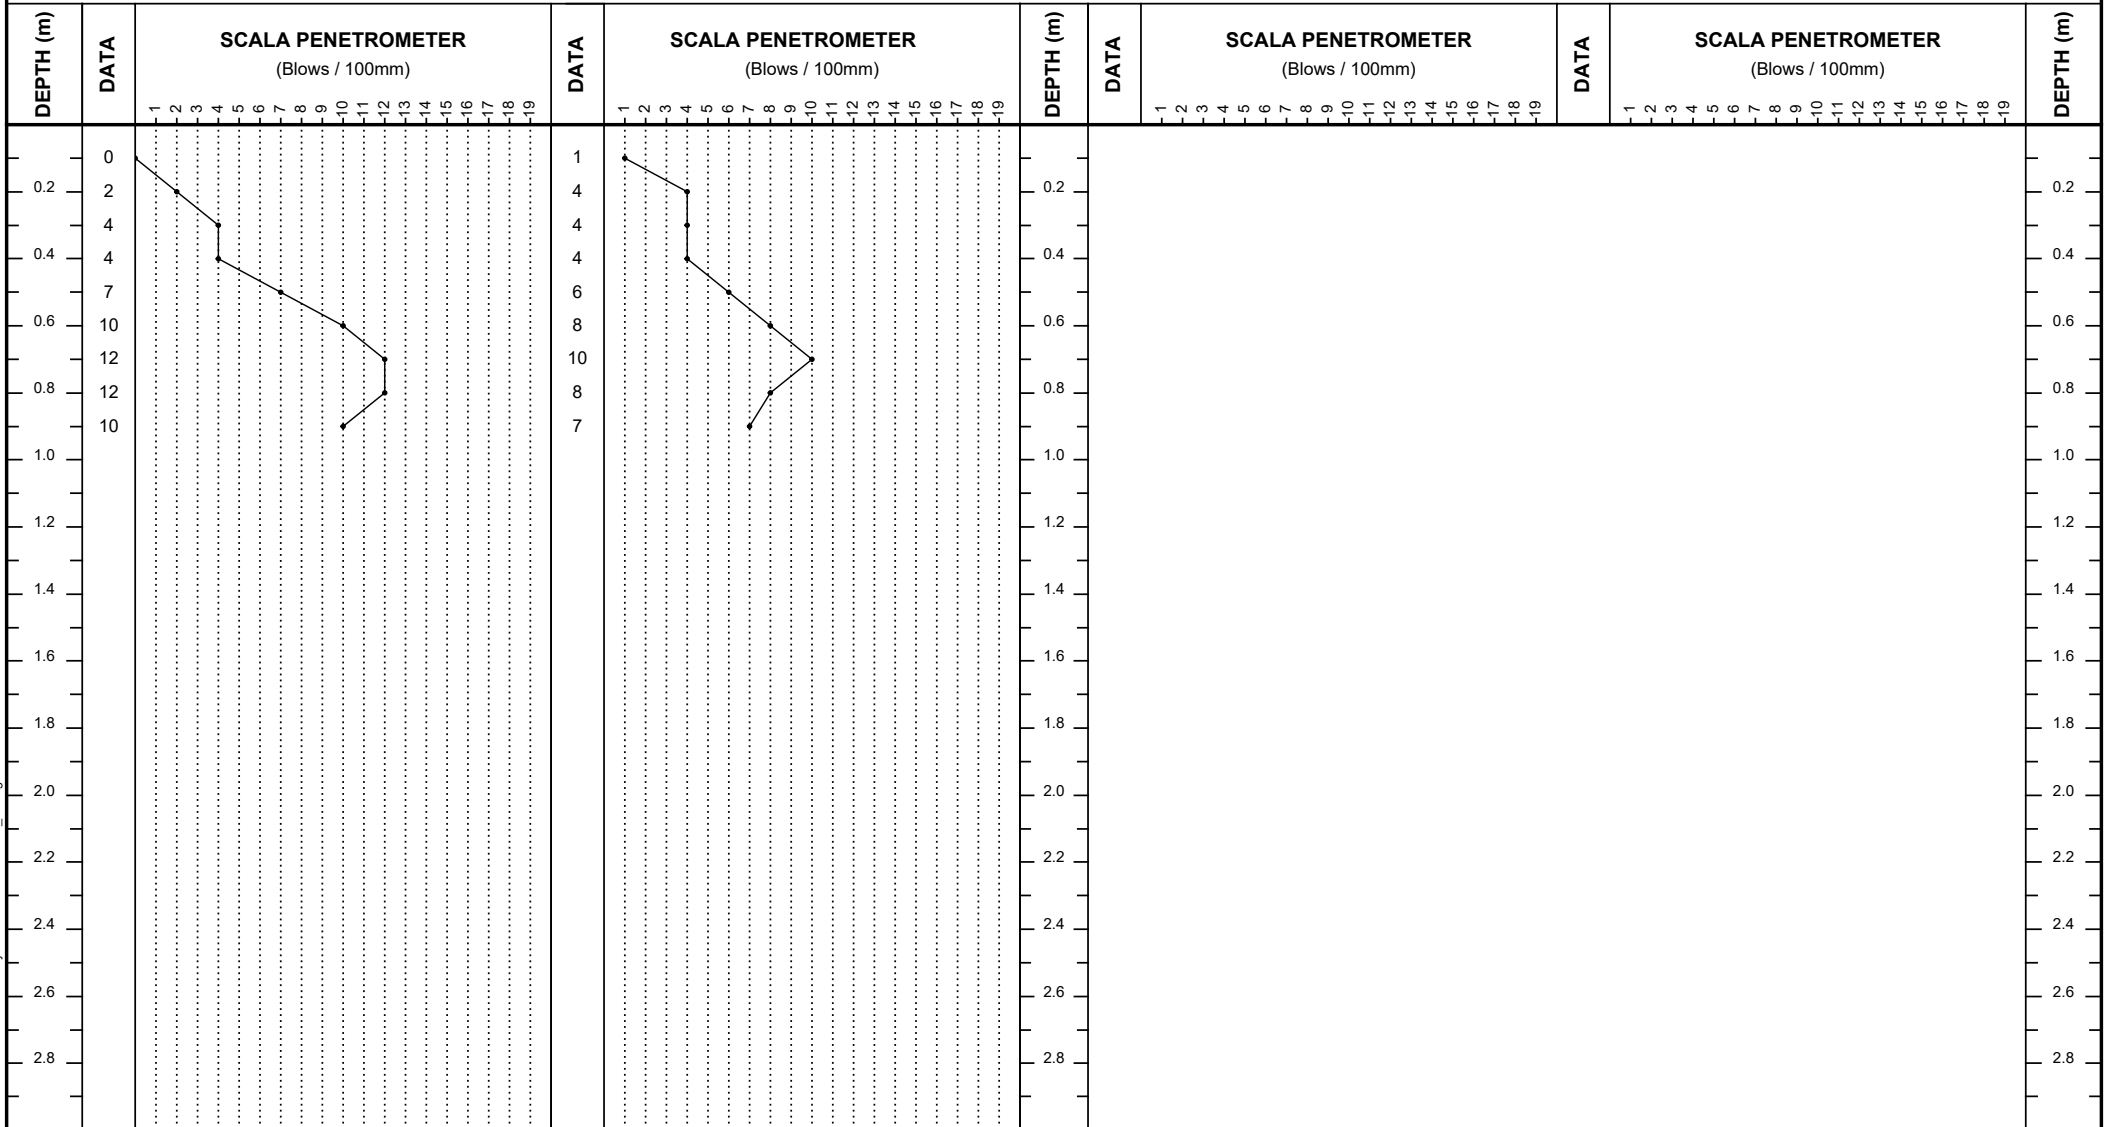
**LOT 11- SP01**

SPs at each of the four locations returned results between 4 and 14 blows per 100mm penetration below the topsoil and within the engineered fill layer. SPs were terminated at 0.9m depth to confirm near surface bearing capacities, and to avoid damage to the geogrids and geotextile. In addition, the density of the engineered fill and bearing capacity of its underlying subgrade have been confirmed via extensive geotechnical inspection and fill compaction testing during subdivision earthworks.

Our SP testing was carried out in accordance with NZS 4402:1988, Test 6.5.2, *Dynamic Cone Penetrometer*. The SP results are also attached.
