Date: 30 August 2023
Project No: LTC21220-A
Revision: B

**RE: SHALLOW SOIL TEST REPORT
FUTURE RESIDENTIAL FOUNDATIONS
LOT 16, 115 EUREKA STREET, ARANUI**

Test Location Plan
 Lot 16, 115 Eureka Street,
 ARANUI, CHRISTCHURCH

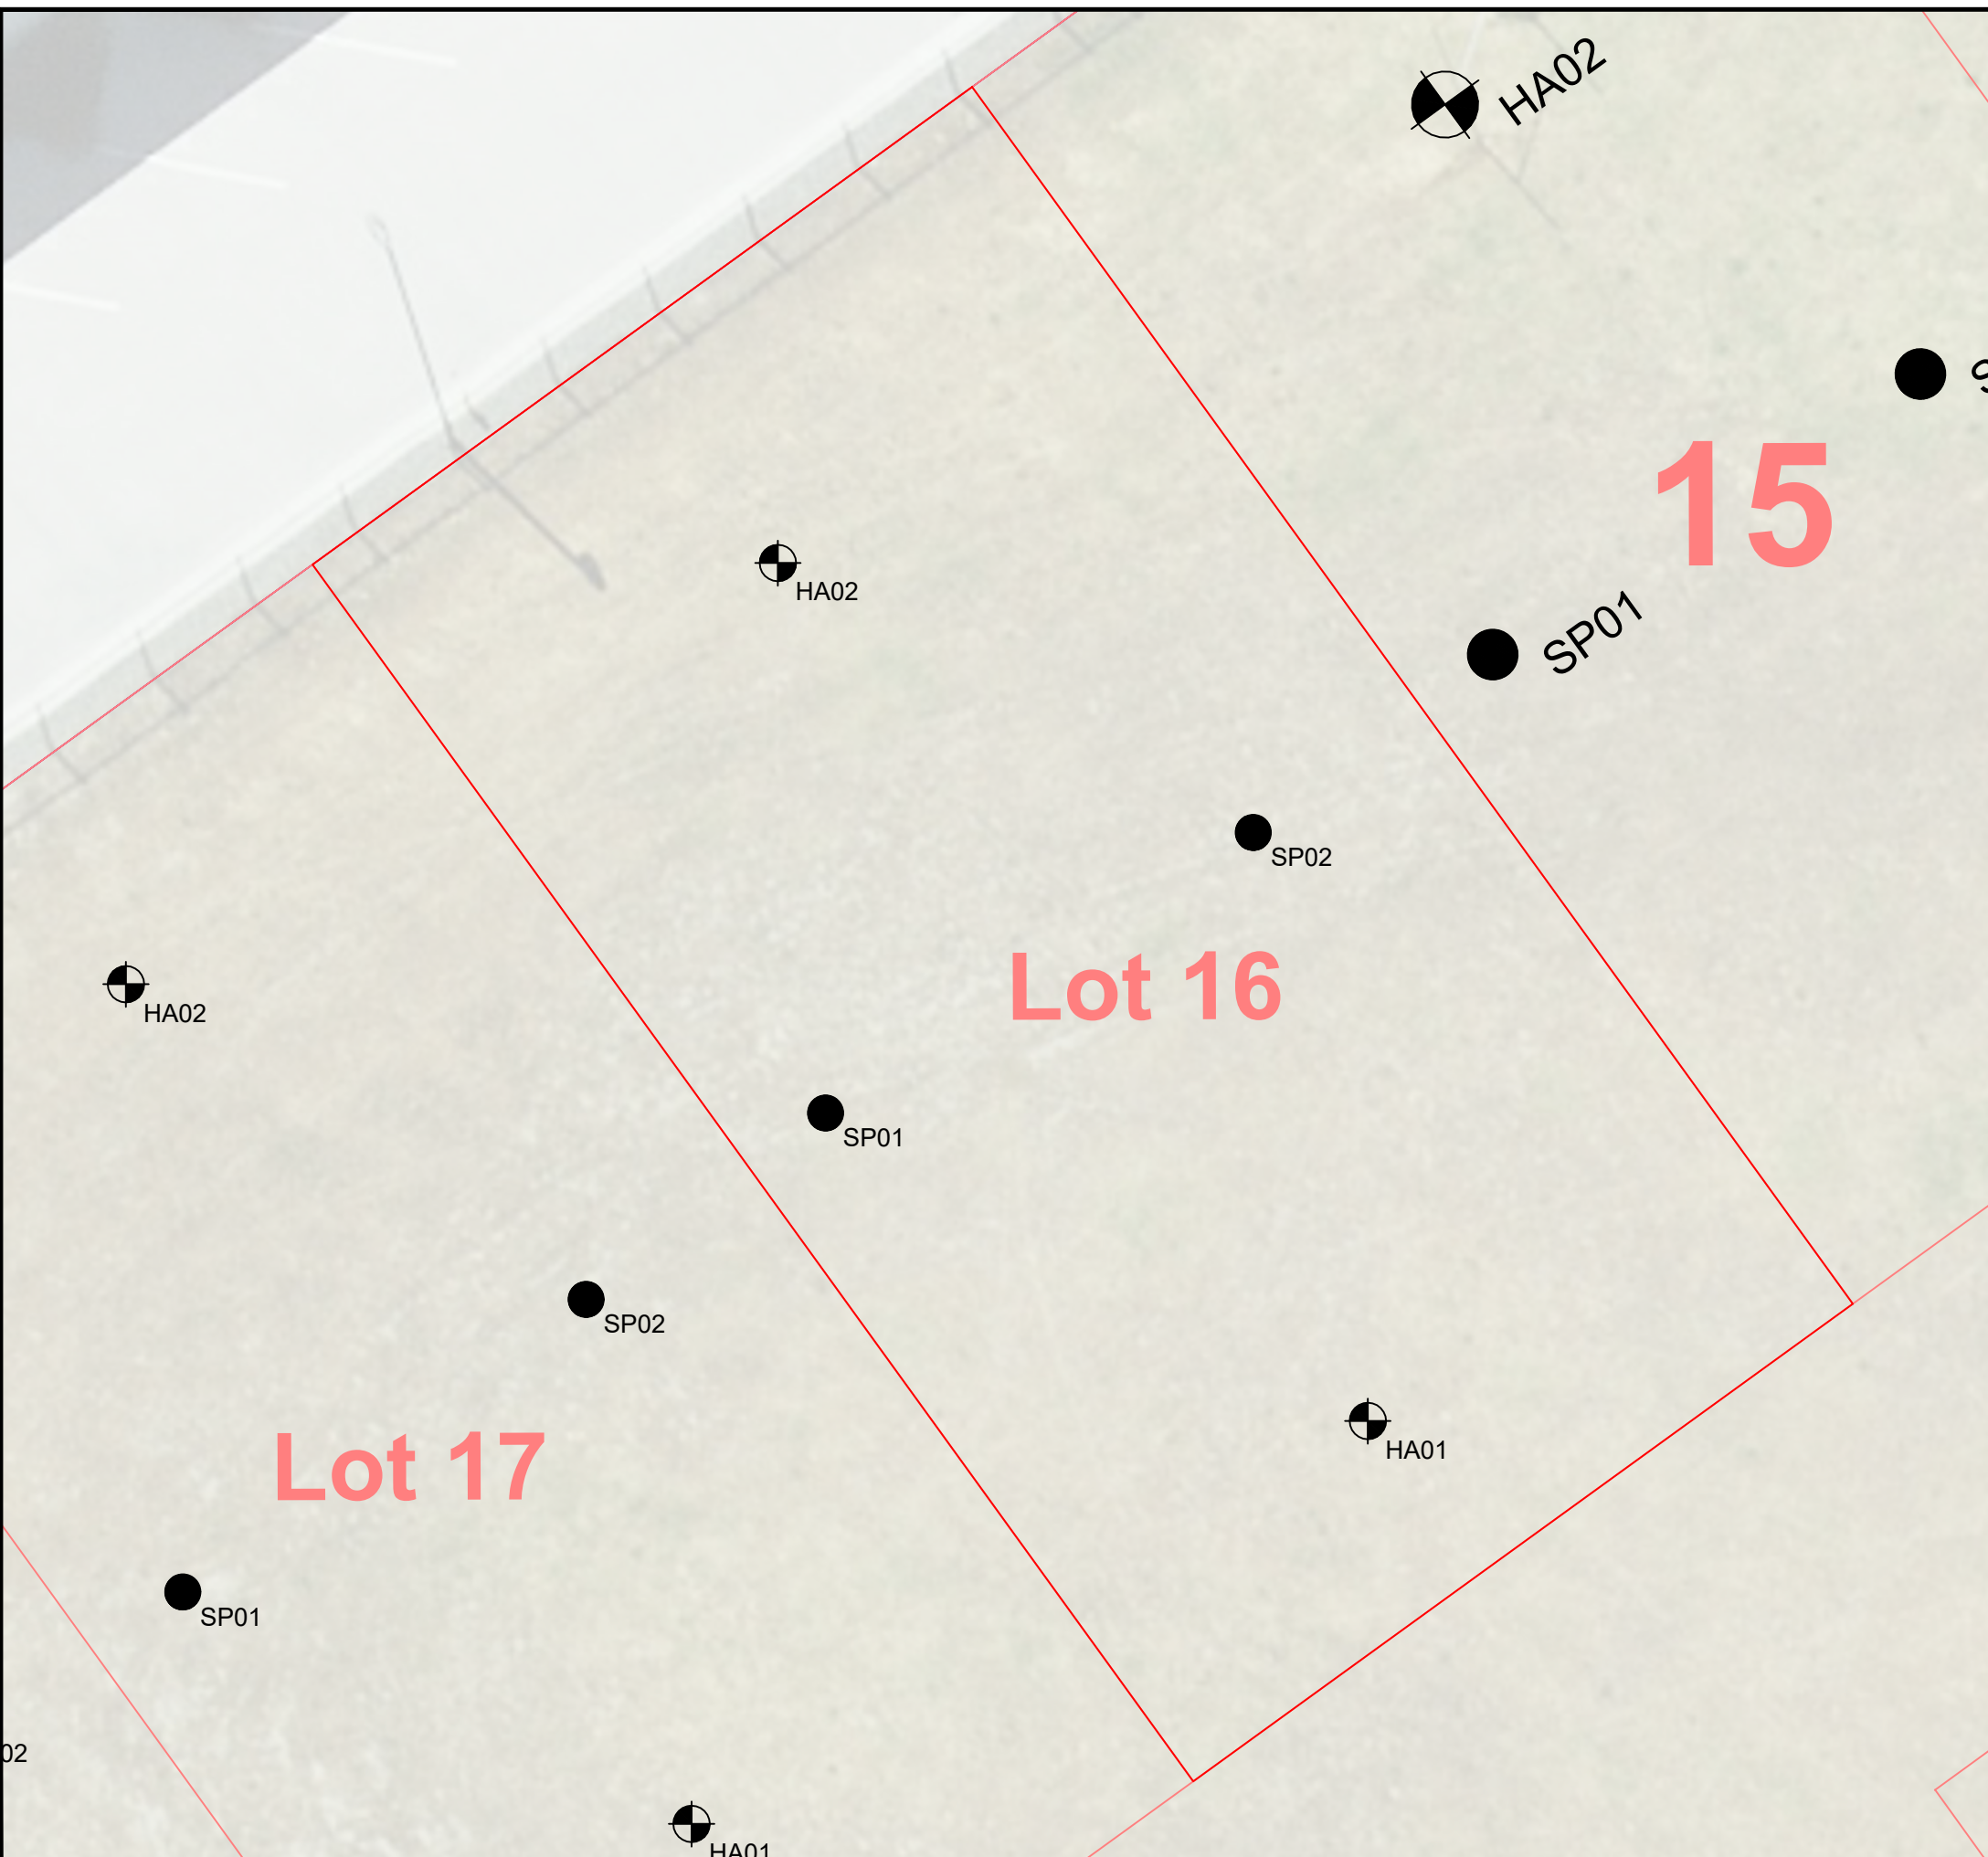
Drawing No: Lot 16/TLP	Drawn by: RM	Date: 30 August 2023
Scale: 1: 125 (A3) 1: 2000 (A3)	Checked by: D Wilson	Revision: B
Filename: LTC21220 - A - Drawings.dwg

LandTech investigated the site on 1 June 2023, conducting two hand augers with corresponding Scala Penetrometer tests (SPs) and two additional SPs. The locations of the hand auger and SPs were measured using inferred lot boundaries and are approximate only. The test locations are shown on our LandTech *Test Location Plan*, Drawing No. Lot 16/ TLP, attached to this report.

HA01 LandTech Consulting Ltd. augerhole locations, drilled 01 June 2023
-

SP01 LandTech Consulting Ltd. DCP test location, tested 01 June 2023
-   Proposed boundary
-   Existing boundary

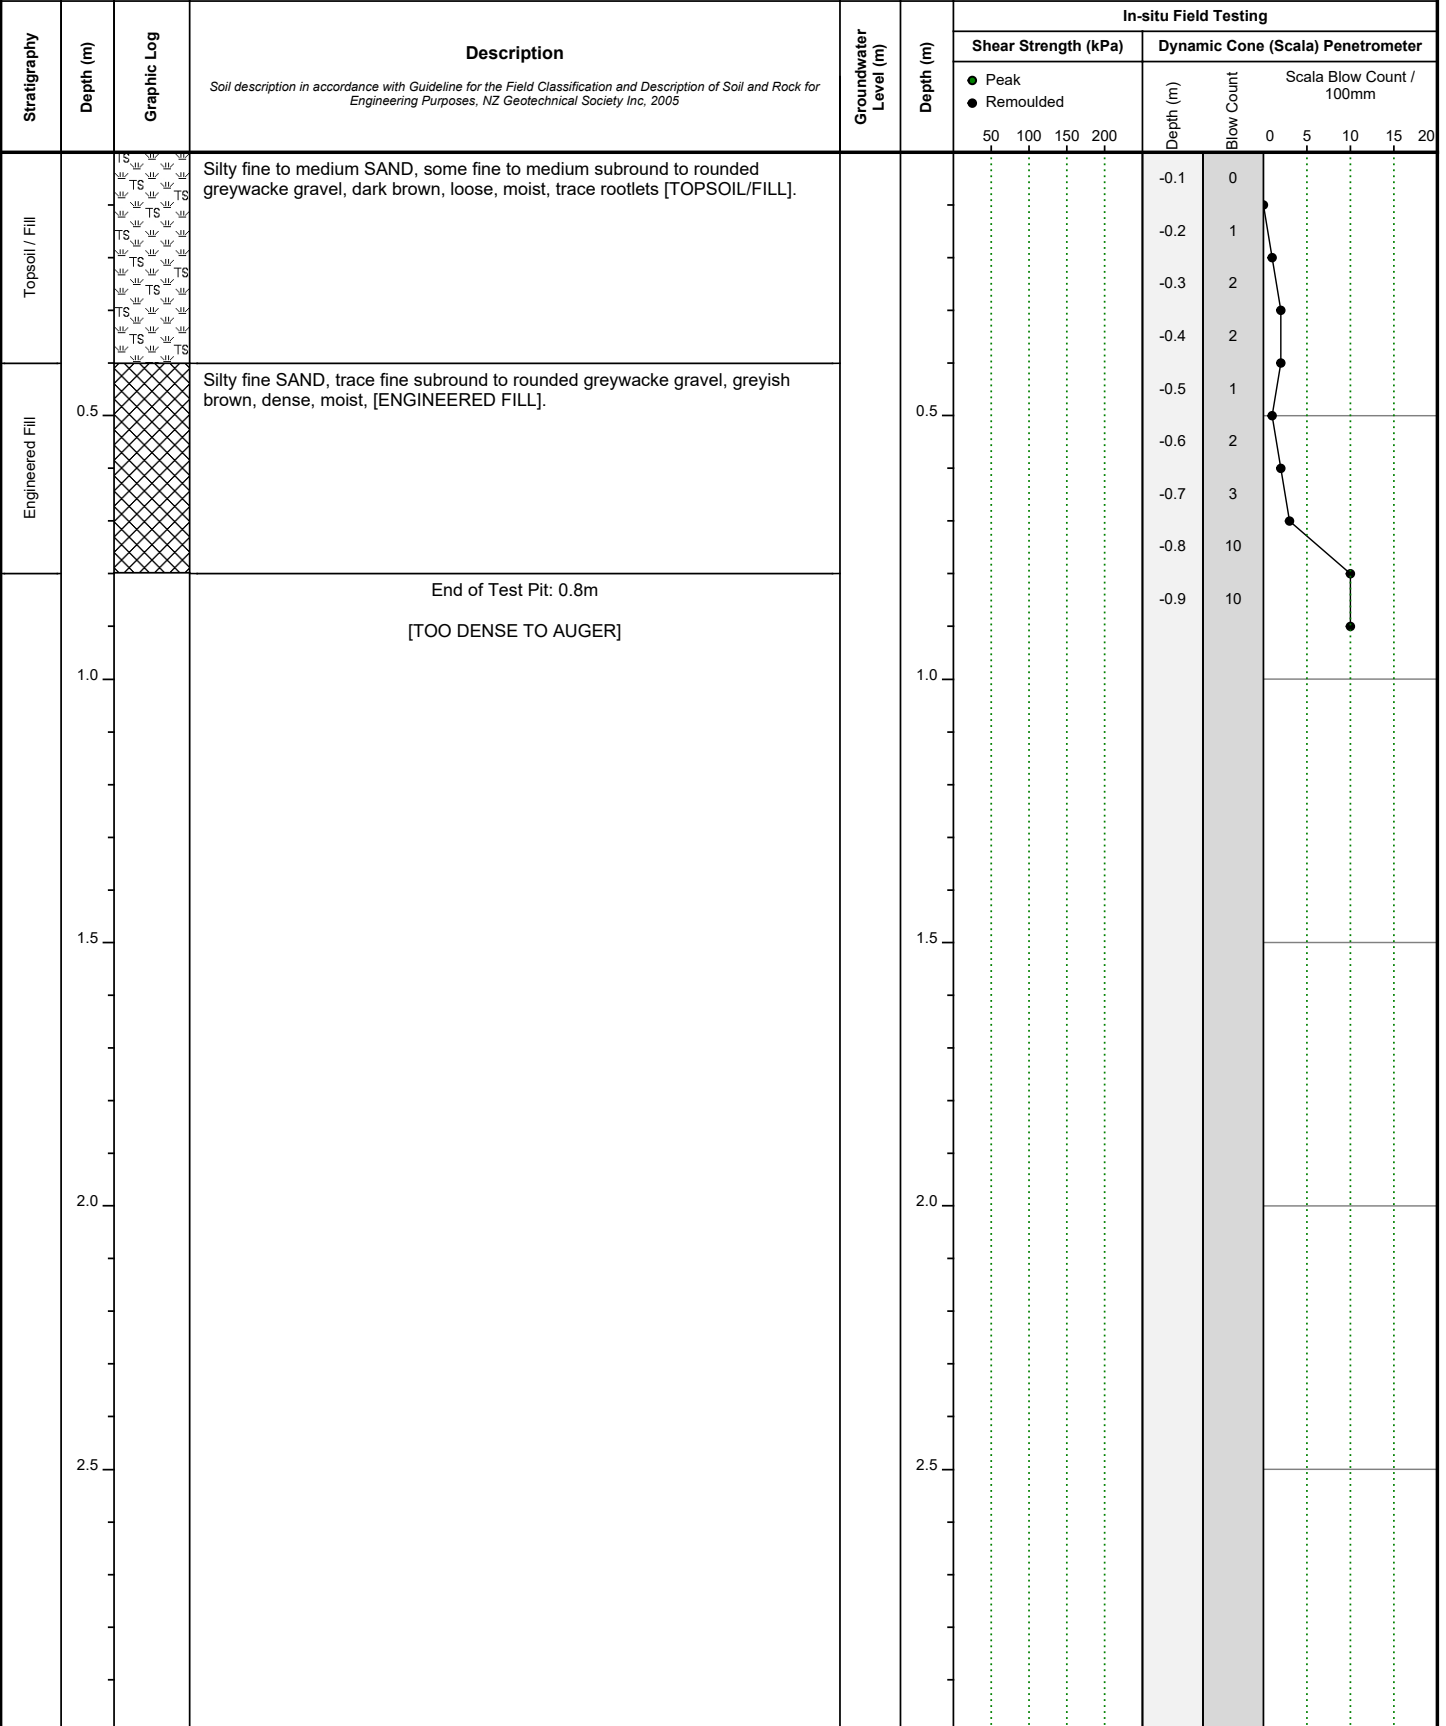
Test Pit No.: Lot 16 - HA01

Topsoil was encountered within the hand augers from the ground surface to 0.4m depth, which was typically a dark brown silty sand material with some gravel. Engineered fill was encountered below the topsoil to the base of auger holes, which was a compacted greyish brown sandy gravel material with minor silt. The hand augers were terminated at depths between 0.5m to 0.8m due to inferred dense gravel. Groundwater was not encountered during testing.

Project No.: LTC21220-A Coordinates: NZTM2000: E1576293.81, N5183019.91 Logged By: RM
 Drill Type: 50mm Hand Auger Reduced Level: 2.83m (LVD1937) Shear Vane No.:
 Date Started: 01-Jun-23 Ground Conditions: Near level, Topsoil. Calibration Factor:
 Date Finished: 01-Jun-23 Groundwater Level (m): Not Encountered Calibration Date:

Too dense to auger due to inferred gravel. In-situ testing in accordance with the following standards:
 Scala Penetrometer Testing: NZS 4402:1988, Test 6.5.2, Dynamic Cone Penetrometer
 Shear Vane Testing: Guideline for Hand Held Shear Vane Test, NZGS, August 2001

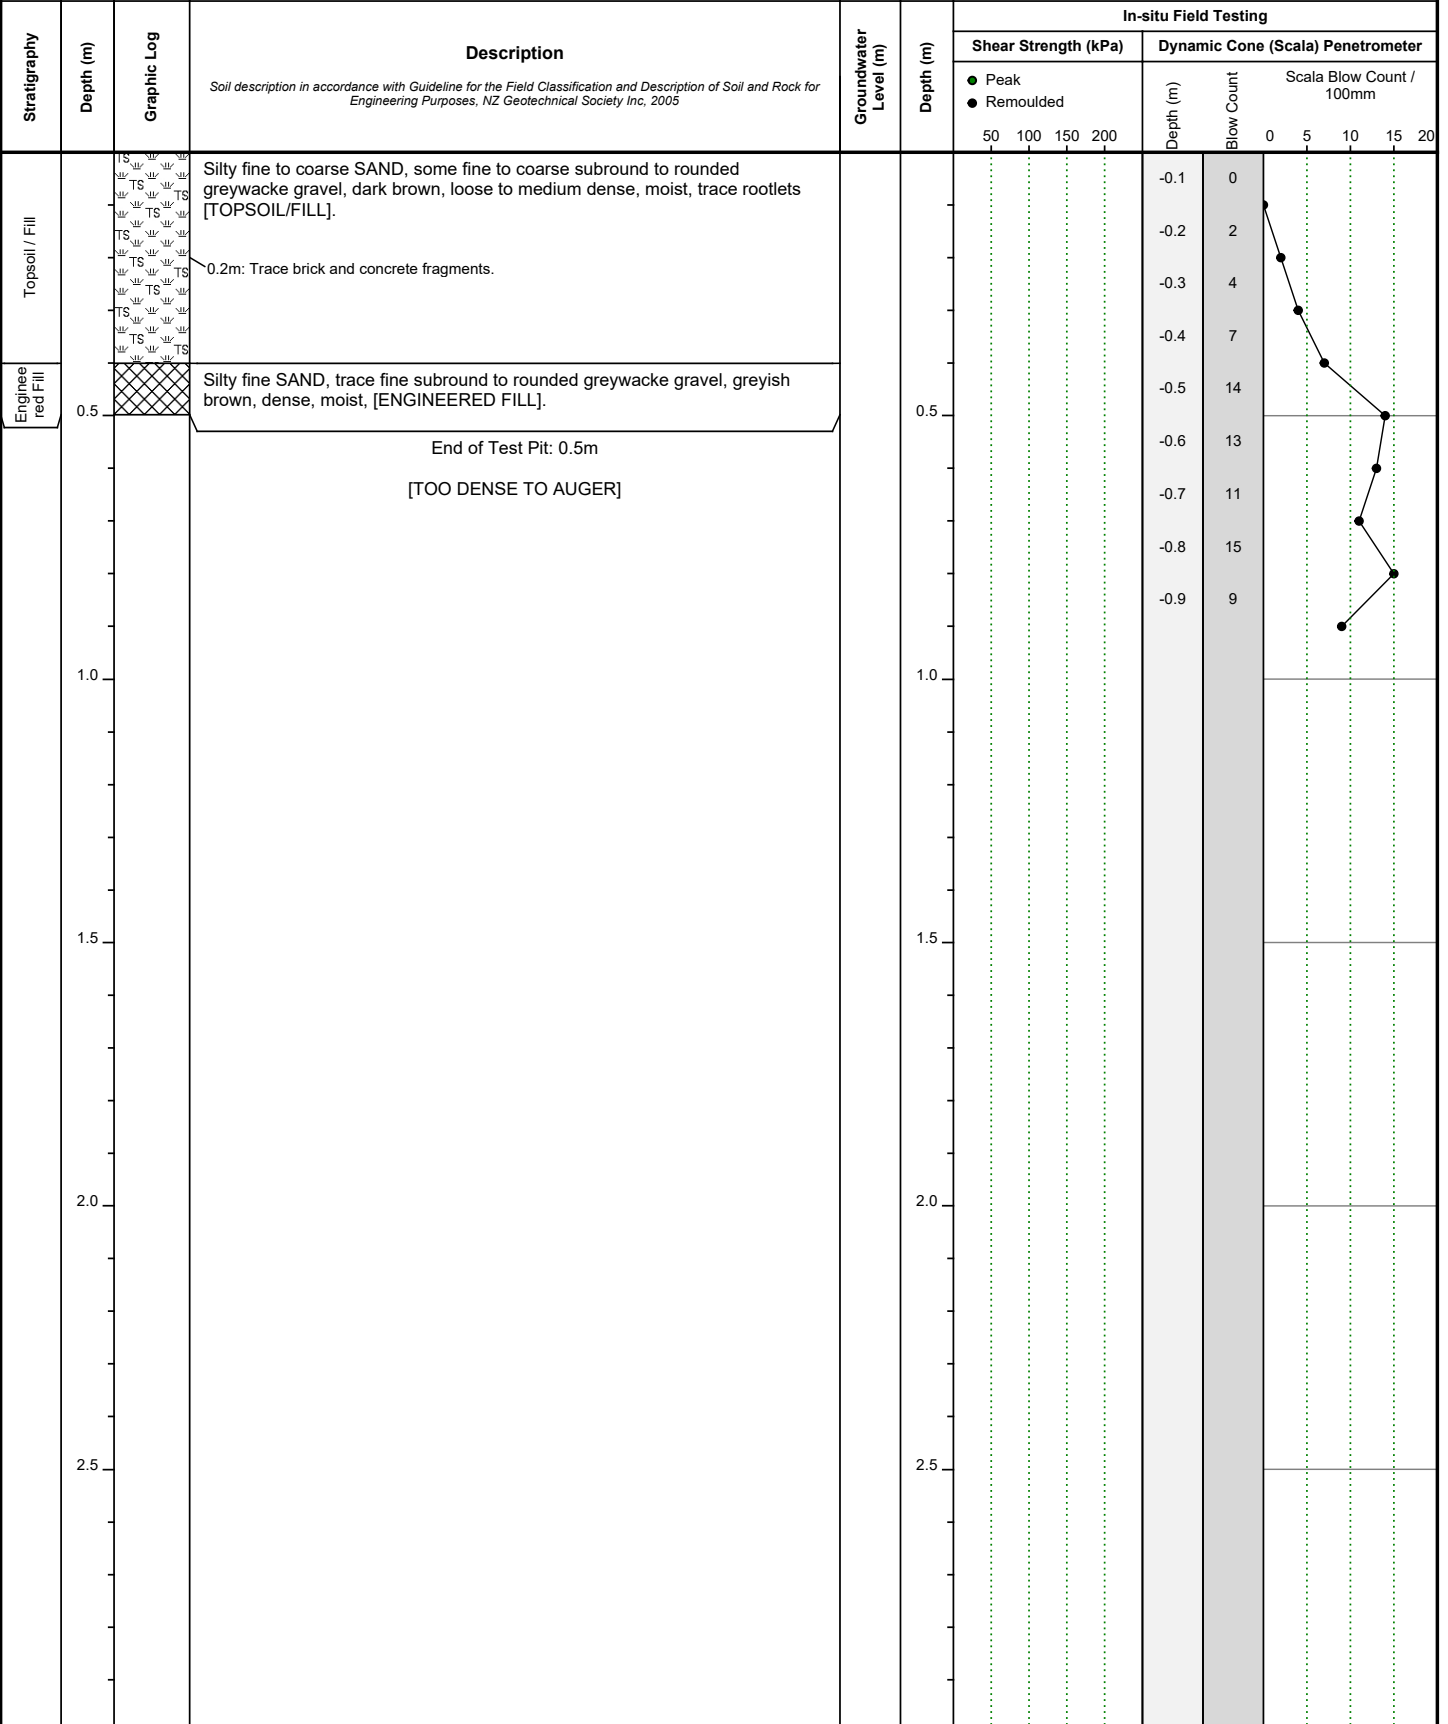
Test Pit No.: Lot 16 - HA02

Project No.: LTC21220-A Coordinates: NZTM2000: E1576283.14, N5183035.37 Logged By: RM
 Drill Type: 50mm Hand Auger Reduced Level: 2.83m (LVD1937) Shear Vane No.:
 Date Started: 01-Jun-23 Ground Conditions: Near level, Topsoil. Calibration Factor:
 Date Finished: 01-Jun-23 Groundwater Level (m): Not Encountered Calibration Date:

Too dense to auger due to inferred gravel.

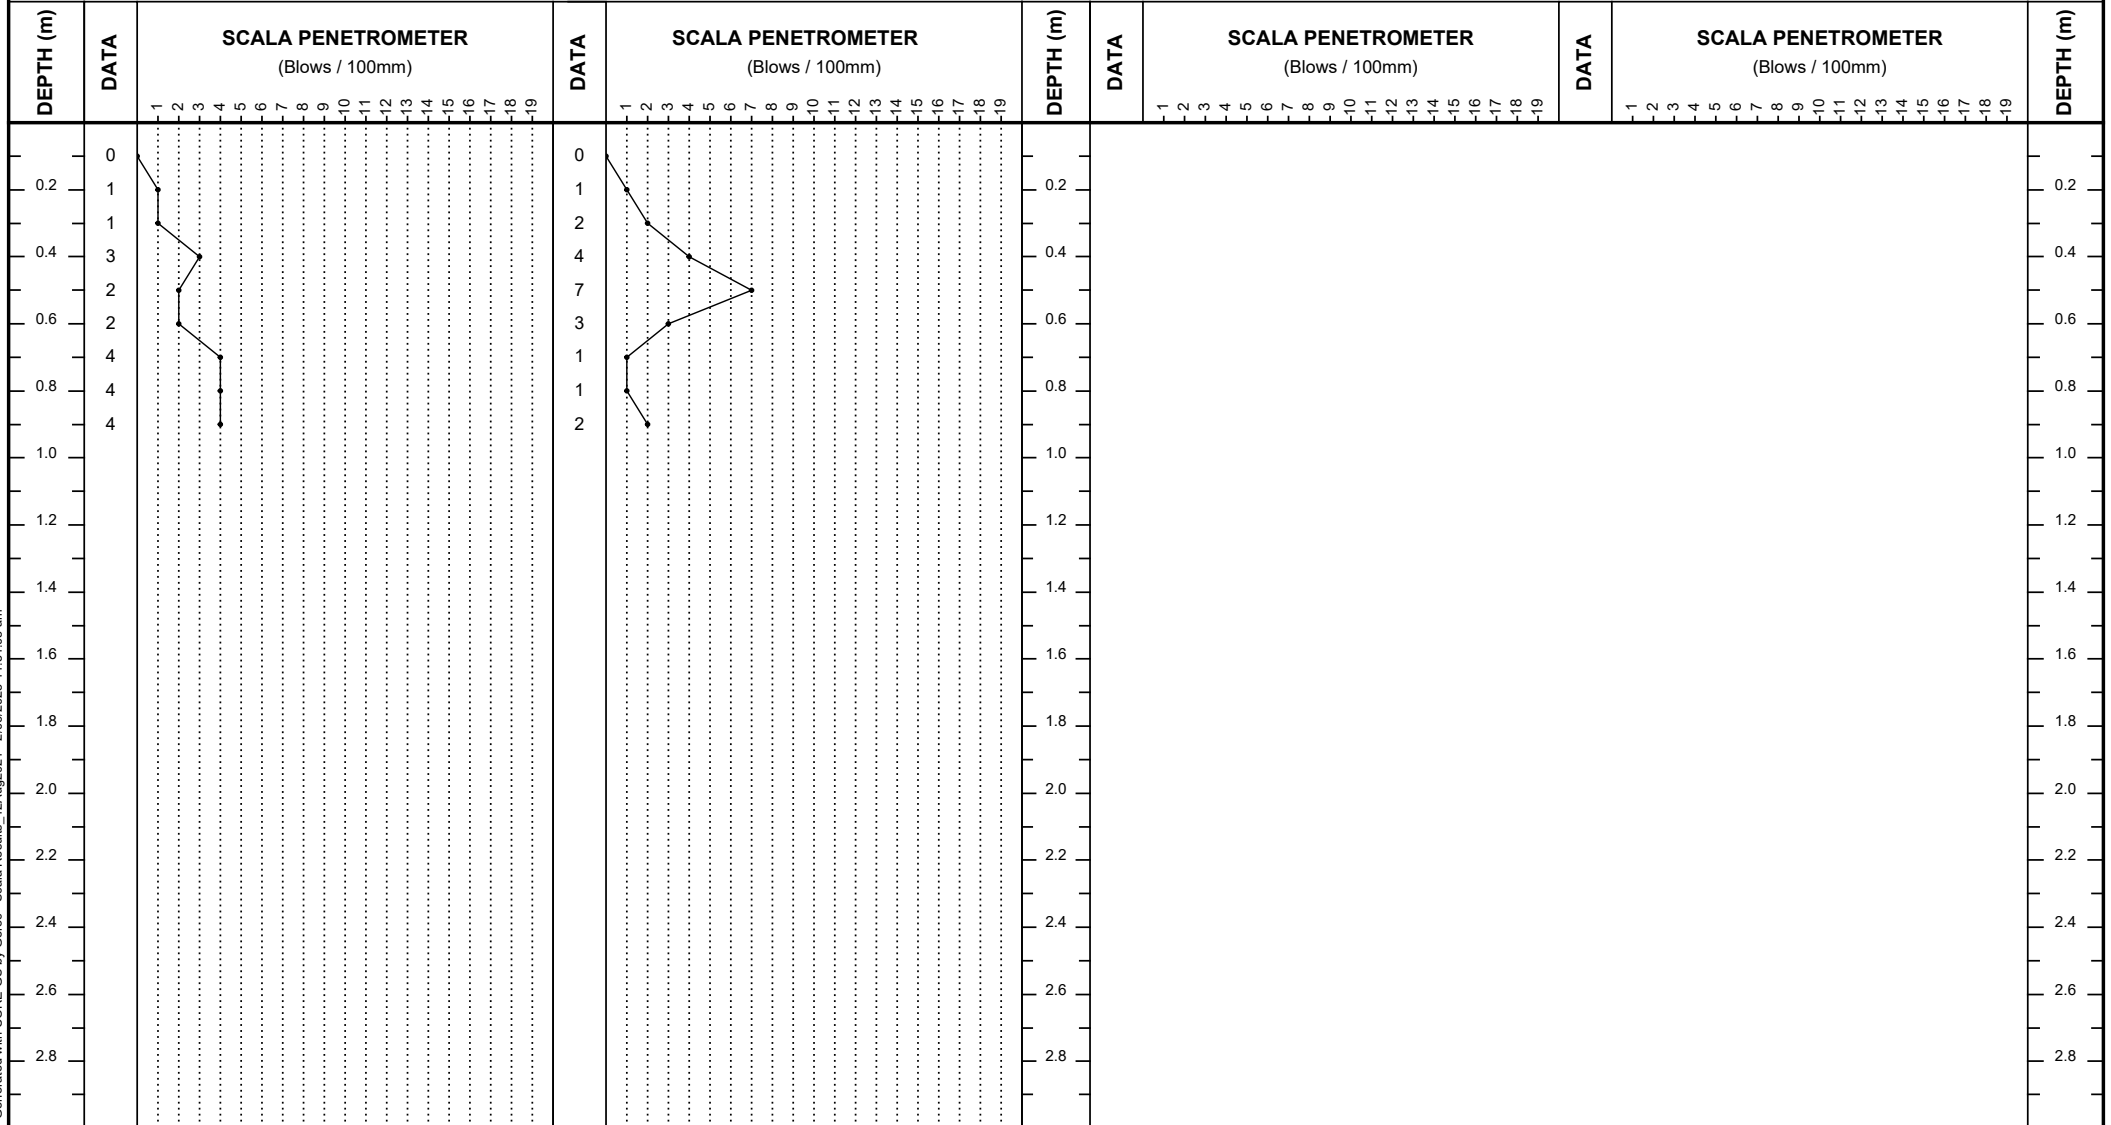
LOT 16- SP01

SPs at each of the four locations returned results between 1 and 15 blows per 100mm penetration below the topsoil and within the engineered fill layer. SPs were terminated at 0.9m depth to confirm near surface bearing capacities, and to avoid damage to the geogrids and geotextile. In addition, the density of the engineered fill and bearing capacity of its underlying subgrade have been confirmed via extensive geotechnical inspection and fill compaction testing during subdivision earthworks.

Tested By: KY
 Ground Conditions: Near level, Topsoil.
 Coordinates: NZTM2000 E 1576291.80
 N 5183030.53
 Test Date: 01-Jun-23

Tested By: KY
 Ground Conditions: Near level, Topsoil.
 Coordinates: NZTM2000 E 1576284.07
 N 5183025.60
 Test Date: 01-Jun-23
