Date: 30 August 2023  
Project No: LTC21220-A  
Revision: B

**RE: SHALLOW SOIL TEST REPORT  
FUTURE RESIDENTIAL FOUNDATIONS  
LOT 2, 115 EUREKA STREET, ARANUI**

**Test Location Plan**  
 Lot 2, 115 Eureka Street,  
 ARANUI, CHRISTCHURCH

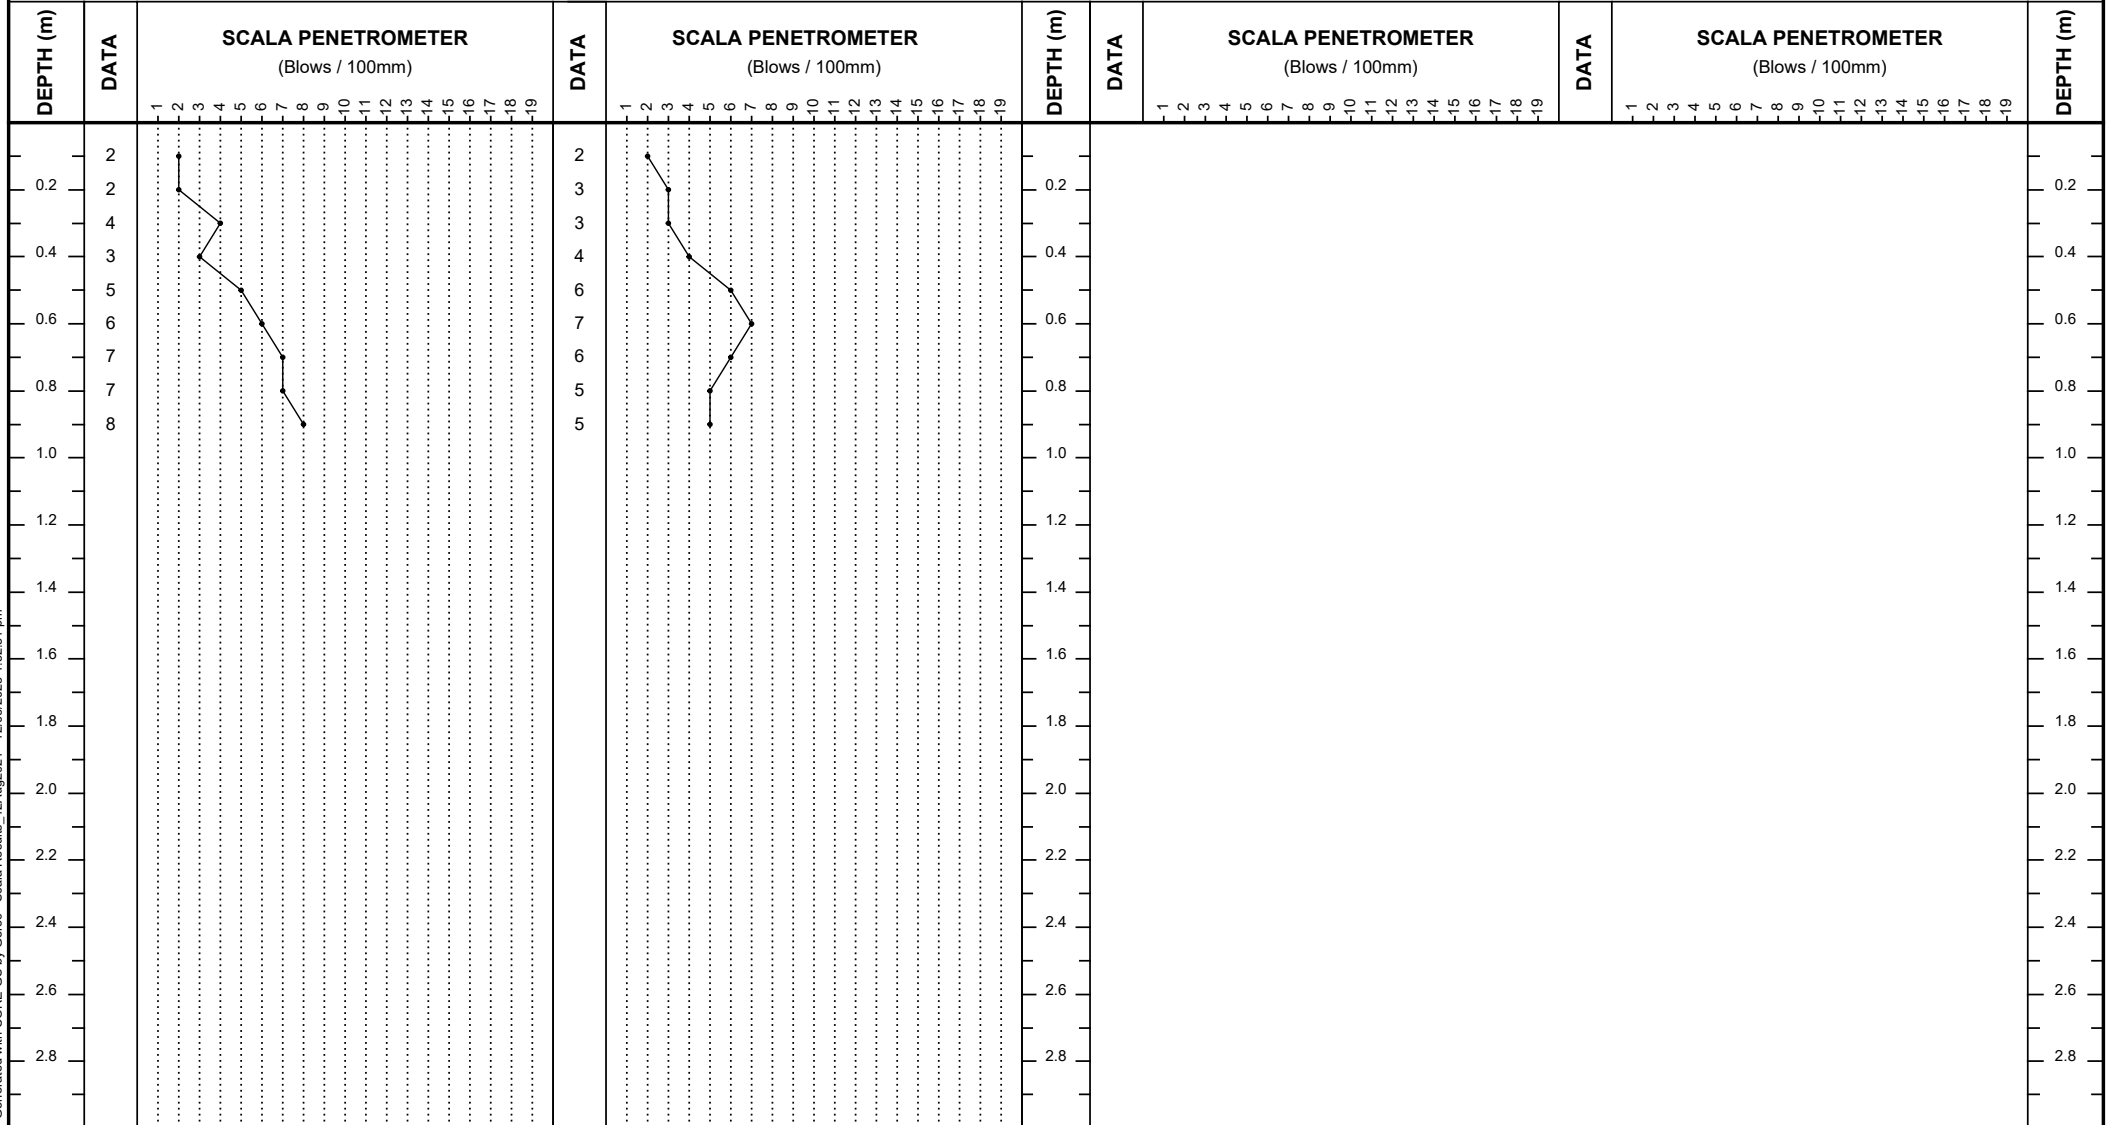
**Lot 2 - SP01**

**Lot 2 - SP02**

**Tested By:** RM  
**Ground Conditions:** Near Level, Topsoil & Grass  
**Coordinates:** NZTM2000 E 1576445.97  
N 5182986.22  
**Test Date:** 08-Jun-23

**Tested By:** RM  
**Ground Conditions:** Near Level, Topsoil & Grass  
**Coordinates:** NZTM2000 E 1576449.46  
N 5182994.74  
**Test Date:** 08-Jun-23

SPs at each of the four locations returned results between 3 and 12 blows per 100mm penetration below the topsoil and within the engineered fill layer. SPs were terminated at 0.9m depth to confirm near surface bearing capacities, and to avoid damage to the geogrids and geotextile. In addition, the density of the engineered fill and bearing capacity of its underlying subgrade have been confirmed via extensive geotechnical inspection and fill compaction testing during subdivision earthworks.
