Date: 16 May 2023
Project No: LTC21220-A

**RE: SHALLOW SOIL TEST REPORT
FUTURE RESIDENTIAL FOUNDATIONS
LOT 32, 115 EUREKA STREET, ARANUI**

Test Location Plan
 Lot 32, 115 Eureka Street,
 ARANUI, CHRISTCHURCH

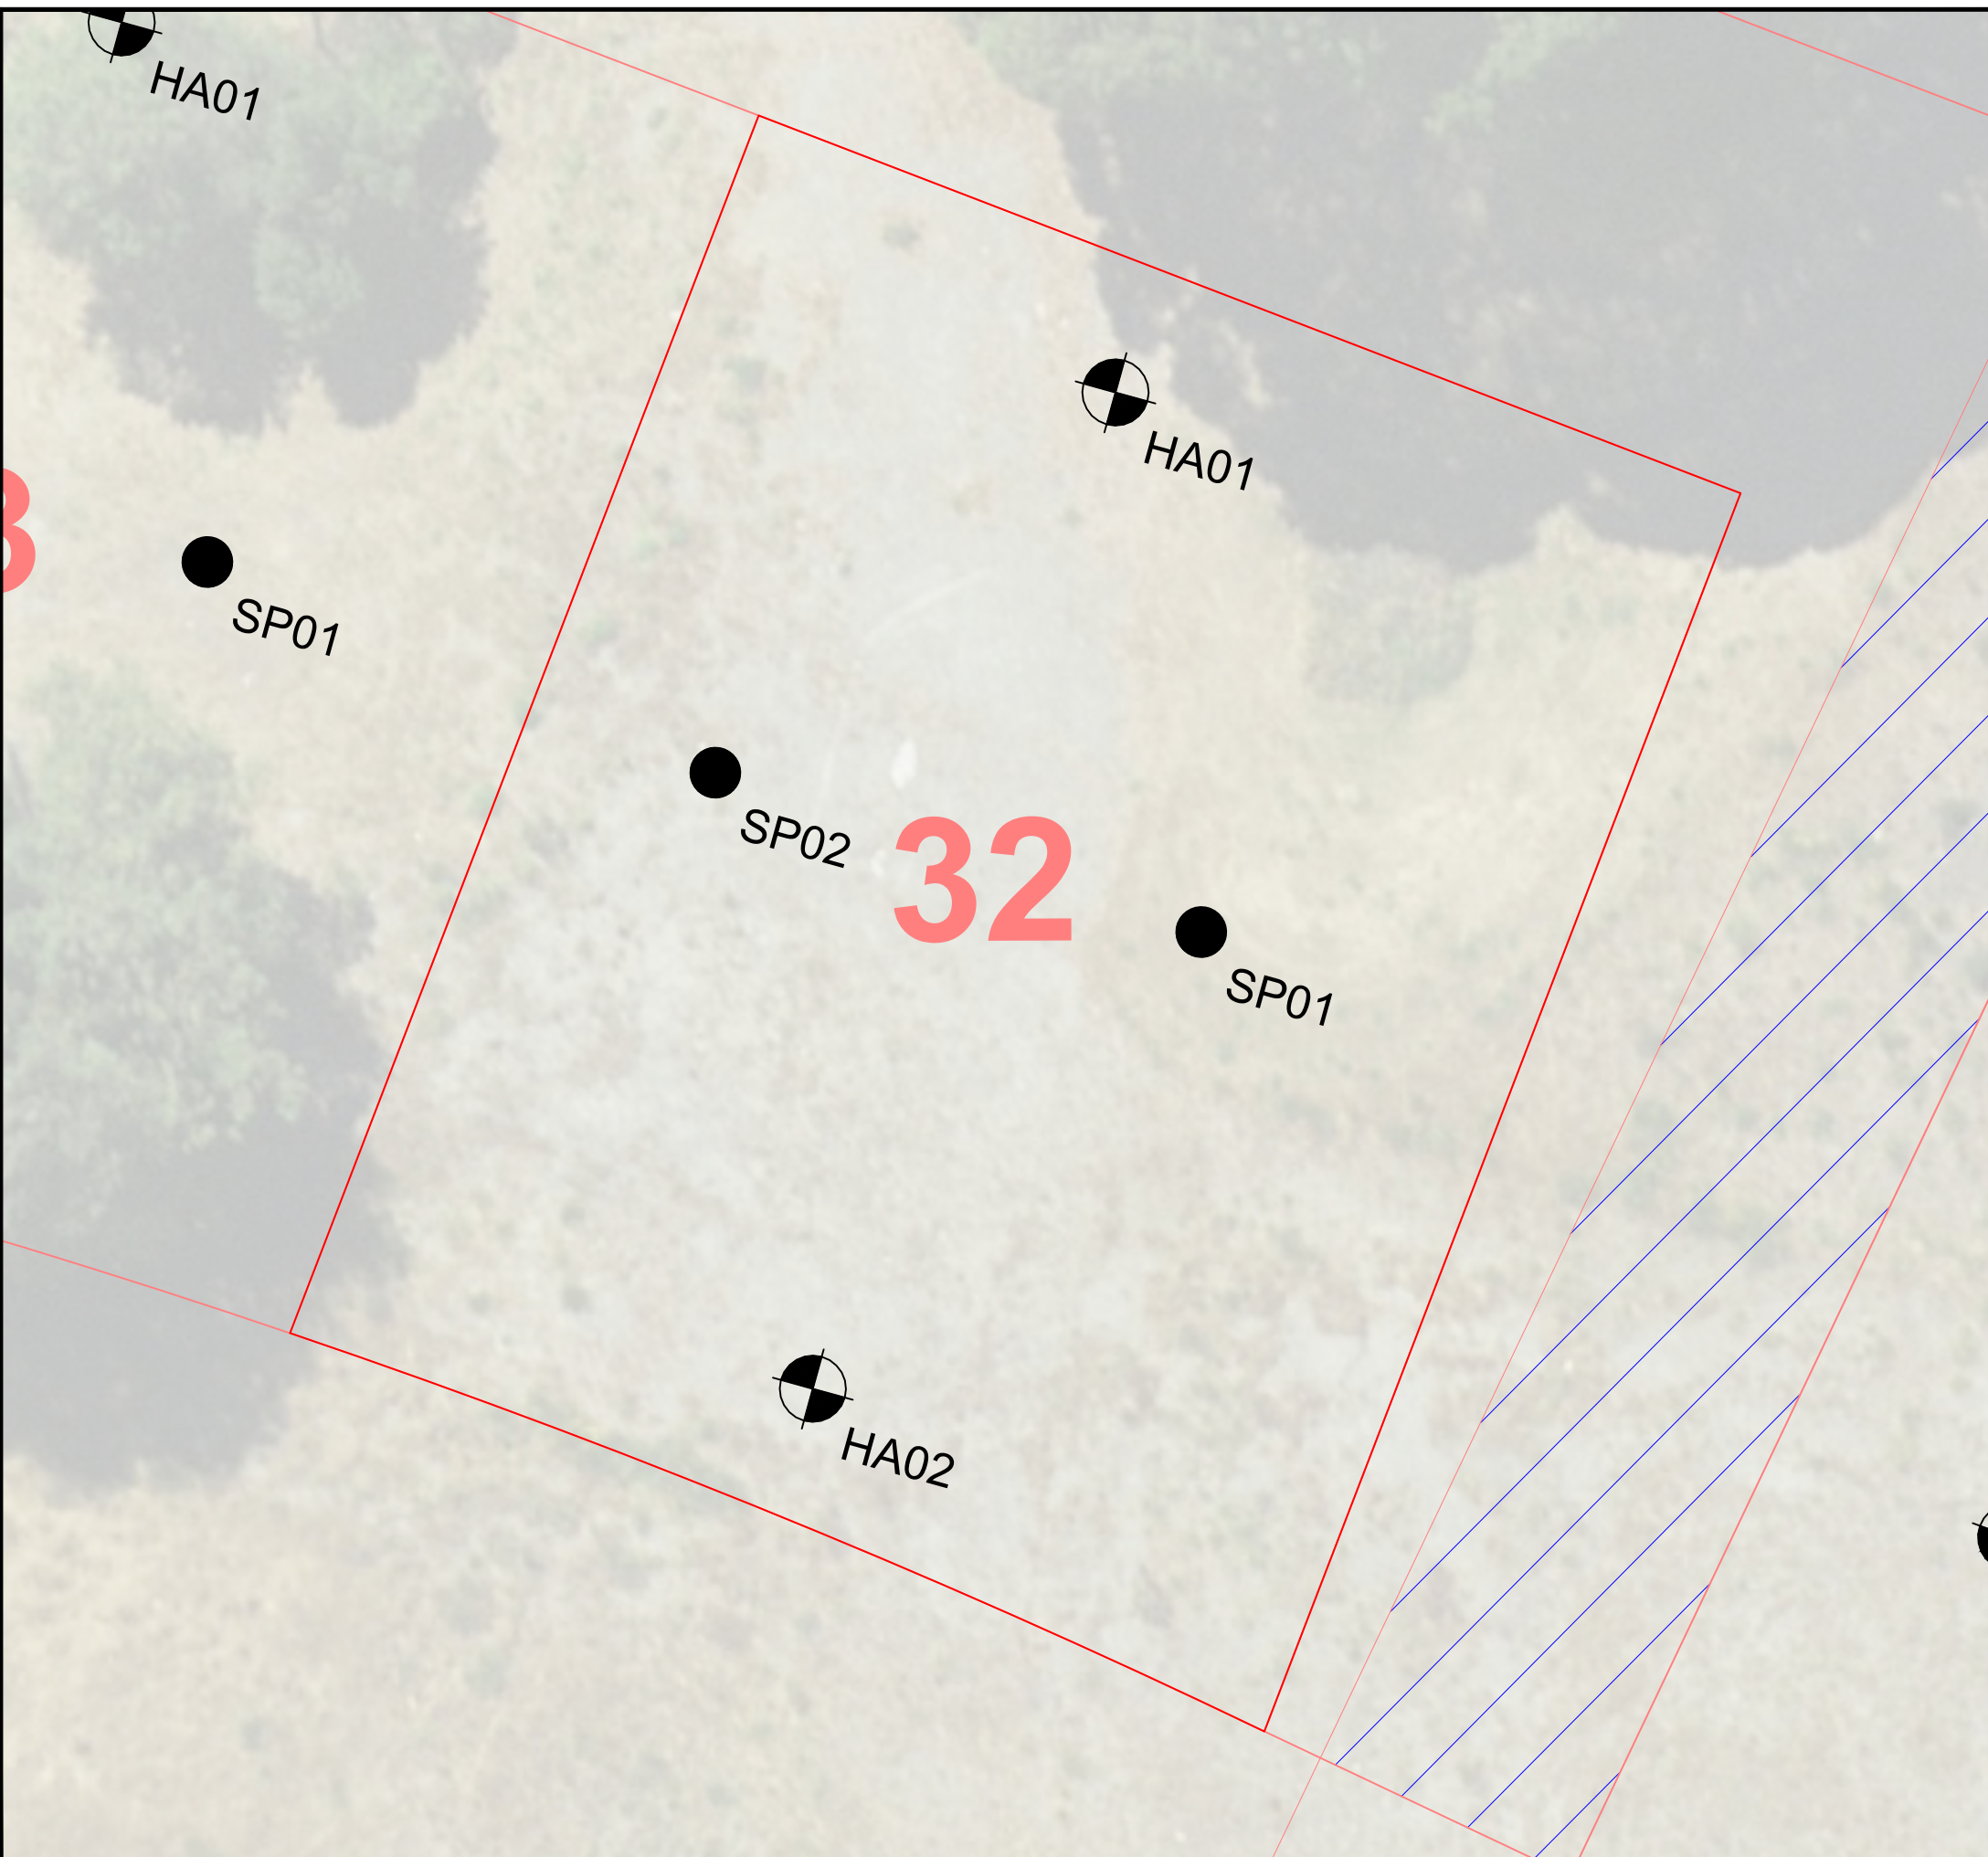
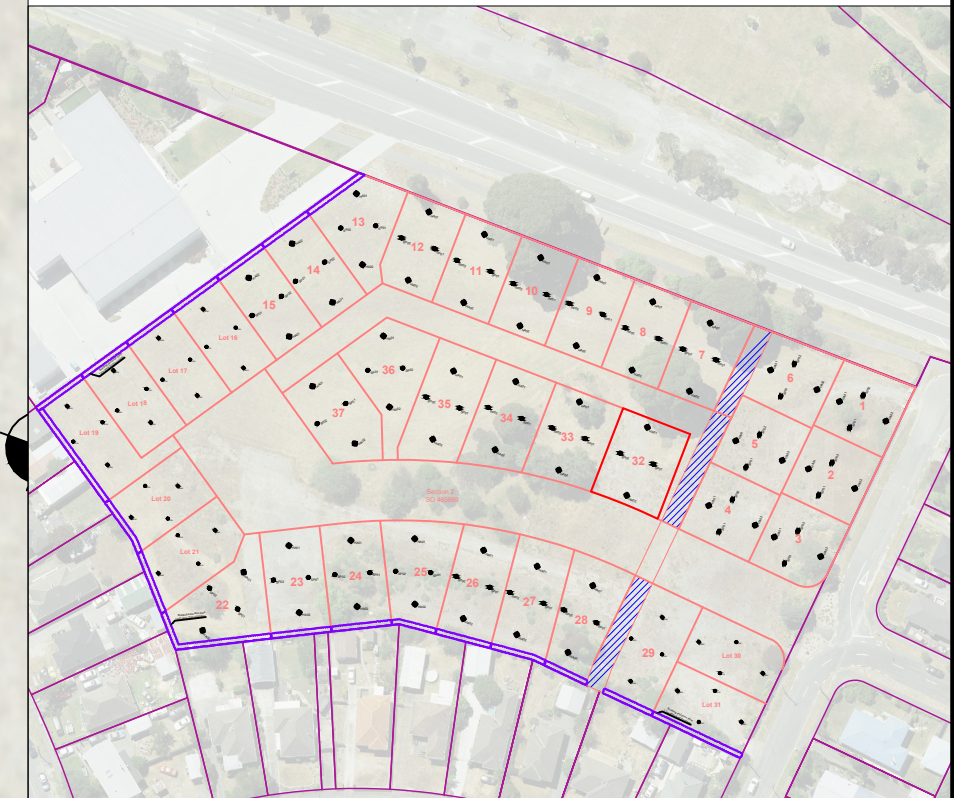
Drawing No: Lot 32/TLP	Drawn by: KY	Date: 15 May 2023
Scale: 1: 125 (A3) 1: 2000 (A3)	Checked by: D Wilson	Revision: A
Filename: LTC21220 - A - Drawings.dwg

LandTech investigated the site on 12 May 2023, conducting two hand augers with corresponding Scala Penetrometer tests (SPs) and two additional SPs. The locations of the hand auger and SPs were measured using inferred lot boundaries and are approximate only. The test locations are shown on our LandTech *Test Location Plan*, Drawing No. Lot 32/ TLP, attached to this report.

HA01 LandTech Consulting Ltd. augerhole locations, drilled 12 May 2023
-

SP01 LandTech Consulting Ltd. DCP test location, tested 12 May 2023
-

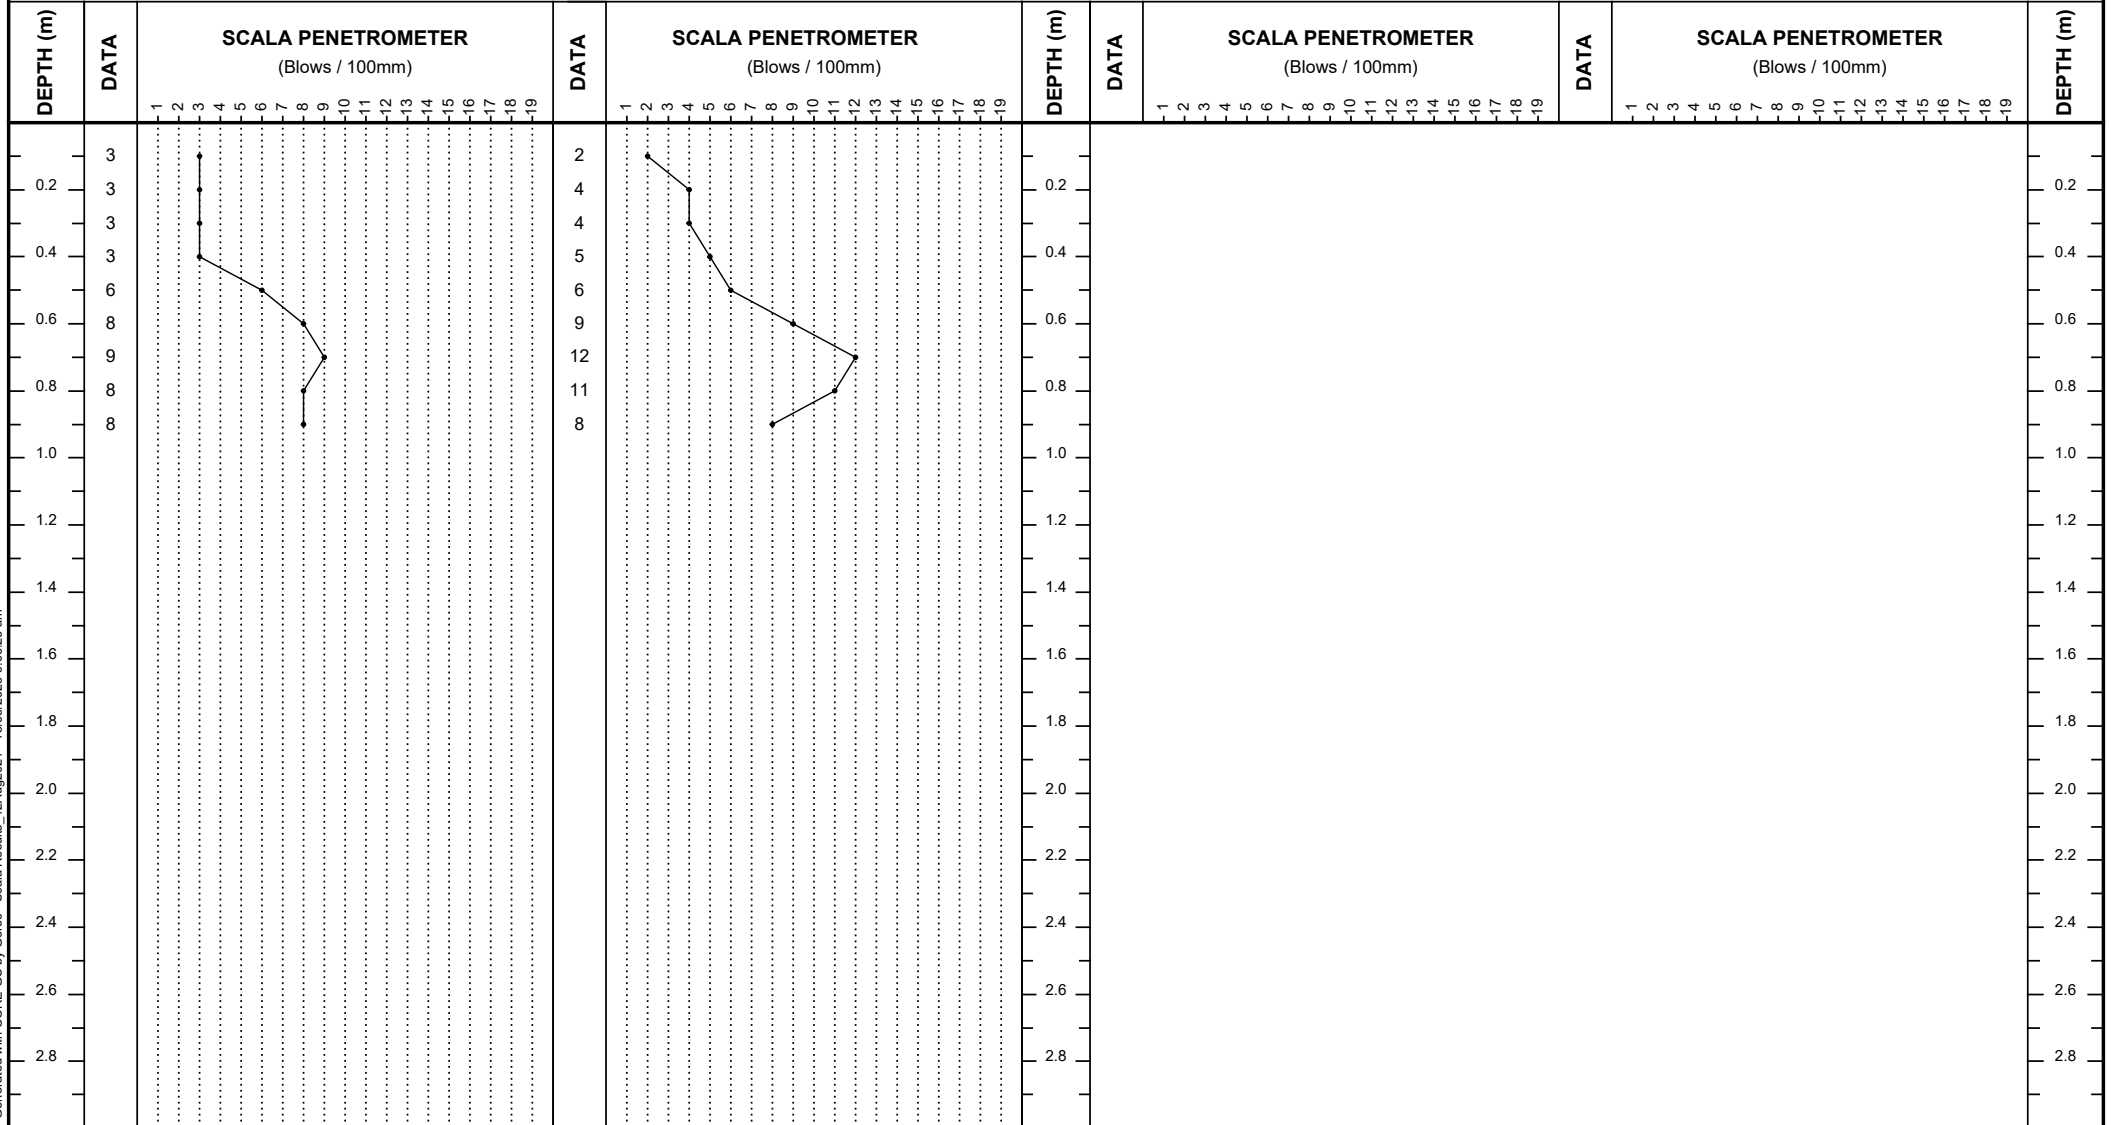
LOT 32- SP01

SPs at each of the four locations returned results between 3 and 12 blows per 100mm penetration below the topsoil and within the engineered fill layer. SPs were terminated at 0.9m depth to confirm near surface bearing capacities, and to avoid damage to the geogrids and geotextile. In addition, the density of the engineered fill and bearing capacity of its underlying subgrade have been confirmed via extensive geotechnical inspection and fill compaction testing during subdivision earthworks.

Tested By: KY
 Ground Conditions: Near level, Topsoil.
 Coordinates: NZTM2000 E 1576402.25
 N 5182993.81
 Test Date: 12-May-23

Tested By: KY
 Ground Conditions: Near level, Topsoil.
 Coordinates: NZTM2000 E 1576393.02
 N 5182997.36
 Test Date: 12-May-23
