Date: 16 May 2023
Project No: LTC21220-A

**RE: SHALLOW SOIL TEST REPORT
FUTURE RESIDENTIAL FOUNDATIONS
LOT 35, 115 EUREKA STREET, ARANUI**

Test Location Plan
 Lot 35, 115 Eureka Street,
 ARANUI, CHRISTCHURCH

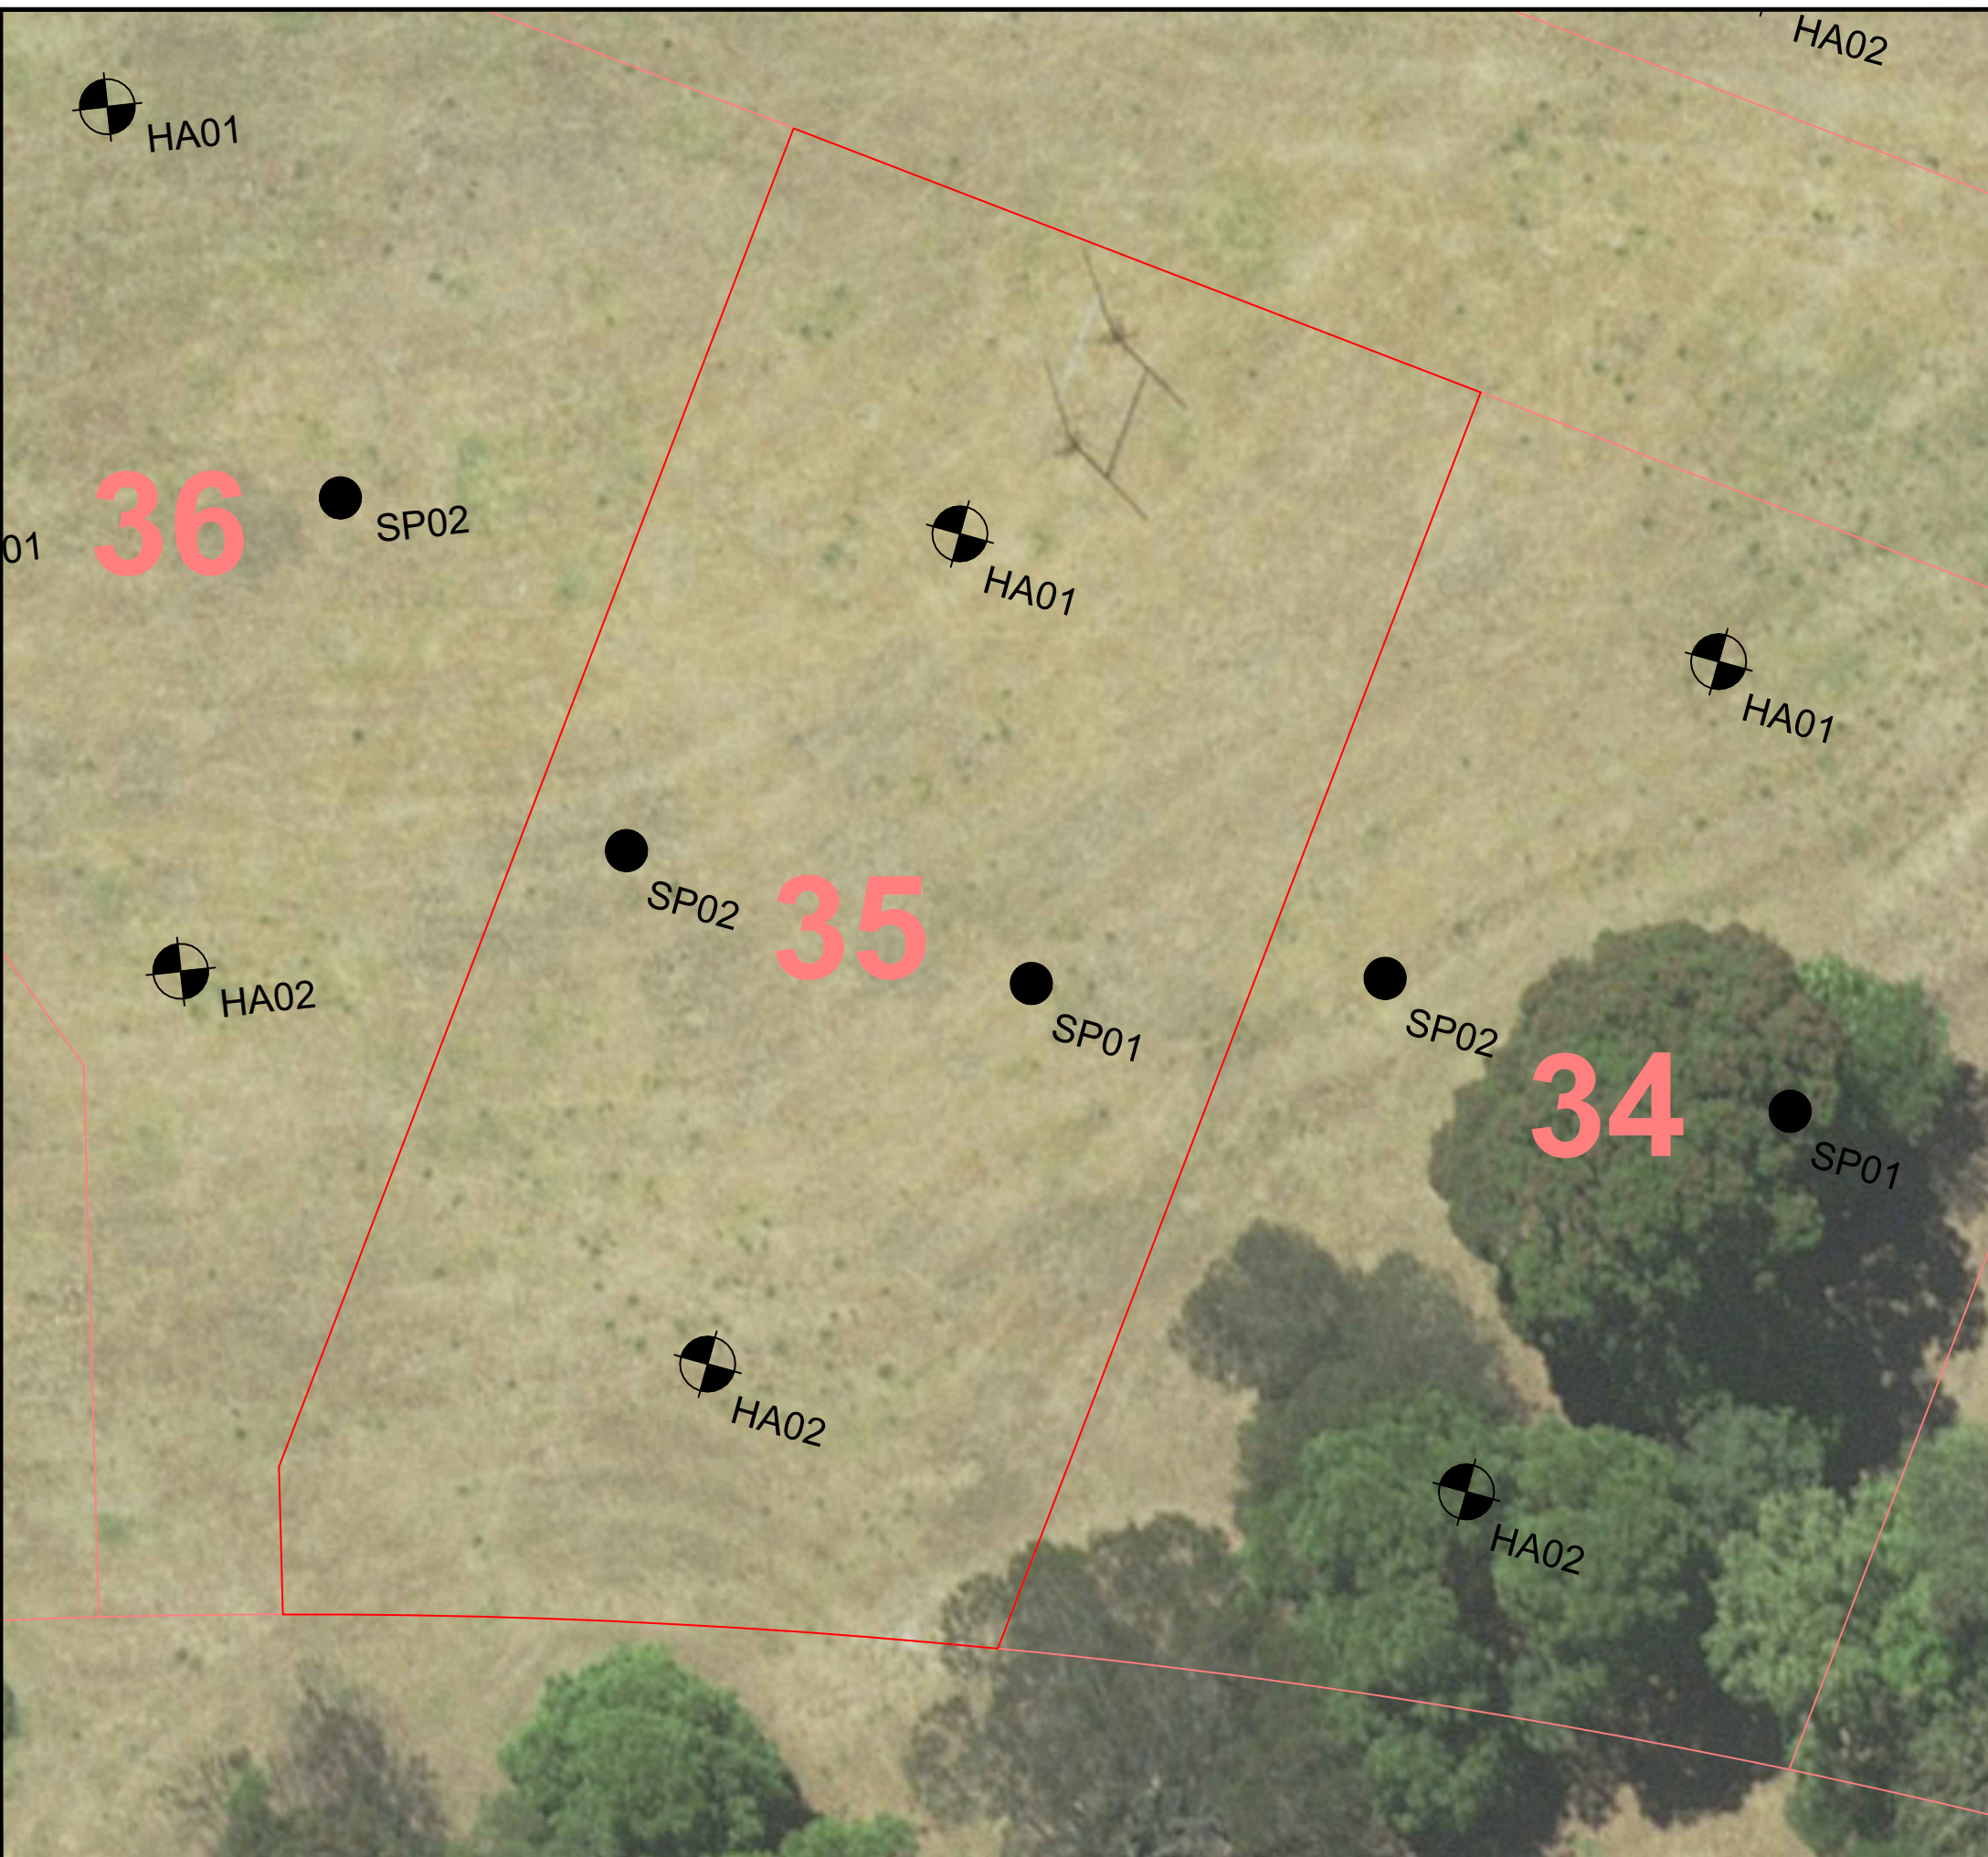
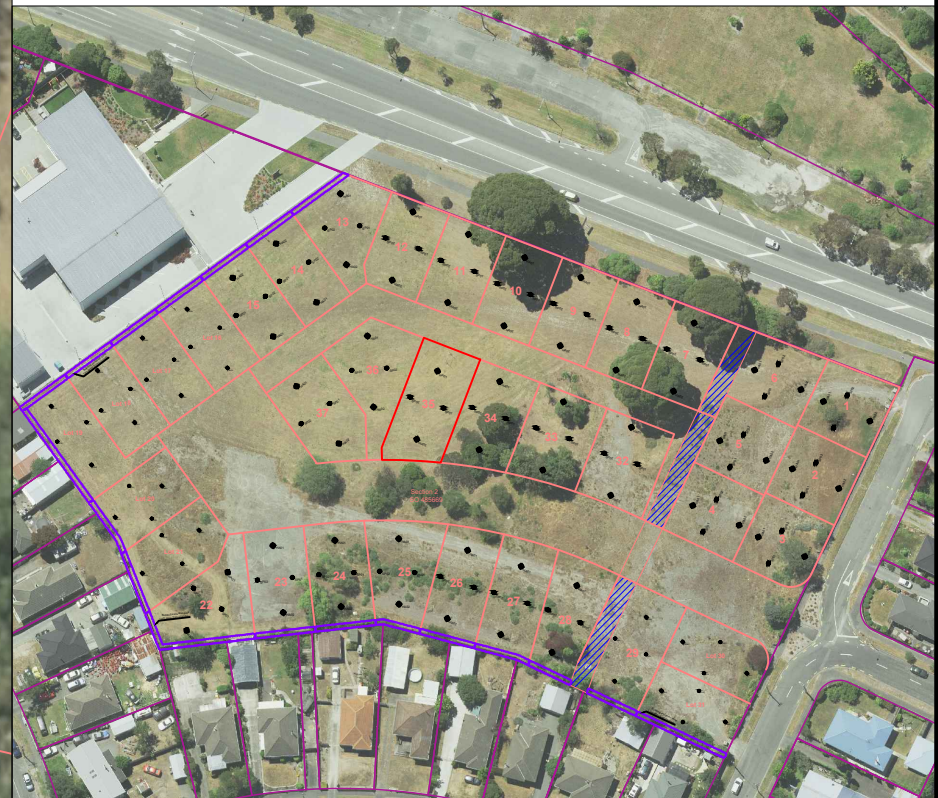
LandTech investigated the site on 12 May 2023, conducting two hand augers with corresponding Scala Penetrometer tests (SPs) and two additional SPs. The locations of the hand auger and SPs were measured using inferred lot boundaries and are approximate only. The test locations are shown on our LandTech *Test Location Plan*, Drawing No. Lot 35/ TLP, attached to this report.

- HA01 LandTech Consulting Ltd. augerhole locations, drilled 12 May 2023
- SP01 LandTech Consulting Ltd. DCP test location, tested 12 May 2023
- Proposed boundary
- Building exclusion zone
- Existing boundary

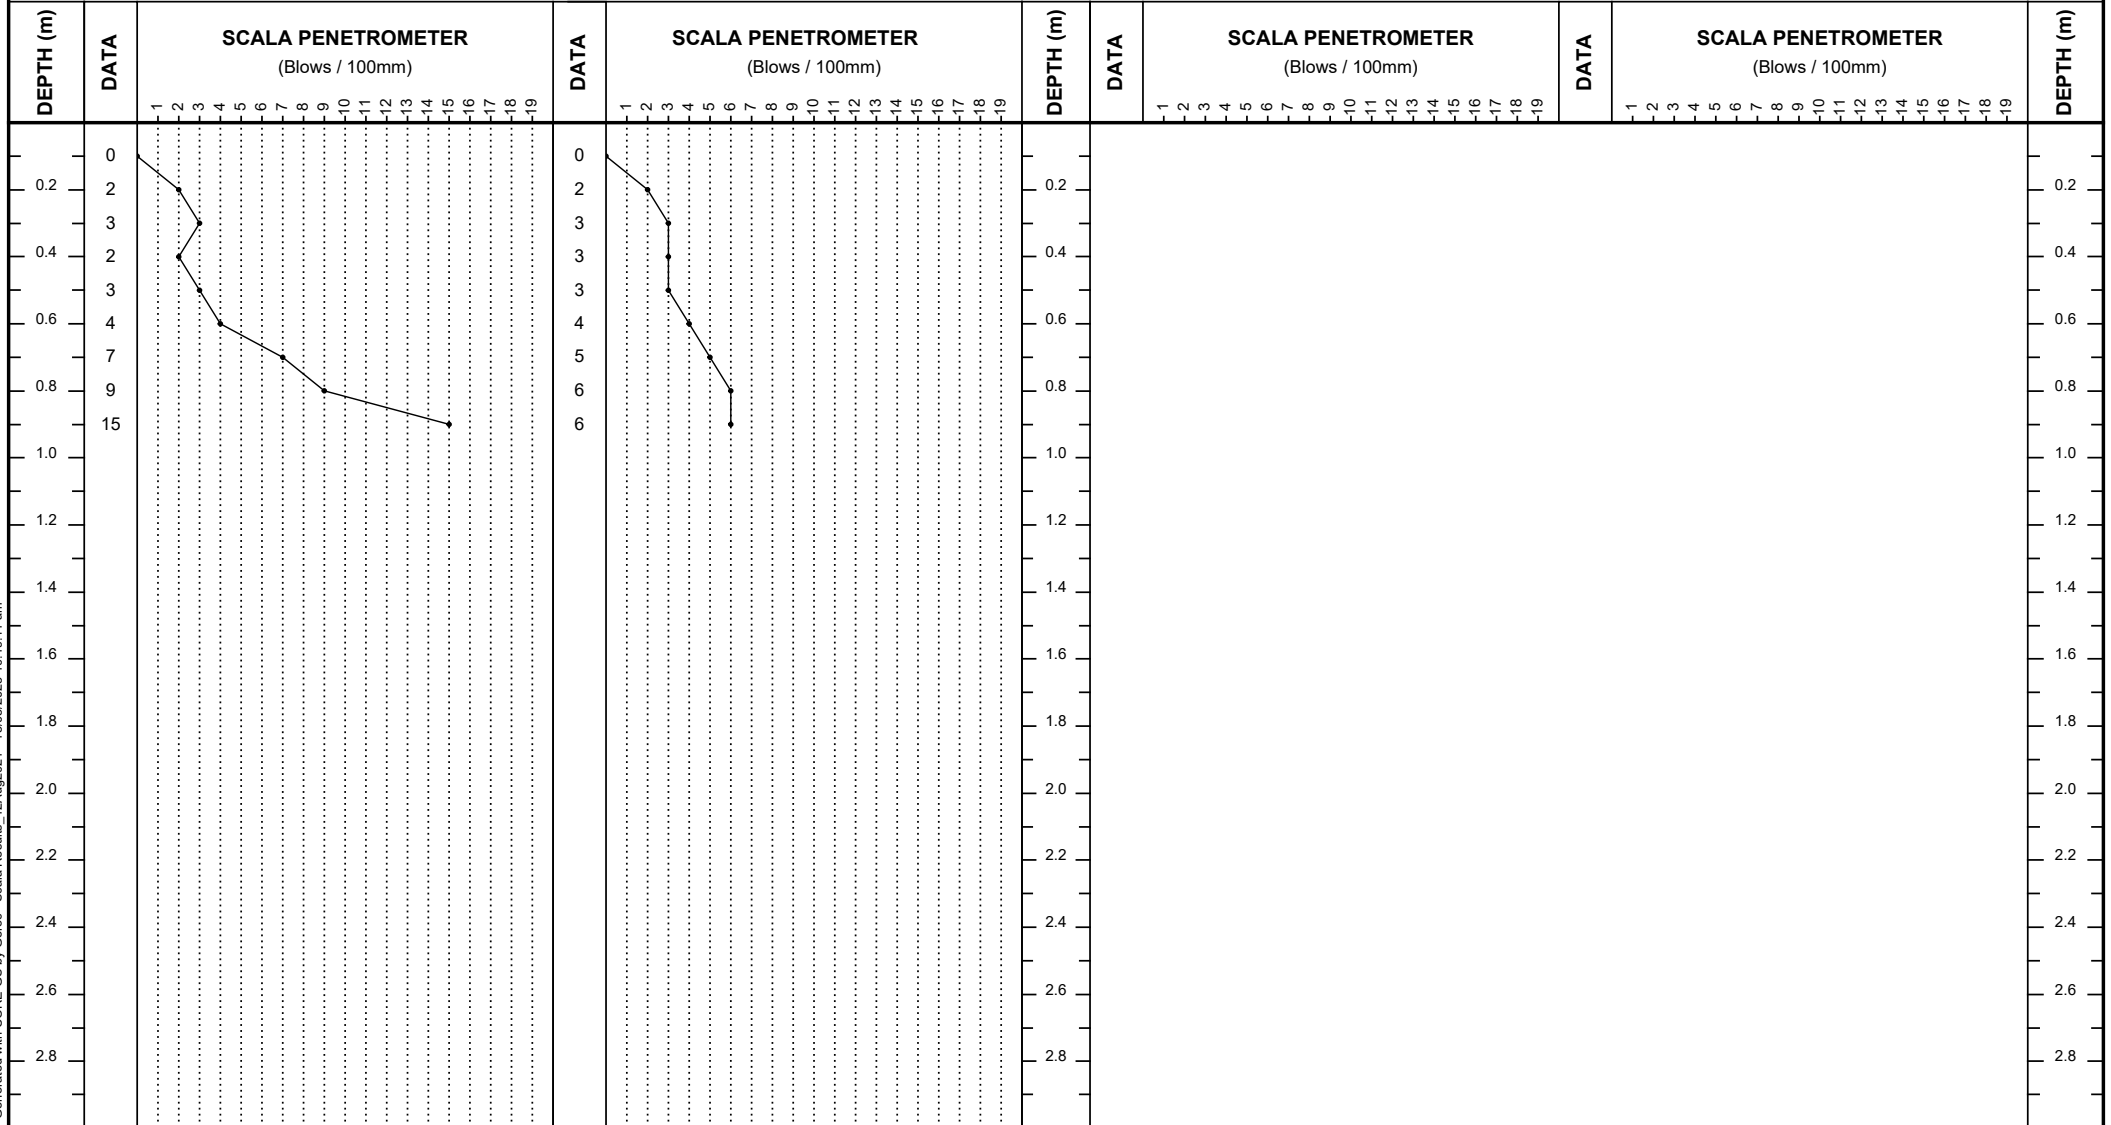
LOT 35- SP01

SPs at each of the four locations returned results between 2 and 15 blows per 100mm penetration below the topsoil and within the engineered fill layer. SPs were terminated at 0.9m depth to confirm near surface bearing capacities, and to avoid damage to the geogrids and geotextile. In addition, the density of the engineered fill and bearing capacity of its underlying subgrade have been confirmed via extensive geotechnical inspection and fill compaction testing during subdivision earthworks.

Tested By: KY
Ground Conditions: Near level, Topsoil.
Coordinates: NZTM2000 E 1576350.97
 N 5183009.30
Test Date: 12-May-23

Tested By: KY
Ground Conditions: Near level, Topsoil.
Coordinates: NZTM2000 E 1576342.14
 N 5183012.22
Test Date: 12-May-23
