Date: 16 May 2023
Project No: LTC21220-A

**RE: SHALLOW SOIL TEST REPORT
FUTURE RESIDENTIAL FOUNDATIONS
LOT 36, 115 EUREKA STREET, ARANUI**

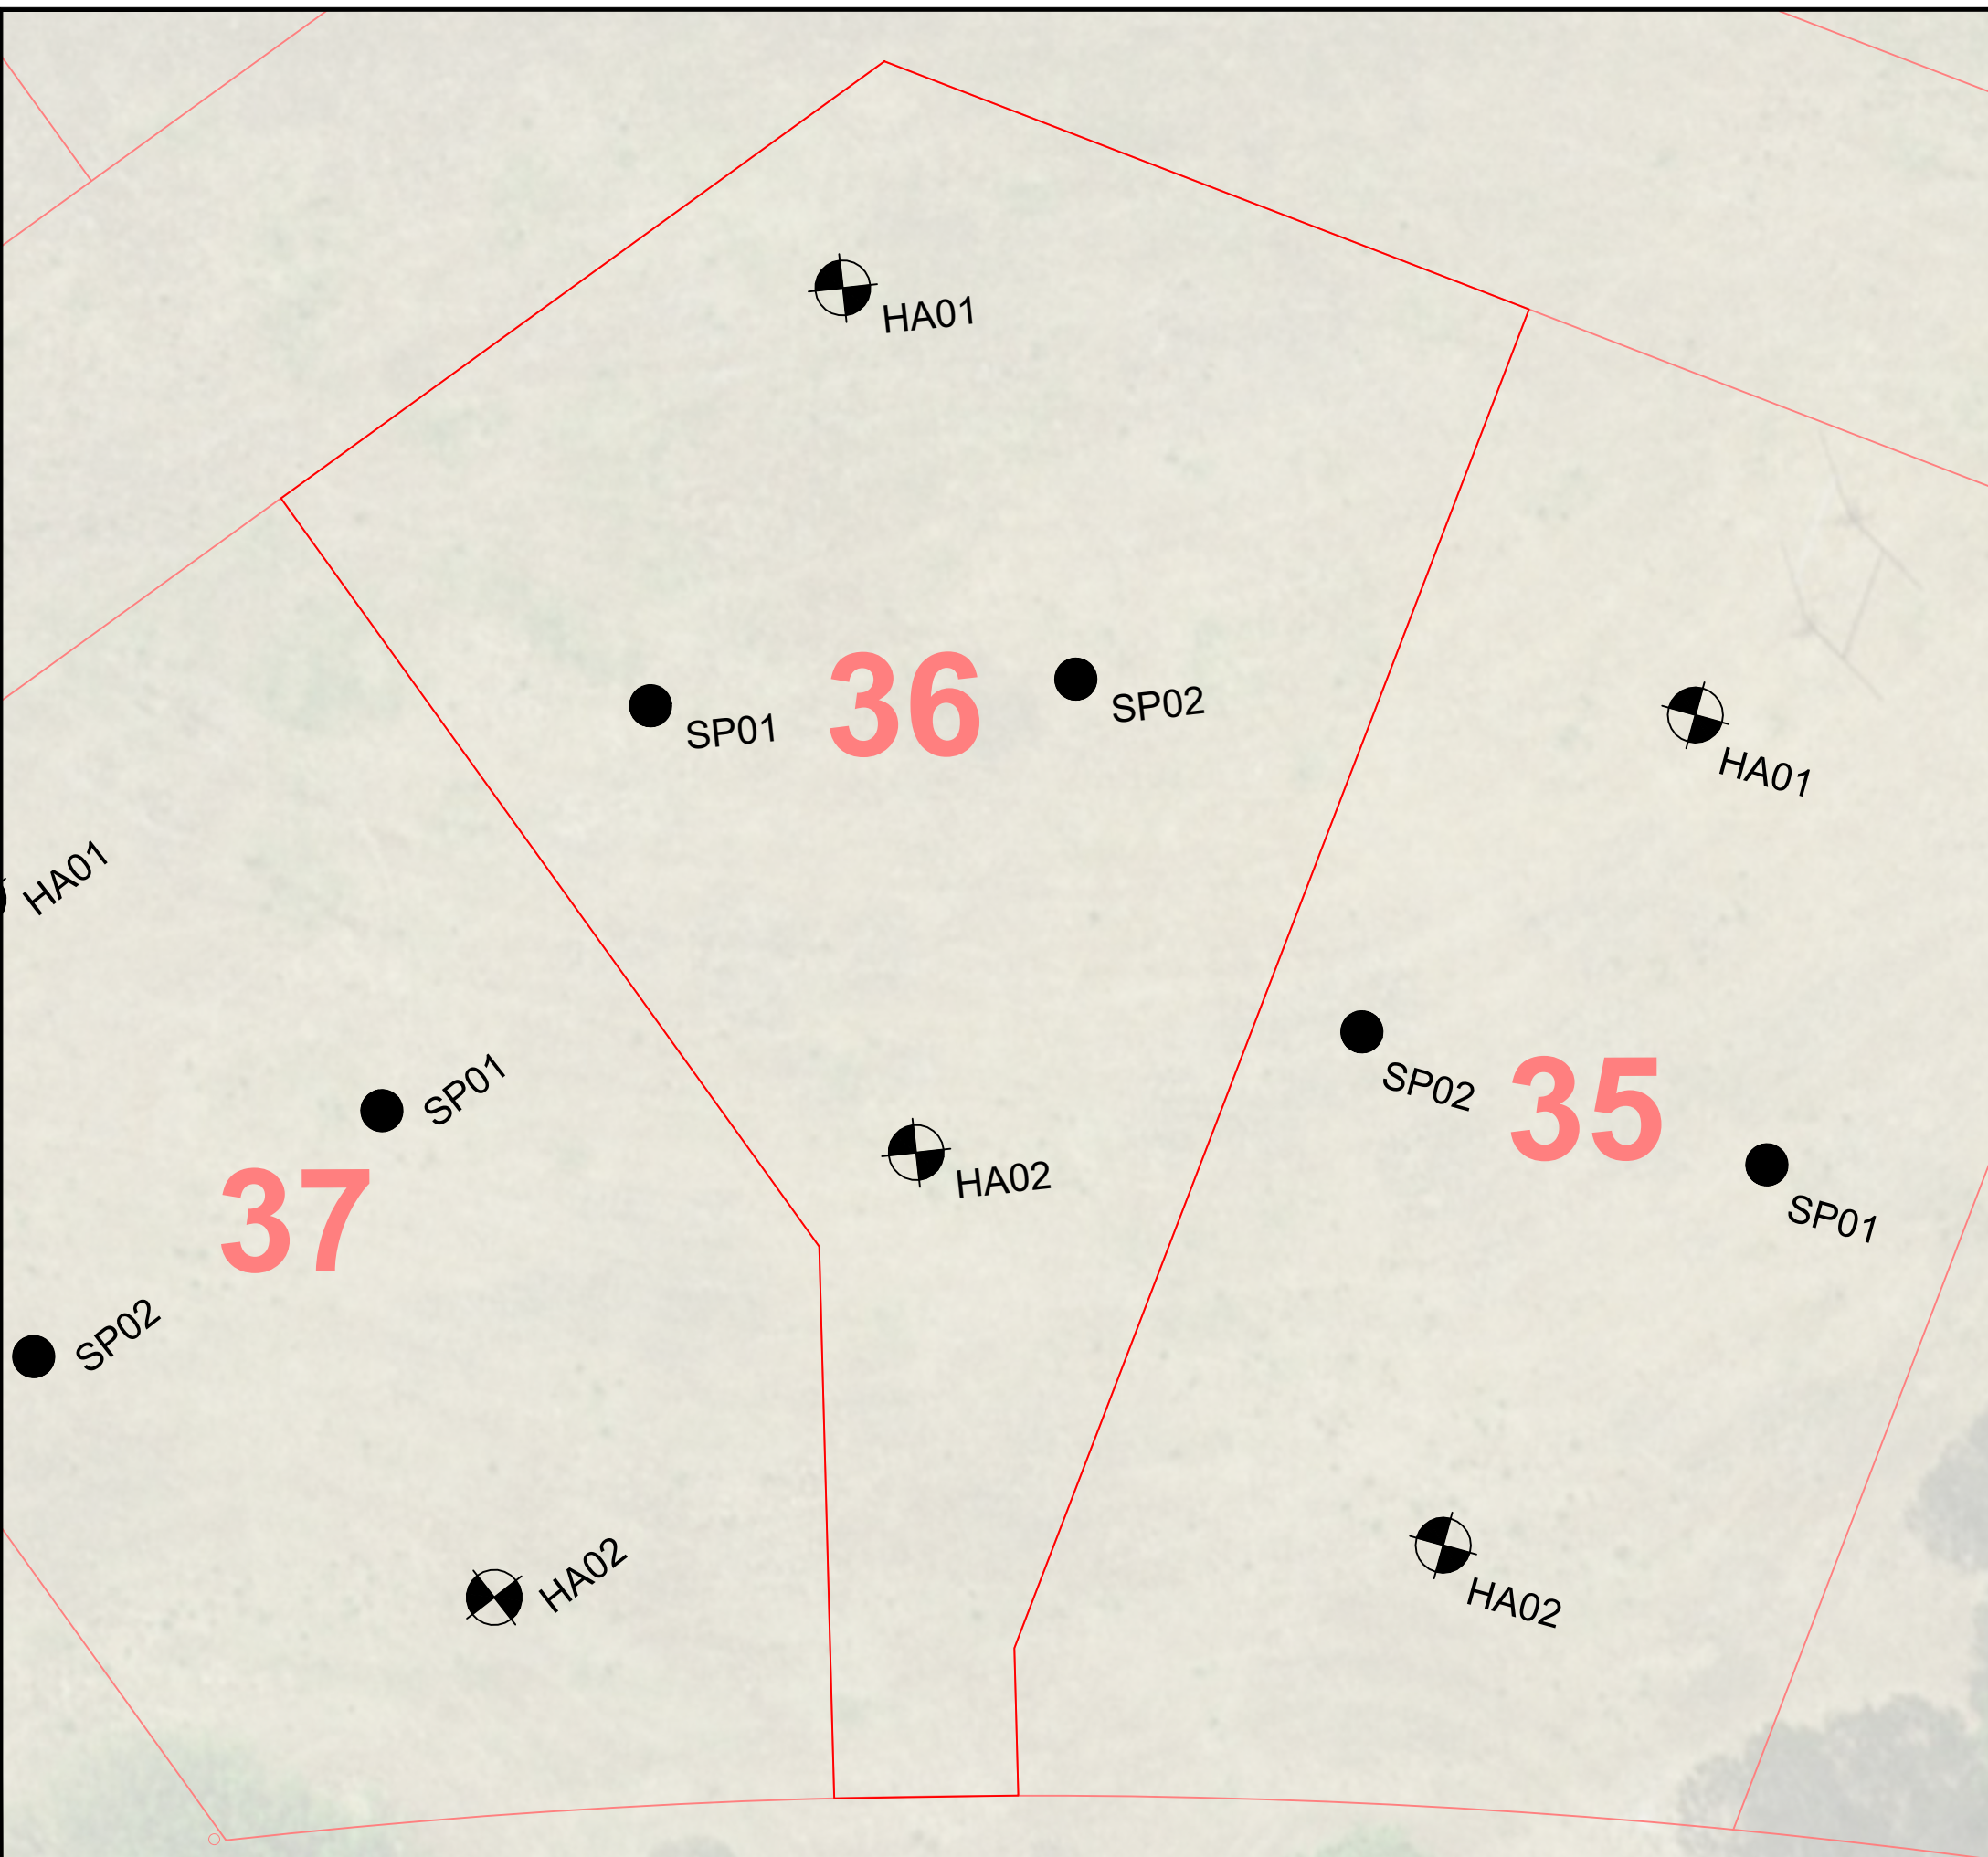
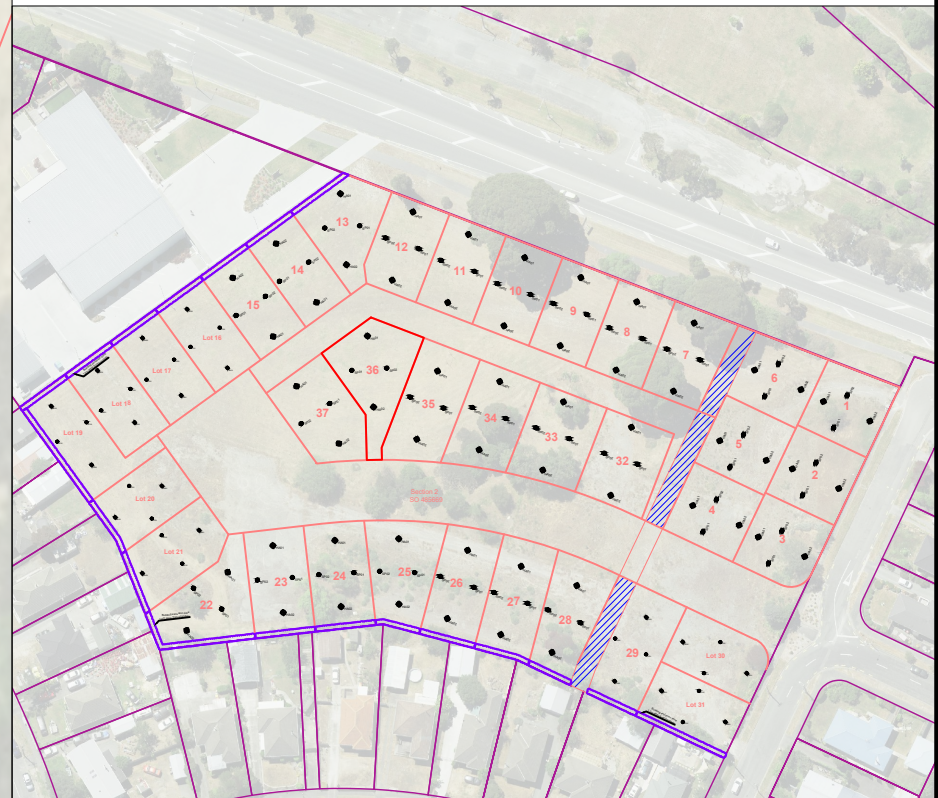
Drawing No: Lot 36/TLP	Drawn by: KY	Date: 15 May 2023
Scale: 1: 150 (A3) 1: 2000 (A3)	Checked by: D Wilson	Revision: A
Filename: LTC21220 - A - Drawings.dwg

LandTech investigated the site on 12 May 2023, conducting two hand augers with corresponding Scala Penetrometer tests (SPs) and two additional SPs. The locations of the hand auger and SPs were measured using inferred lot boundaries and are approximate only. The test locations are shown on our LandTech *Test Location Plan*, Drawing No. Lot 36/ TLP, attached to this report.

Test Location Plan
 Lot 36, 115 Eureka Street,
 ARANUI, CHRISTCHURCH

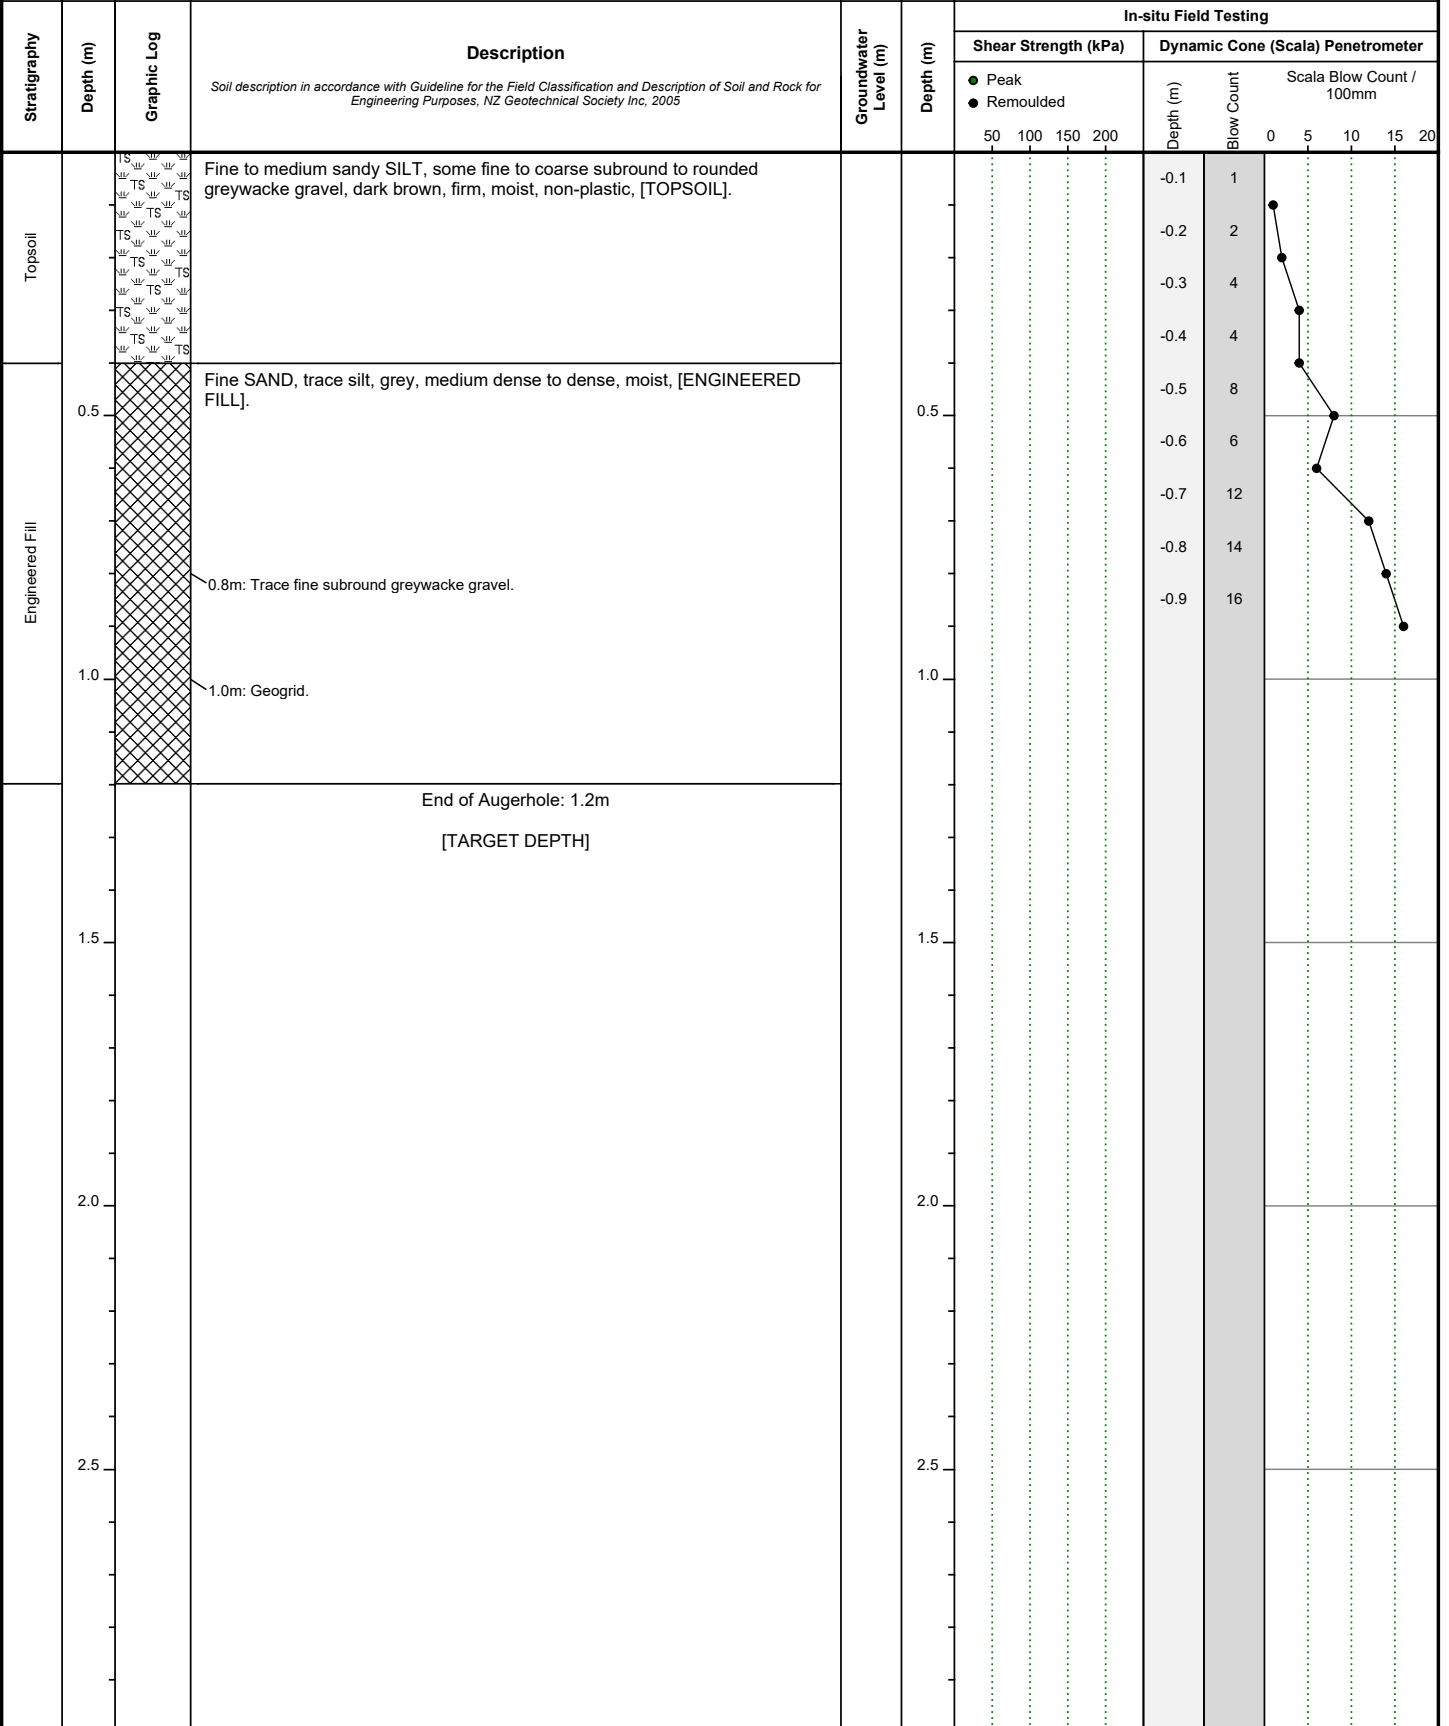
Augerhole No.: Lot 36 - HA01

Project No.: LTC21220-A Coordinates: NZTM2000: E1576332.50, N5183009.57 Logged By: KY
 Drill Type: 50mm Hand Auger Reduced Level: 2.83m (LVD1937) Shear Vane No.:
 Date Started: 12-May-23 Ground Conditions: Near level, Topsoil. Calibration Factor:
 Date Finished: 12-May-23 Groundwater Level (m): Not Encountered Calibration Date:

Target depth achieved.

Topsoil was encountered within the hand augers from the ground surface to 0.4m depth, which was typically a dark brown sandy silt material with some gravel. Engineered fill was encountered below the topsoil to the base of auger holes, which was a compacted dark grey sand material with a trace of silt. The hand augers were terminated at 1.2m depth below ground level to avoid damage to the geotextile layer which was installed at 1.5m depth below ground level. Groundwater was not encountered during testing.

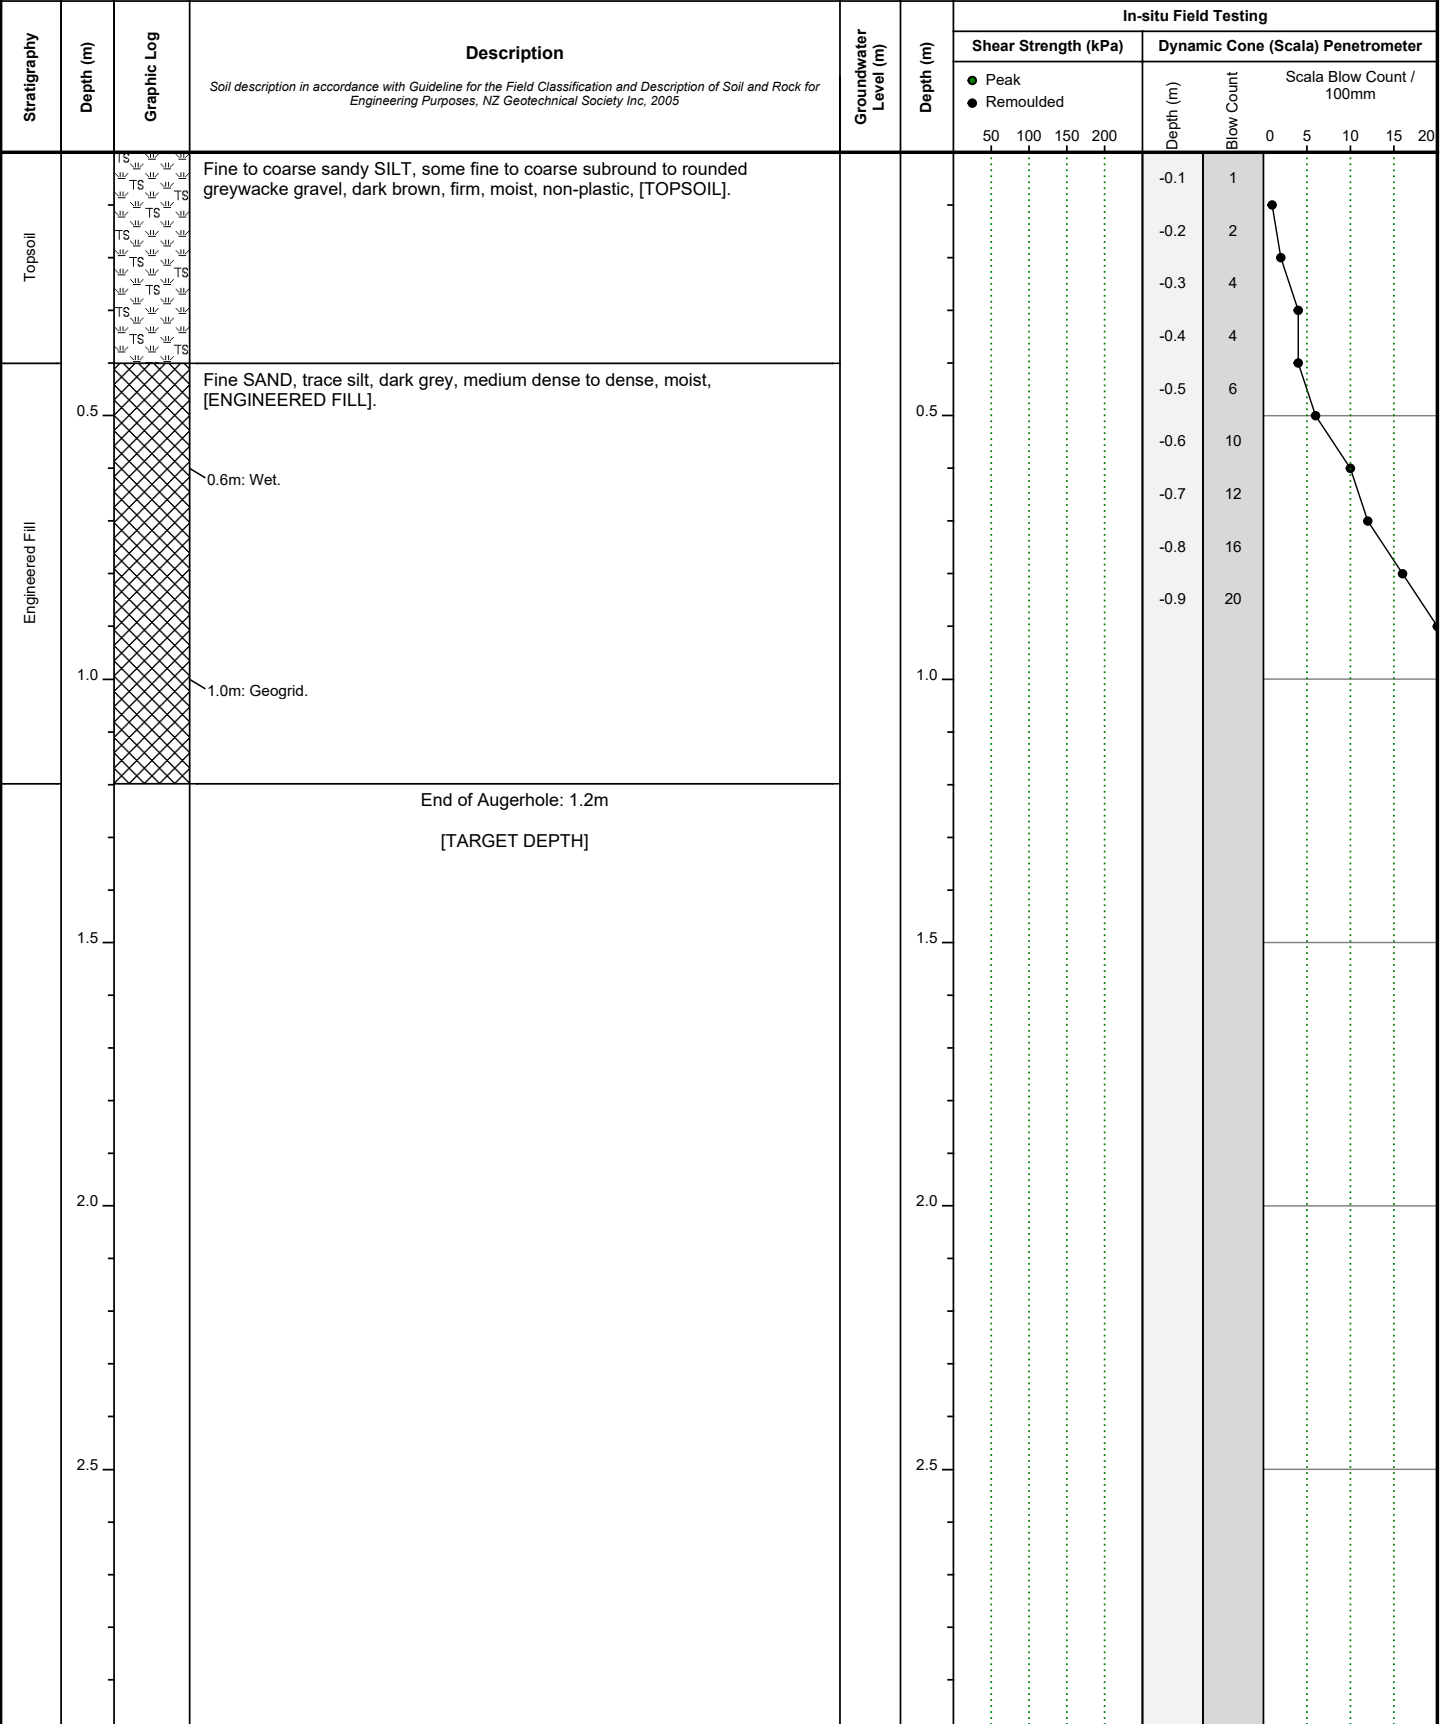
Augerhole No.: Lot 36 - HA02

Project No.: LTC21220-A Coordinates: NZTM2000: E1576330.90, N5183028.34 Logged By: KY
 Drill Type: 50mm Hand Auger Reduced Level: 2.83m (LVD1937) Shear Vane No.:
 Date Started: 12-May-23 Ground Conditions: Near level, Topsoil. Calibration Factor:
 Date Finished: 12-May-23 Groundwater Level (m): Not Encountered Calibration Date:

Target depth achieved. In-situ testing in accordance with the following standards:
 Scala Penetrometer Testing: NZS 4402:1988, Test 6.5.2, Dynamic Cone Penetrometer
 Shear Vane Testing: Guideline for Hand Held Shear Vane Test, NZGS, August 2001

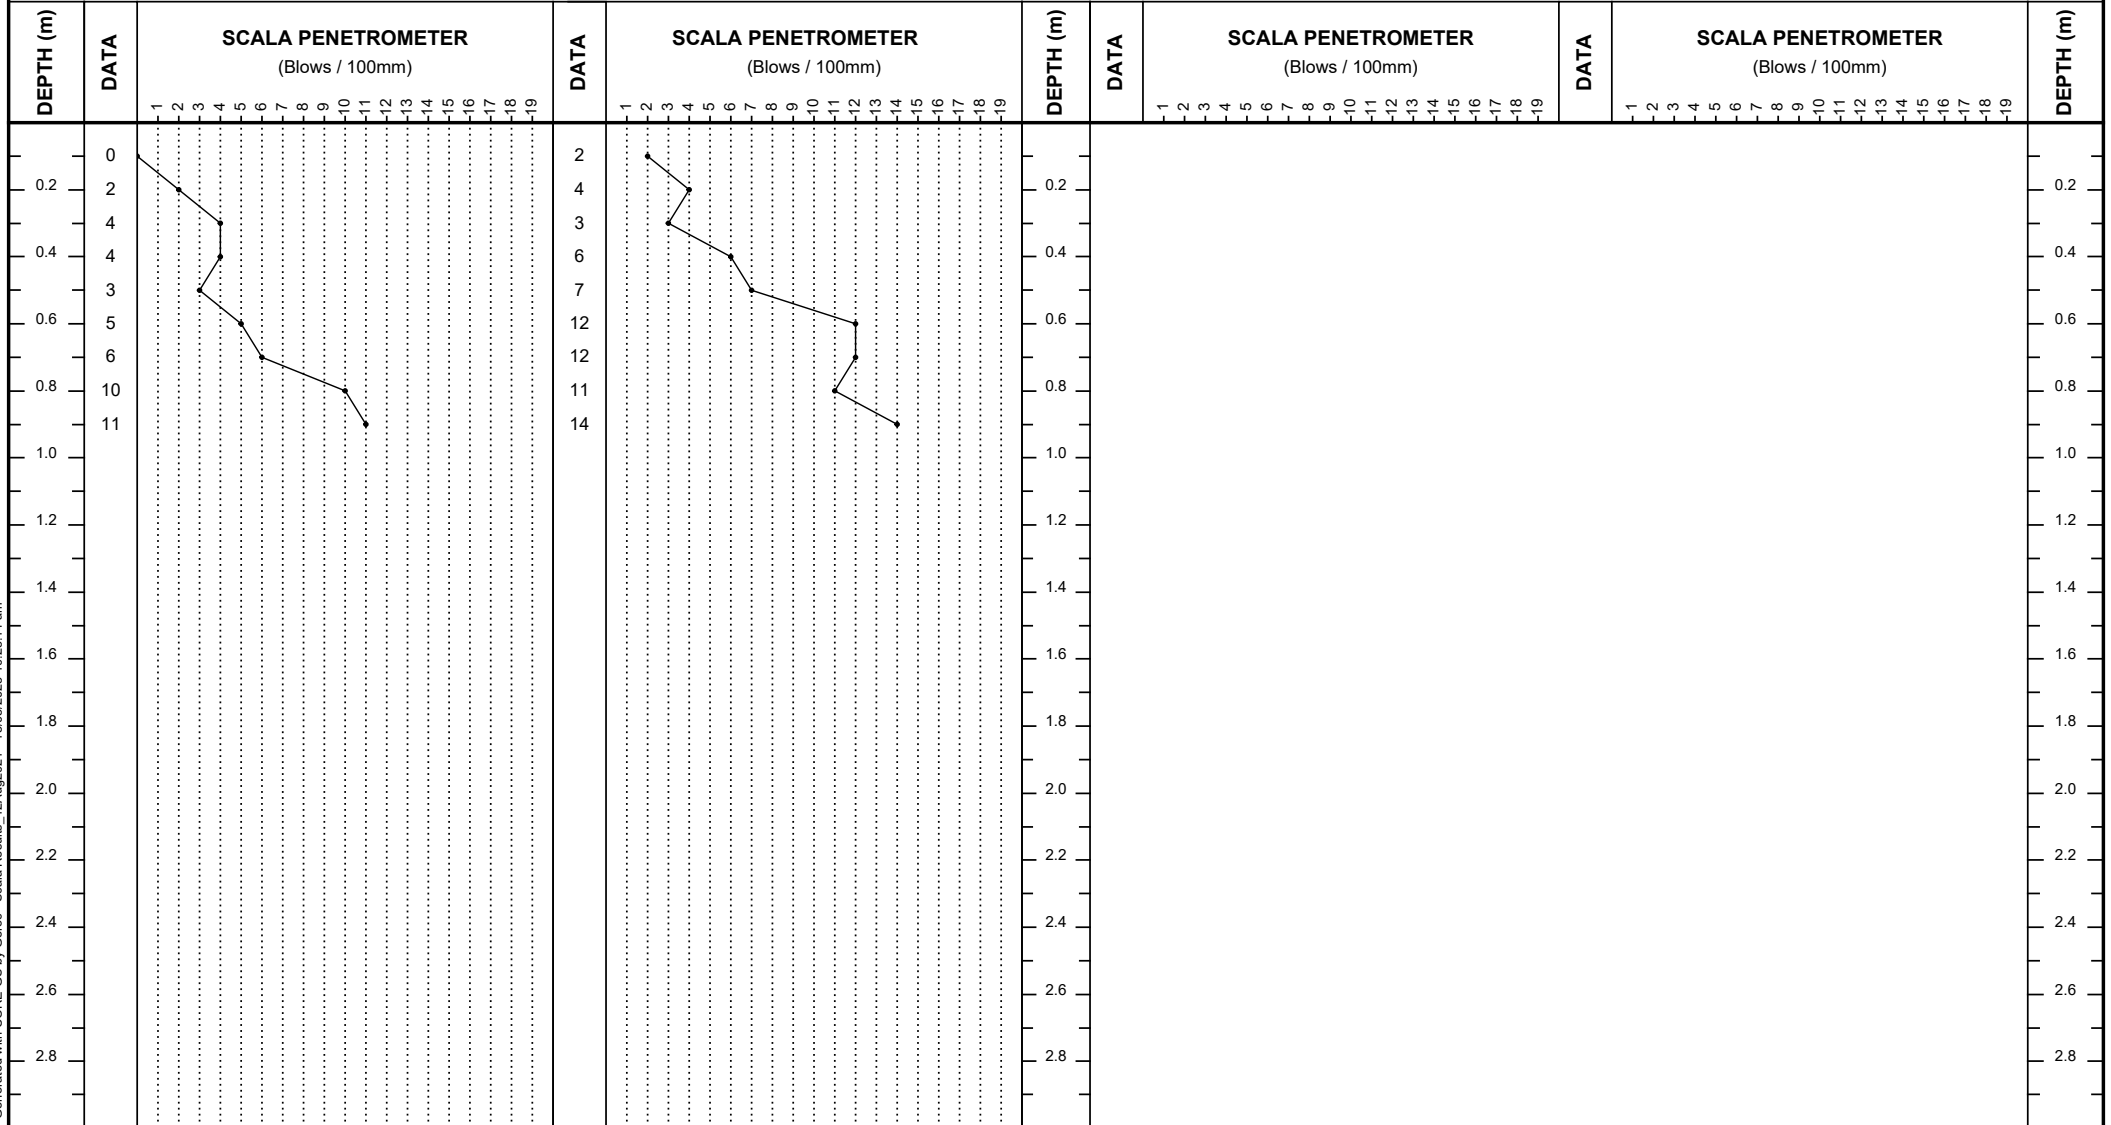
LOT 36- SP01

Tested By: KY
Ground Conditions: Near level, Topsoil.
Coordinates: NZTM2000 E 1576326.73
 N 5183019.27
Test Date: 12-May-23

Tested By: KY
Ground Conditions: Near level, Topsoil.
Coordinates: NZTM2000 E 1576335.96
 N 5183019.85
Test Date: 12-May-23

SPs at each of the four locations returned results between 4 and 20 blows per 100mm penetration below the topsoil and within the engineered fill layer. SPs were terminated at 0.9m depth to confirm near surface bearing capacities, and to avoid damage to the geogrids and geotextile. In addition, the density of the engineered fill and bearing capacity of its underlying subgrade have been confirmed via extensive geotechnical inspection and fill compaction testing during subdivision earthworks.
