Date: 30 August 2023
Project No: LTC21220-A
Revision: B

**RE: SHALLOW SOIL TEST REPORT
FUTURE RESIDENTIAL FOUNDATIONS
LOT 7, 115 EUREKA STREET, ARANUI**

Test Location Plan
 Lot 7, 115 Eureka Street,
 ARANUI, CHRISTCHURCH

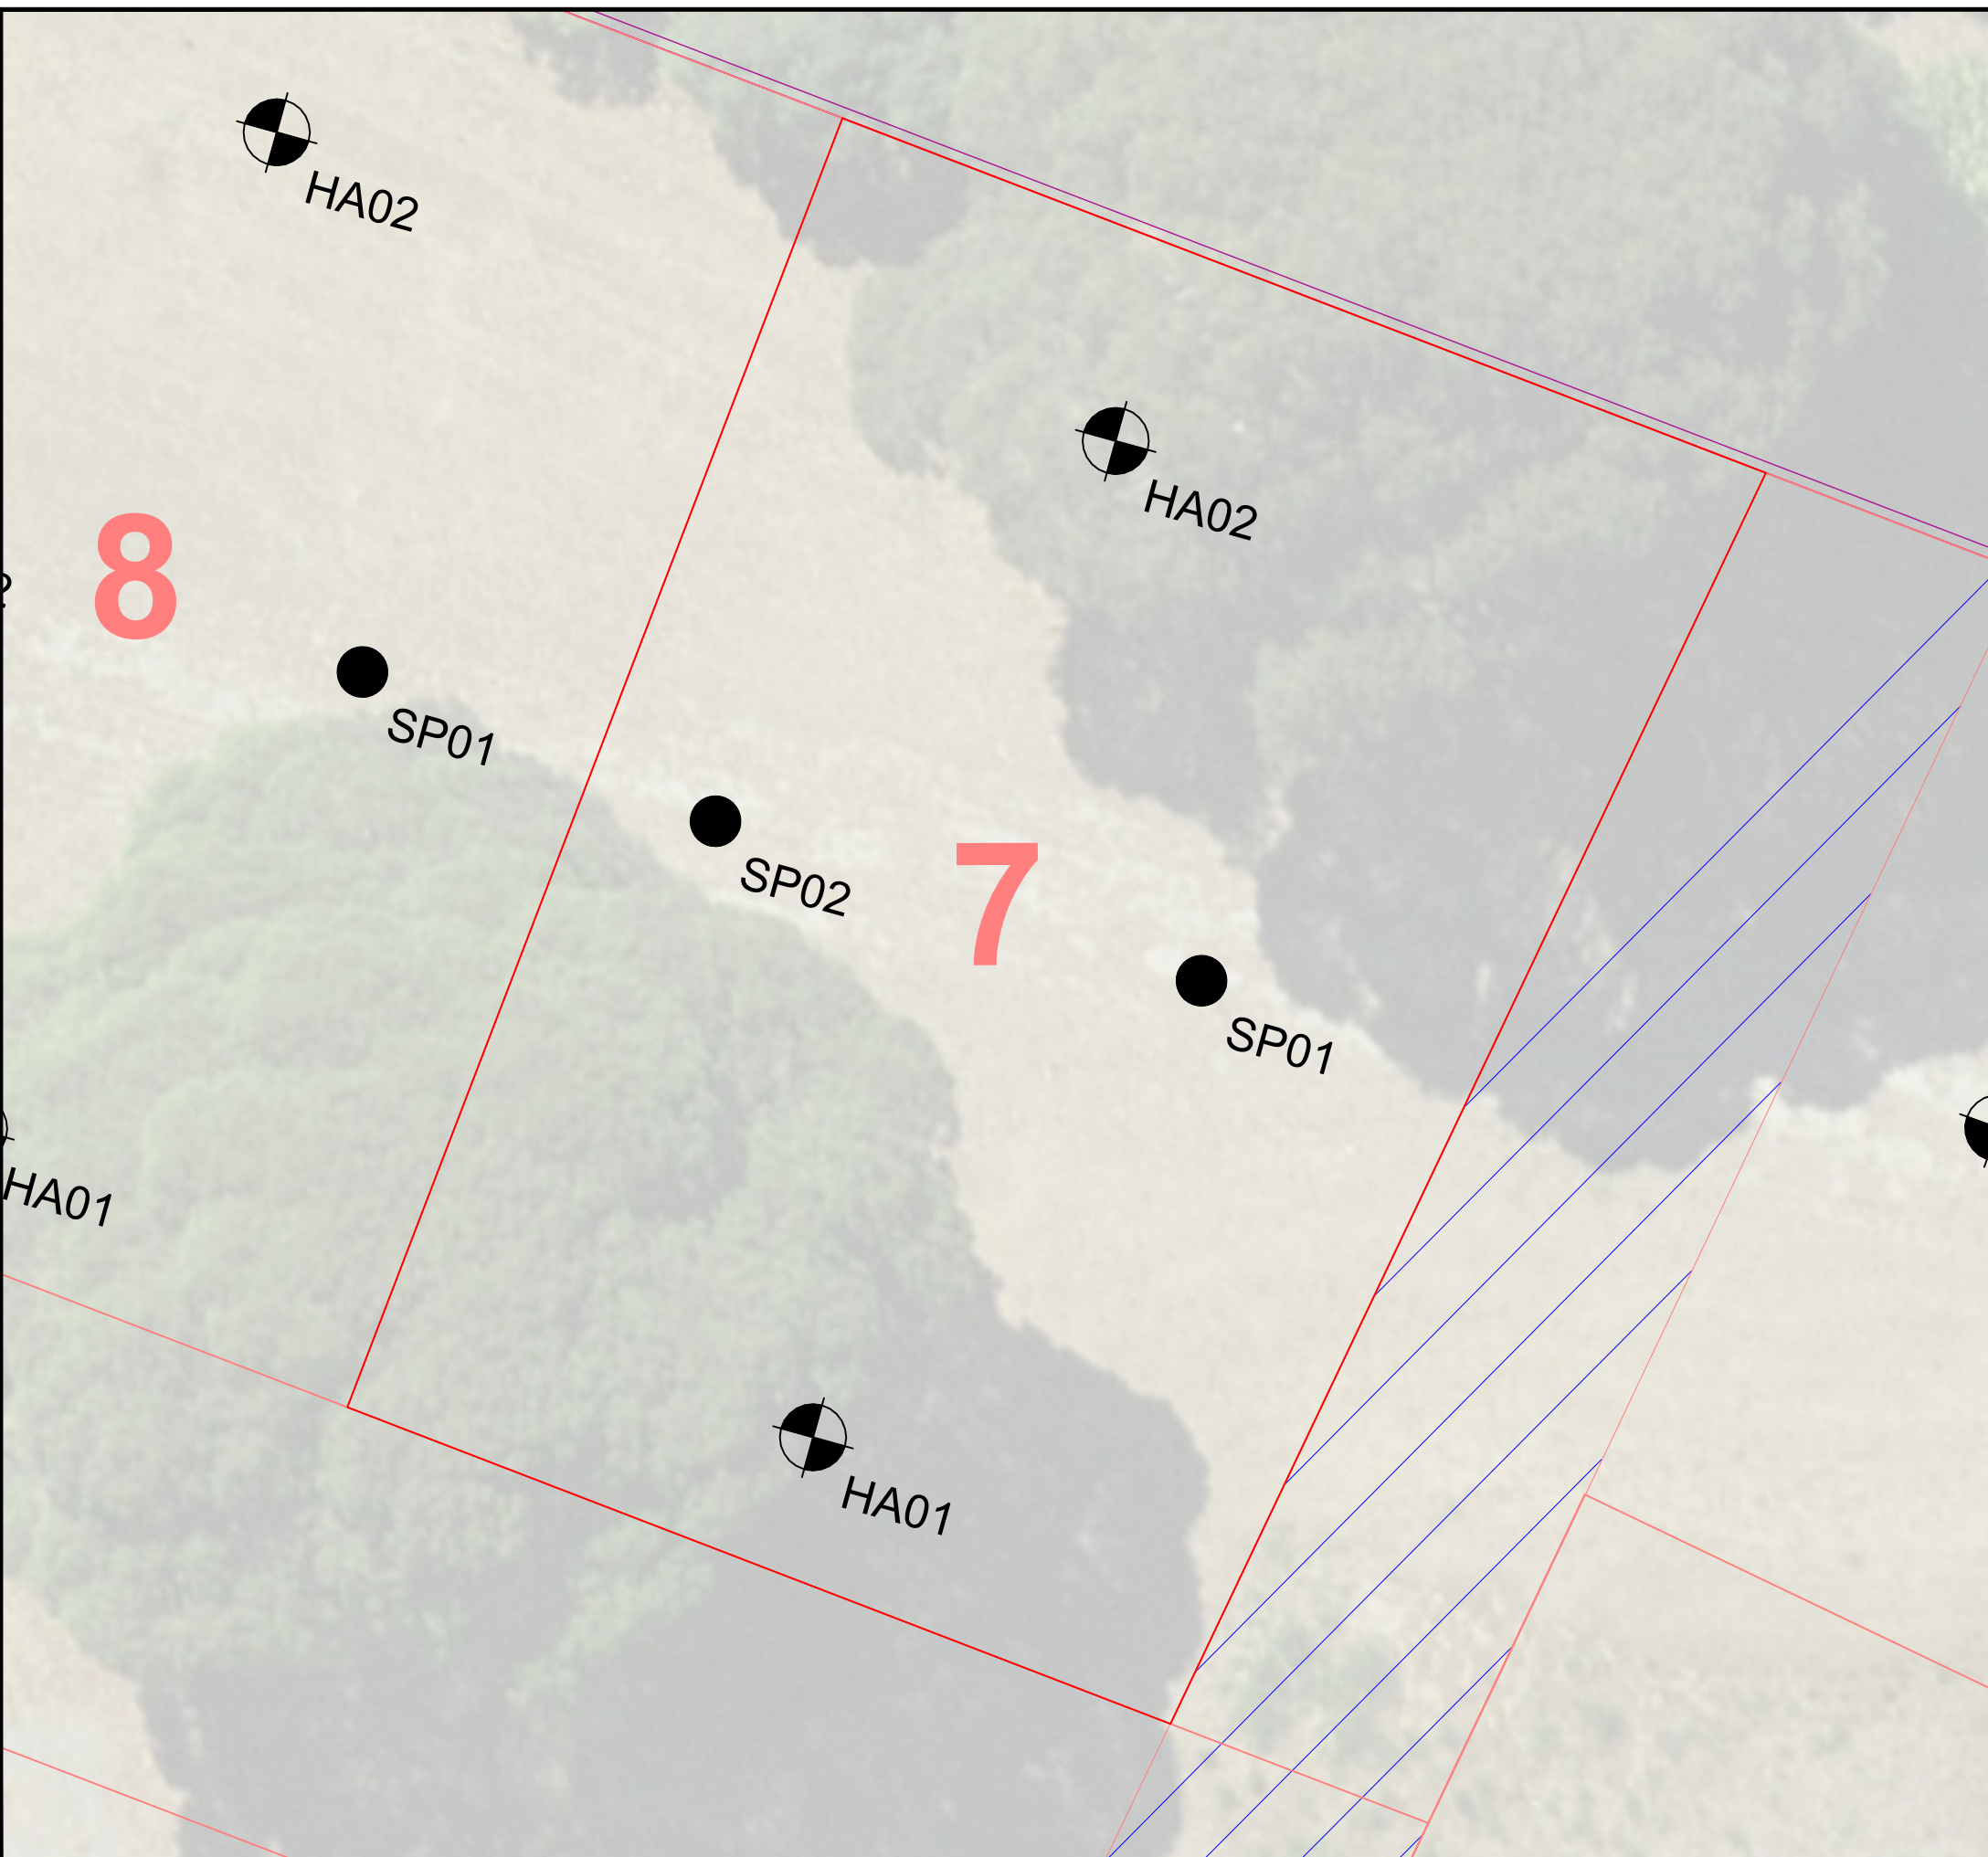
LandTech investigated the site on 24 May 2023, conducting two hand augers with corresponding Scala Penetrometer tests (SPs) and two additional SPs. The locations of the hand auger and SPs were measured using inferred lot boundaries and are approximate only. The test locations are shown on our LandTech *Test Location Plan*, Drawing No. Lot 7/ TLP, attached to this report.

HA01 LandTech Consulting Ltd. augerhole locations, drilled 24 May 2023
-

SP01 LandTech Consulting Ltd. DCP test location, tested 24 May 2023
-

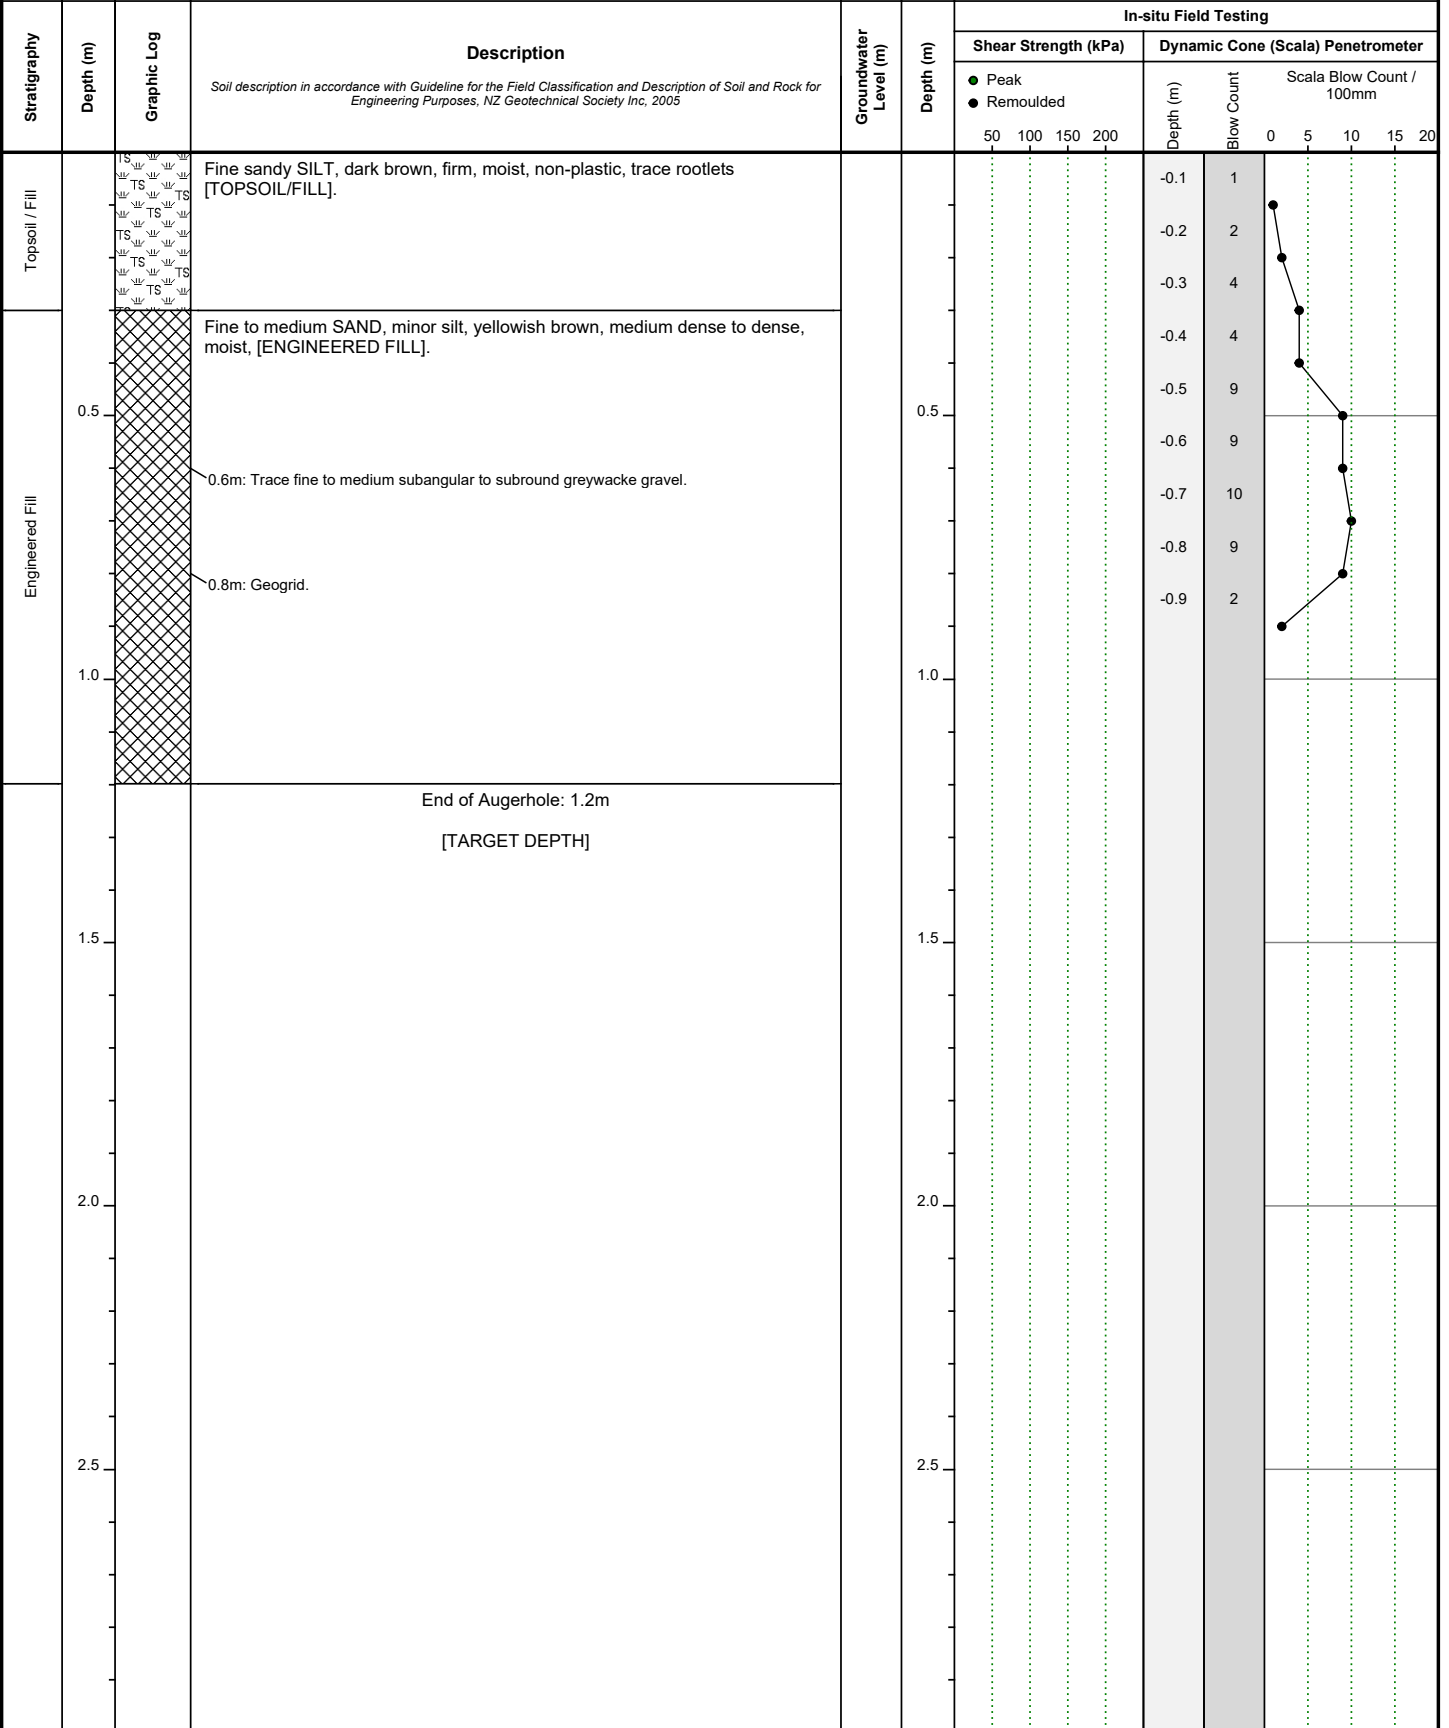
Augerhole No.: Lot 7 - HA01

Topsoil was encountered within the hand augers from the ground surface to 0.3m depth, which was typically a dark brown sandy silt material. Engineered fill was encountered below the topsoil to the base of auger holes, which was a compacted yellowish brown sand material with minor silt. The hand augers were terminated at 1.2m depth below ground level to avoid damage to the geotextile layer which was installed at 1.5m depth below ground level. Groundwater was not encountered during testing.

Project No.: LTC21220-A **Coordinates:** NZTM2000: E1576411.85, N5183013.74 **Logged By:** KY
Drill Type: 50mm Hand Auger **Reduced Level:** 2.83m (LVD1937) **Shear Vane No.:**
Date Started: 24-May-23 **Ground Conditions:** Near level, Topsoil. **Calibration Factor:**
Date Finished: 24-May-23 **Groundwater Level (m):** Not Encountered **Calibration Date:**

Target depth achieved.

From our previous investigation in support of the subdivision, we concluded that TC2 foundations in accordance with MBIE Guidelines (December 2012) may be used at this site following subdivision earthworks and ground remediation (reinforced engineered fill raft). Our current lot-specific shallow soil testing confirms such foundations remain appropriate. In particular, we confirm Option 4 enhanced slab foundations are required.

All foundations must be embedded to a minimum depth of 0.3m below ground level, where an Ultimate Bearing Capacity of 200kPa and a strength reduction factor of (ϕ_s) 0.5 is available. Foundations excavations should expose engineered fill of appropriate bearing capacity. All topsoil and unsuitable materials should be removed below foundations and floor slab areas, and where required layers of compacted hardfill should be placed to the underside of foundations.

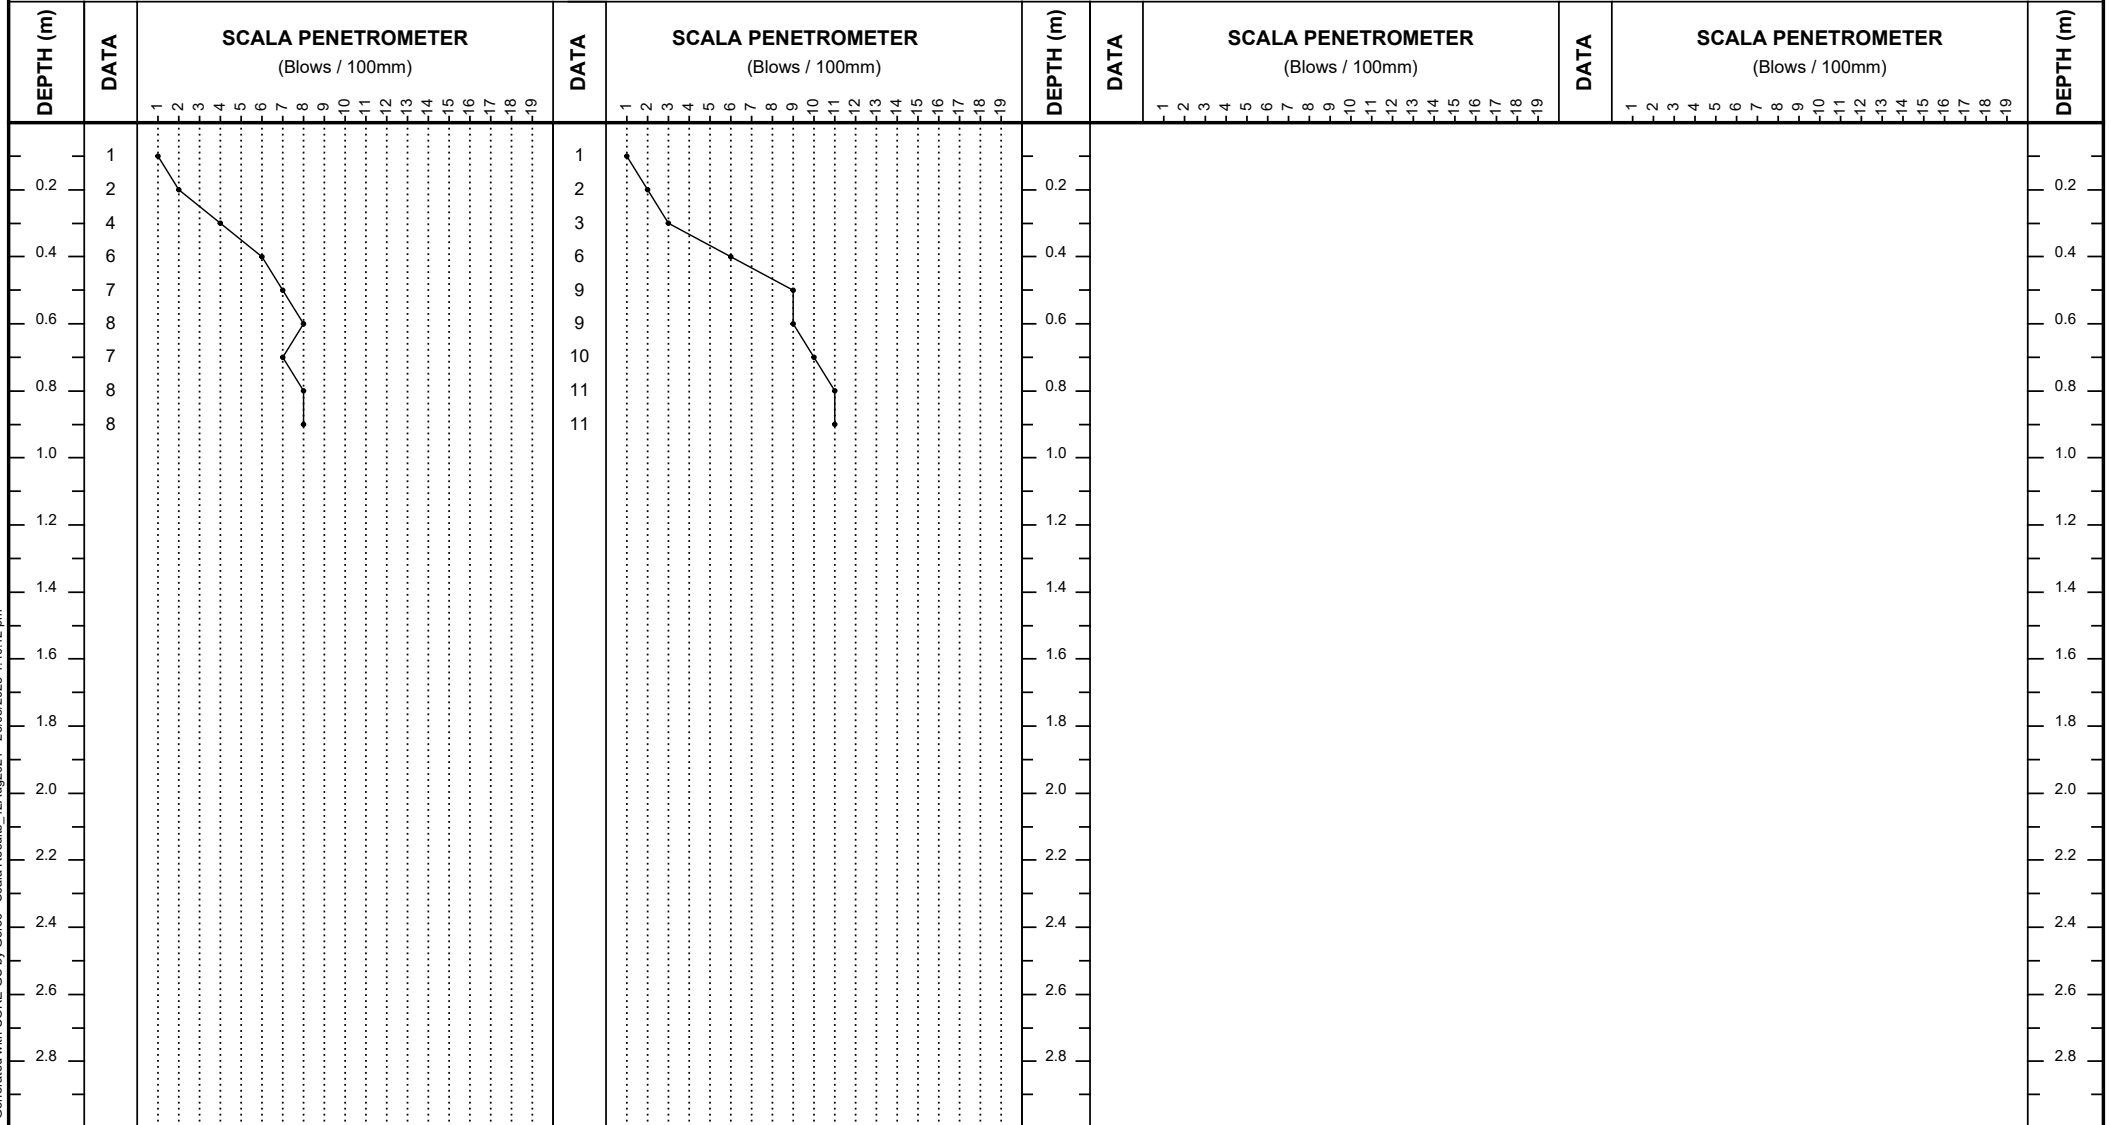
LOT 7- SP01

SPs at each of the four locations returned results between 3 and 11 blows per 100mm penetration below the topsoil and within the engineered fill layer. SPs were terminated at 0.9m depth to confirm near surface bearing capacities, and to avoid damage to the geogrids and geotextile. In addition, the density of the engineered fill and bearing capacity of its underlying subgrade have been confirmed via extensive geotechnical inspection and fill compaction testing during subdivision earthworks.

Tested By: KY
Ground Conditions: Near level, Topsoil.
Coordinates: NZTM2000 E 1576418.88
 N 5183022.01
Test Date: 24-May-23

Tested By: KY
Ground Conditions: Near level, Topsoil.
Coordinates: NZTM2000 E 1576410.08
 N 5183024.89
Test Date: 24-May-23
