Date: 30 August 2023  
Project No: LTC21220-A  
Revision: B

Ngai Tahu Property  
115 Eureka Street, Aranui  
Attention: Simon Tucker

**RE: SHALLOW SOIL TEST REPORT  
FUTURE RESIDENTIAL FOUNDATIONS  
LOT 28, 115 EUREKA STREET, ARANUI**

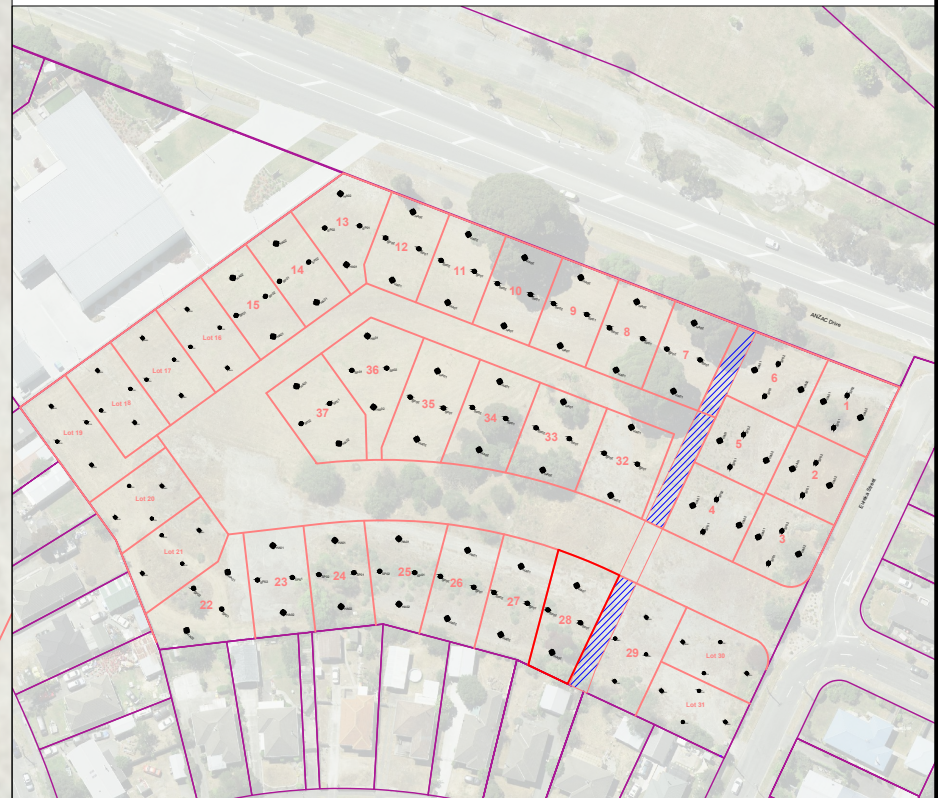
LandTech investigated the site on 23 March 2023, conducting two hand augers with corresponding Scala Penetrometer tests (SPs) and two additional SPs. The locations of the hand auger and SPs were measured using inferred lot boundaries and are approximate only. The test locations are shown on our LandTech *Test Location Plan*, Drawing No. Lot 28/ TLP, attached to this report.
