Date: 30 August 2023
Project No: LTC21220-A
Revision: B

**RE: SHALLOW SOIL TEST REPORT
FUTURE RESIDENTIAL FOUNDATIONS
LOT 19, 115 EUREKA STREET, ARANUI**

1.0 Introduction & Background

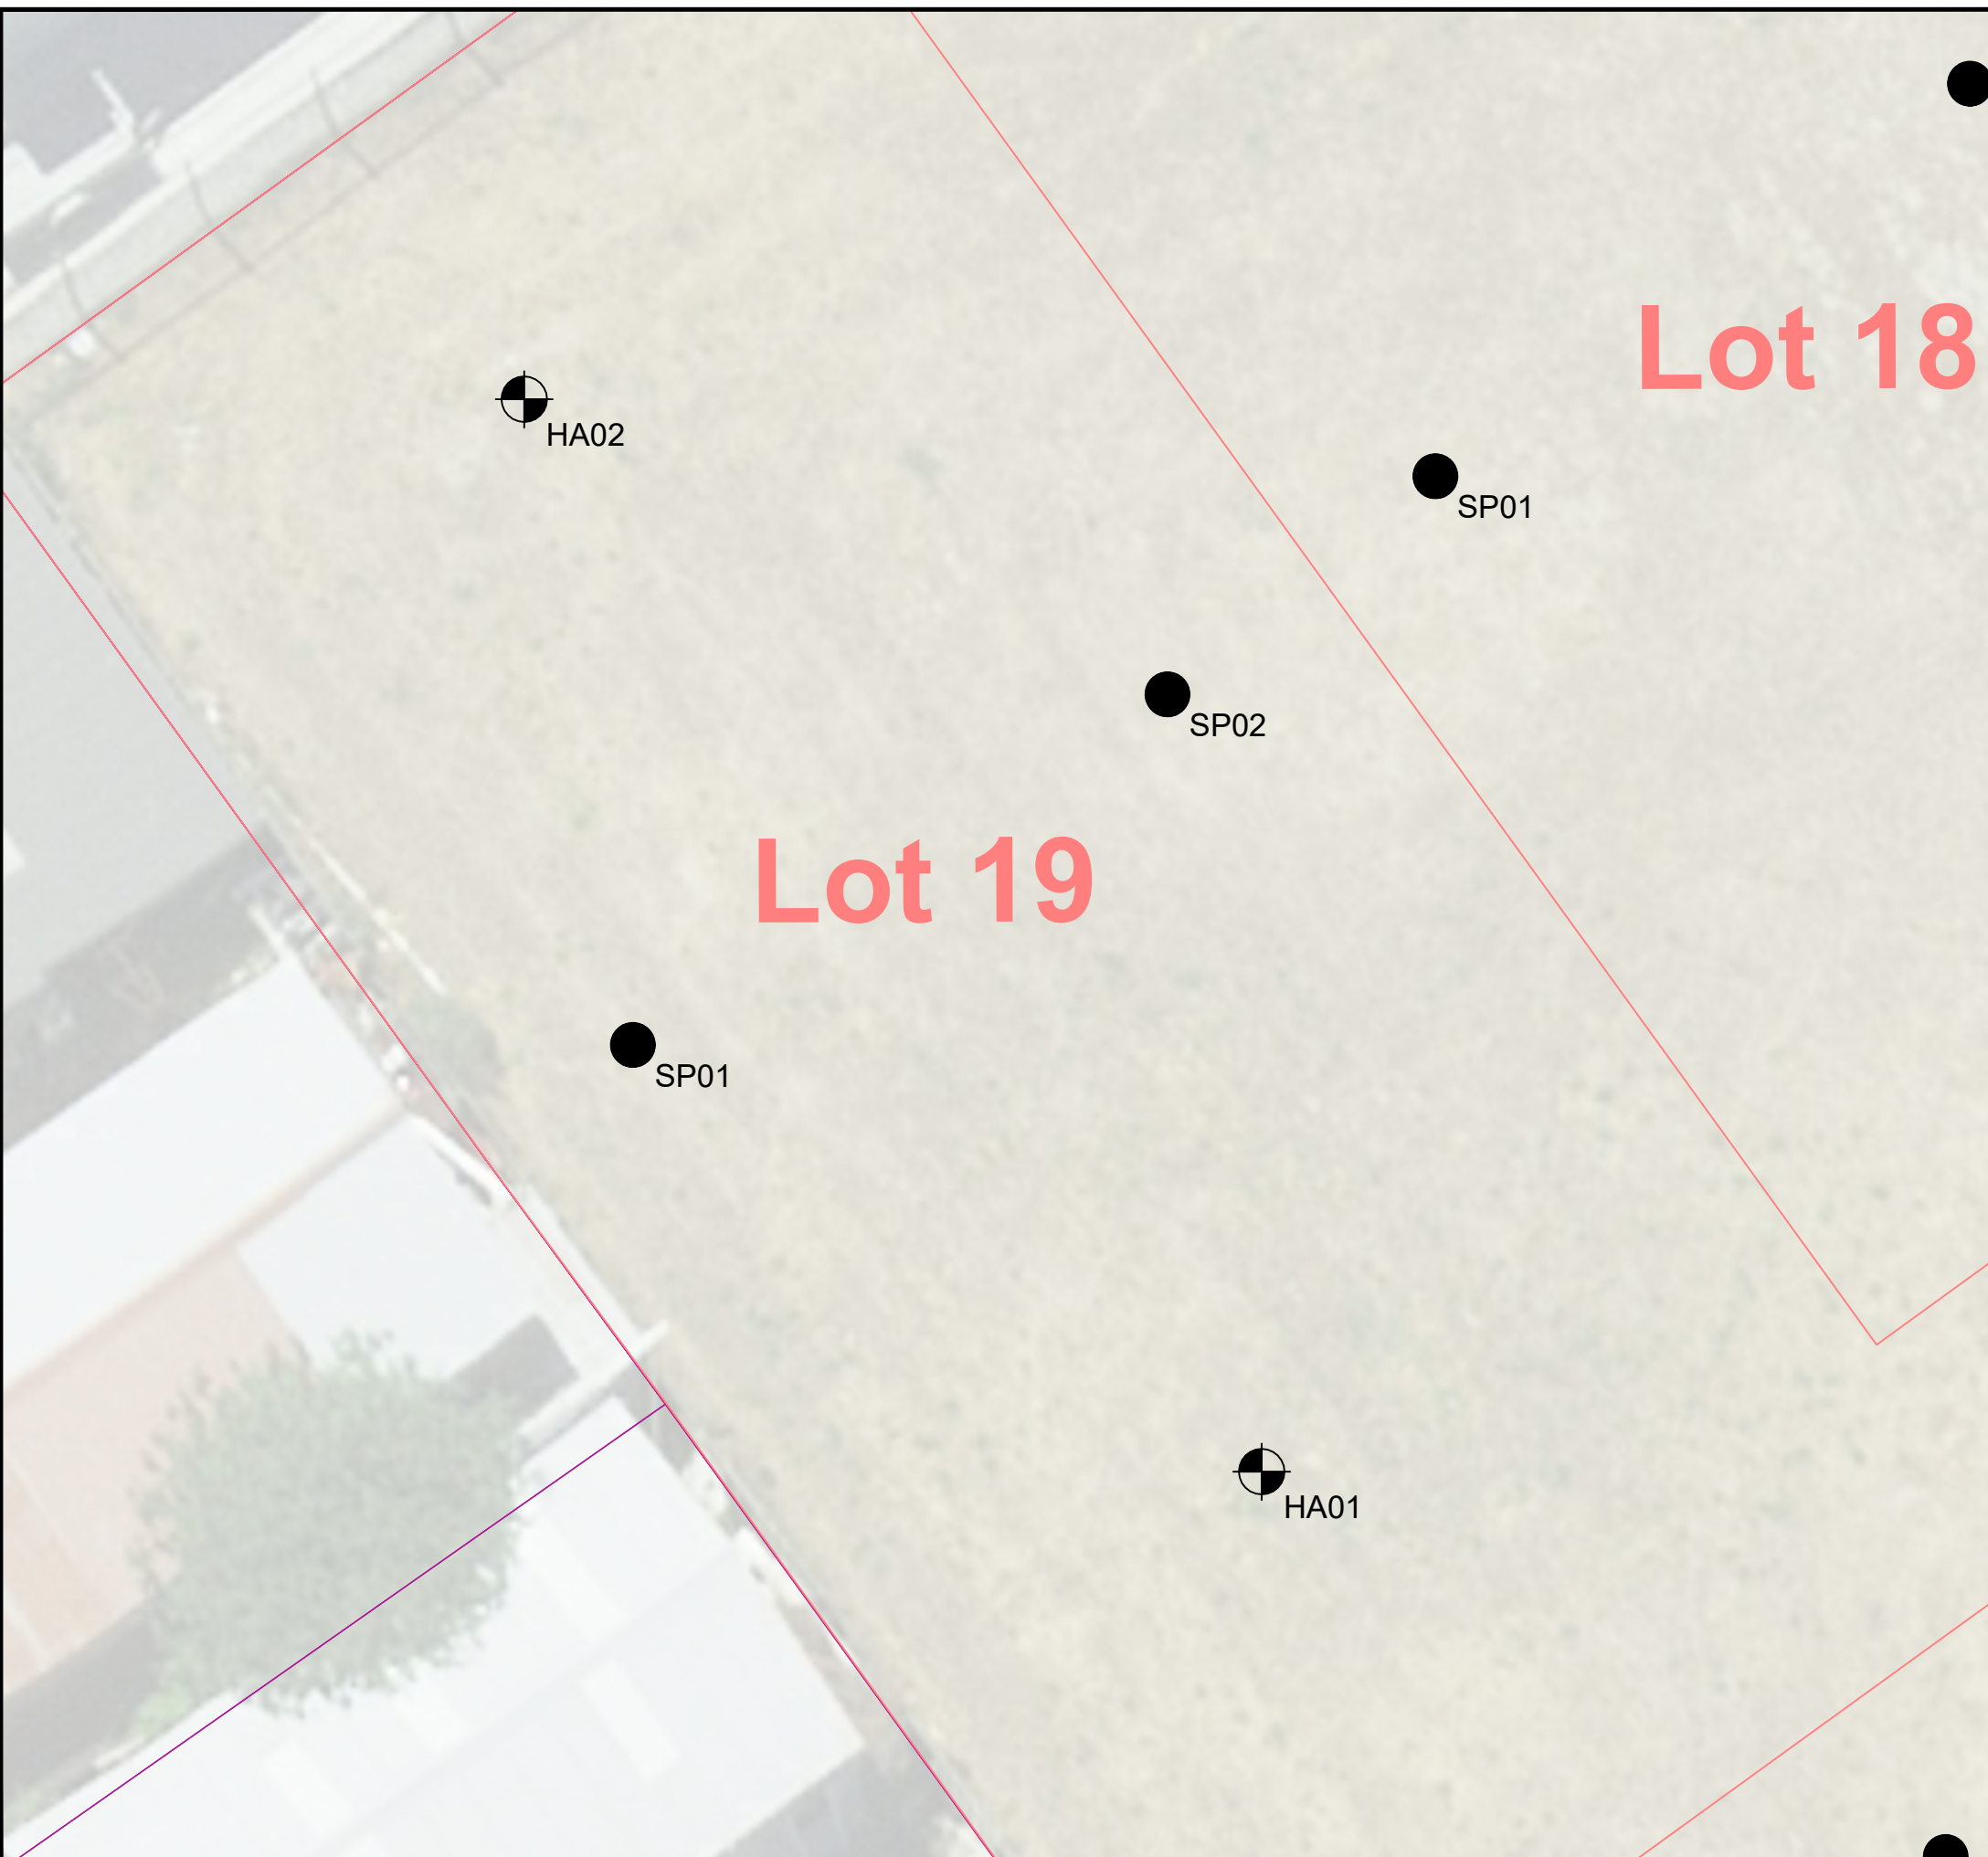
Test Location Plan
 Lot 19, 115 Eureka Street,
 ARANUI, CHRISTCHURCH

HA01 LandTech Consulting Ltd. augerhole locations, drilled 27 April 2023
-

SP01 LandTech Consulting Ltd. DCP test location, tested 27 April 2023
-

LandTech investigated the site on 27 April 2023, conducting two hand augers with corresponding Scala Penetrometer tests (SPs) and two additional SPs. The locations of the hand auger and SPs were measured using inferred lot boundaries and are approximate only. The test locations are shown on our LandTech *Test Location Plan*, Drawing No. Lot 19/ TLP, attached to this report.

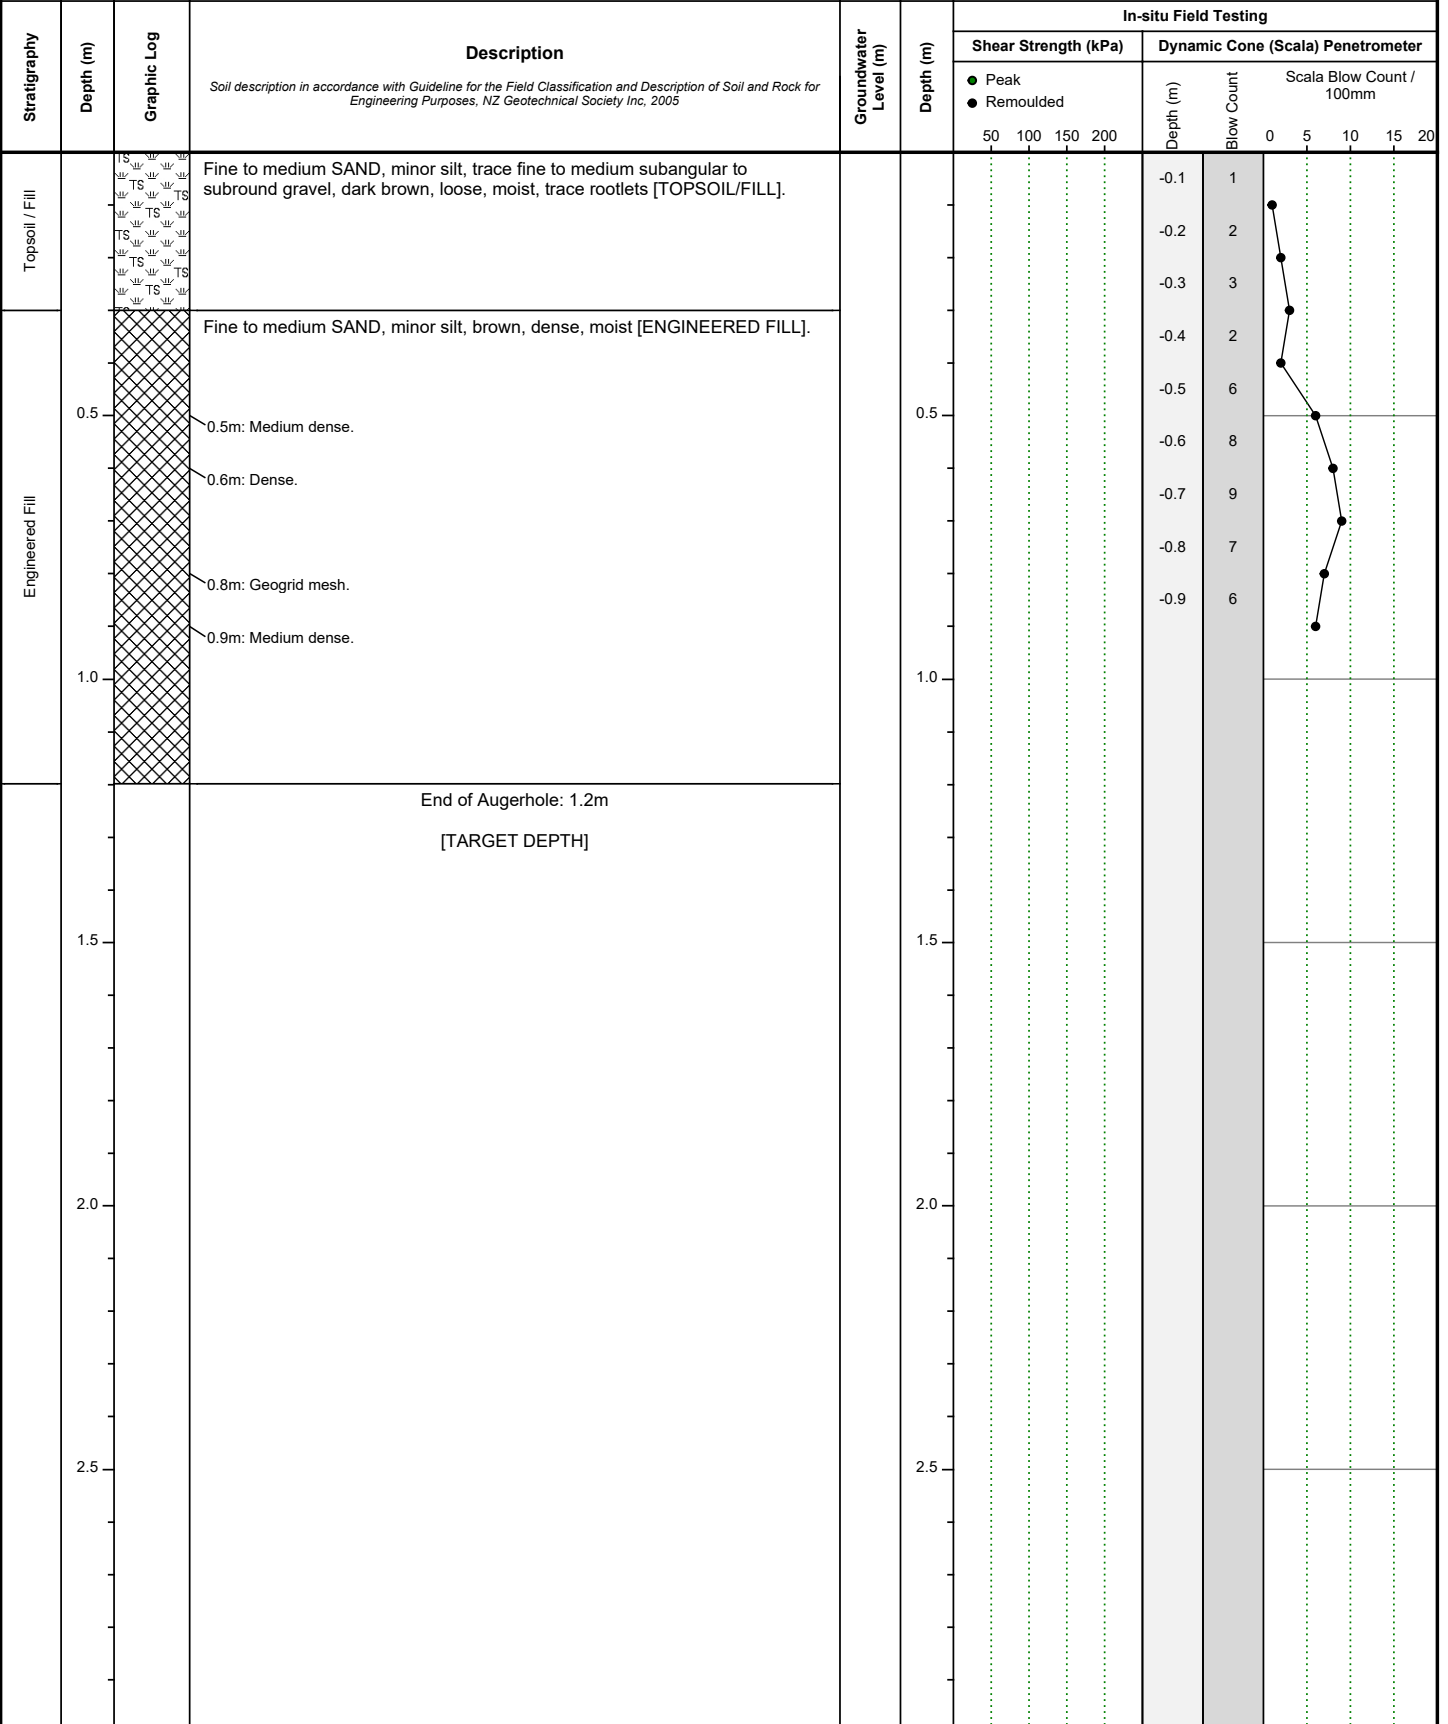
Project No.: LTC21220-A Coordinates: NZTM2000: E1576257.92, N5182994.25 Logged By: SS
 Drill Type: 50mm Hand Auger Reduced Level: 3.50m (LVD1937) Shear Vane No.:
 Date Started: 27-Apr-23 Ground Conditions: Near Level, Topsoil & Grass Calibration Factor:
 Date Finished: 27-Apr-23 Groundwater Level (m): Not Encountered Calibration Date:

Target depth achieved. In-situ testing in accordance with the following standards:
 Scala Penetrometer Testing: NZS 4402:1988, Test 6.5.2, Dynamic Cone Penetrometer
 Shear Vane Testing: Guideline for Hand Held Shear Vane Test, NZGS, August 2001

Soil types and conditions within the hand augers were logged by LandTech technical staff in accordance with New Zealand Geotechnical Society *Guideline for the Description of Soil and Rock for Engineering Purposes* (2005). The hand auger logs for each hole are attached.

Topsoil was encountered within the hand augers from the ground surface to 0.3m depth, which was typically a dark brown minor silt and sand material with trace gravel. Engineered fill was encountered below the topsoil to the base of auger holes, which was a compacted brown sand with minor silt material. The hand augers were terminated at 1.2m depth below ground level to avoid damage to the geotextile layer which was installed at 1.5m depth below ground level. Groundwater was not encountered during testing.

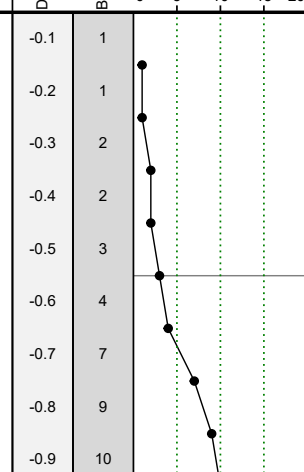
Project No.: LTC21220-A **Coordinates:** NZTM2000: E1576247.24, N5183009.78 **Logged By:** SS
Drill Type: 50mm Hand Auger **Reduced Level:** 3.50m (LVD1937) **Shear Vane No.:**
Date Started: 27-Apr-23 **Ground Conditions:** Near Level, Topsoil & Grass **Calibration Factor:**
Date Finished: 27-Apr-23 **Groundwater Level (m):** Not Encountered **Calibration Date:**

Stratigraphy	Depth (m)	Graphic Log	Description <i>Soil description in accordance with Guideline for the Field Classification and Description of Soil and Rock for Engineering Purposes, NZ Geotechnical Society Inc, 2005</i>	Groundwater Level (m)	Depth (m)	In-situ Field Testing												
						Shear Strength (kPa)				Dynamic Cone (Scala) Penetrometer								
						<ul style="list-style-type: none"> ● Peak ● Remoulded 				Depth (m) Blow Count Scala Blow Count / 100mm								
						50	100	150	200									
Topsoil / Fill			Fine to medium SAND, minor silt, trace fine to medium subangular to subround gravel, dark brown, loose, moist, trace rootlets [TOPSOIL/FILL].															
Engineered Fill	0.5		Fine to medium SAND, trace silt, brown, loose, moist [ENGINEERED FILL]. 0.5m: Medium dense. 0.7m: Medium dense, geogrid mesh. 0.8m: Dense, minor orange mottles (200mm). 1.0m: Wet.		0.5													
			End of Augerhole: 1.2m [TARGET DEPTH]

Target depth achieved.

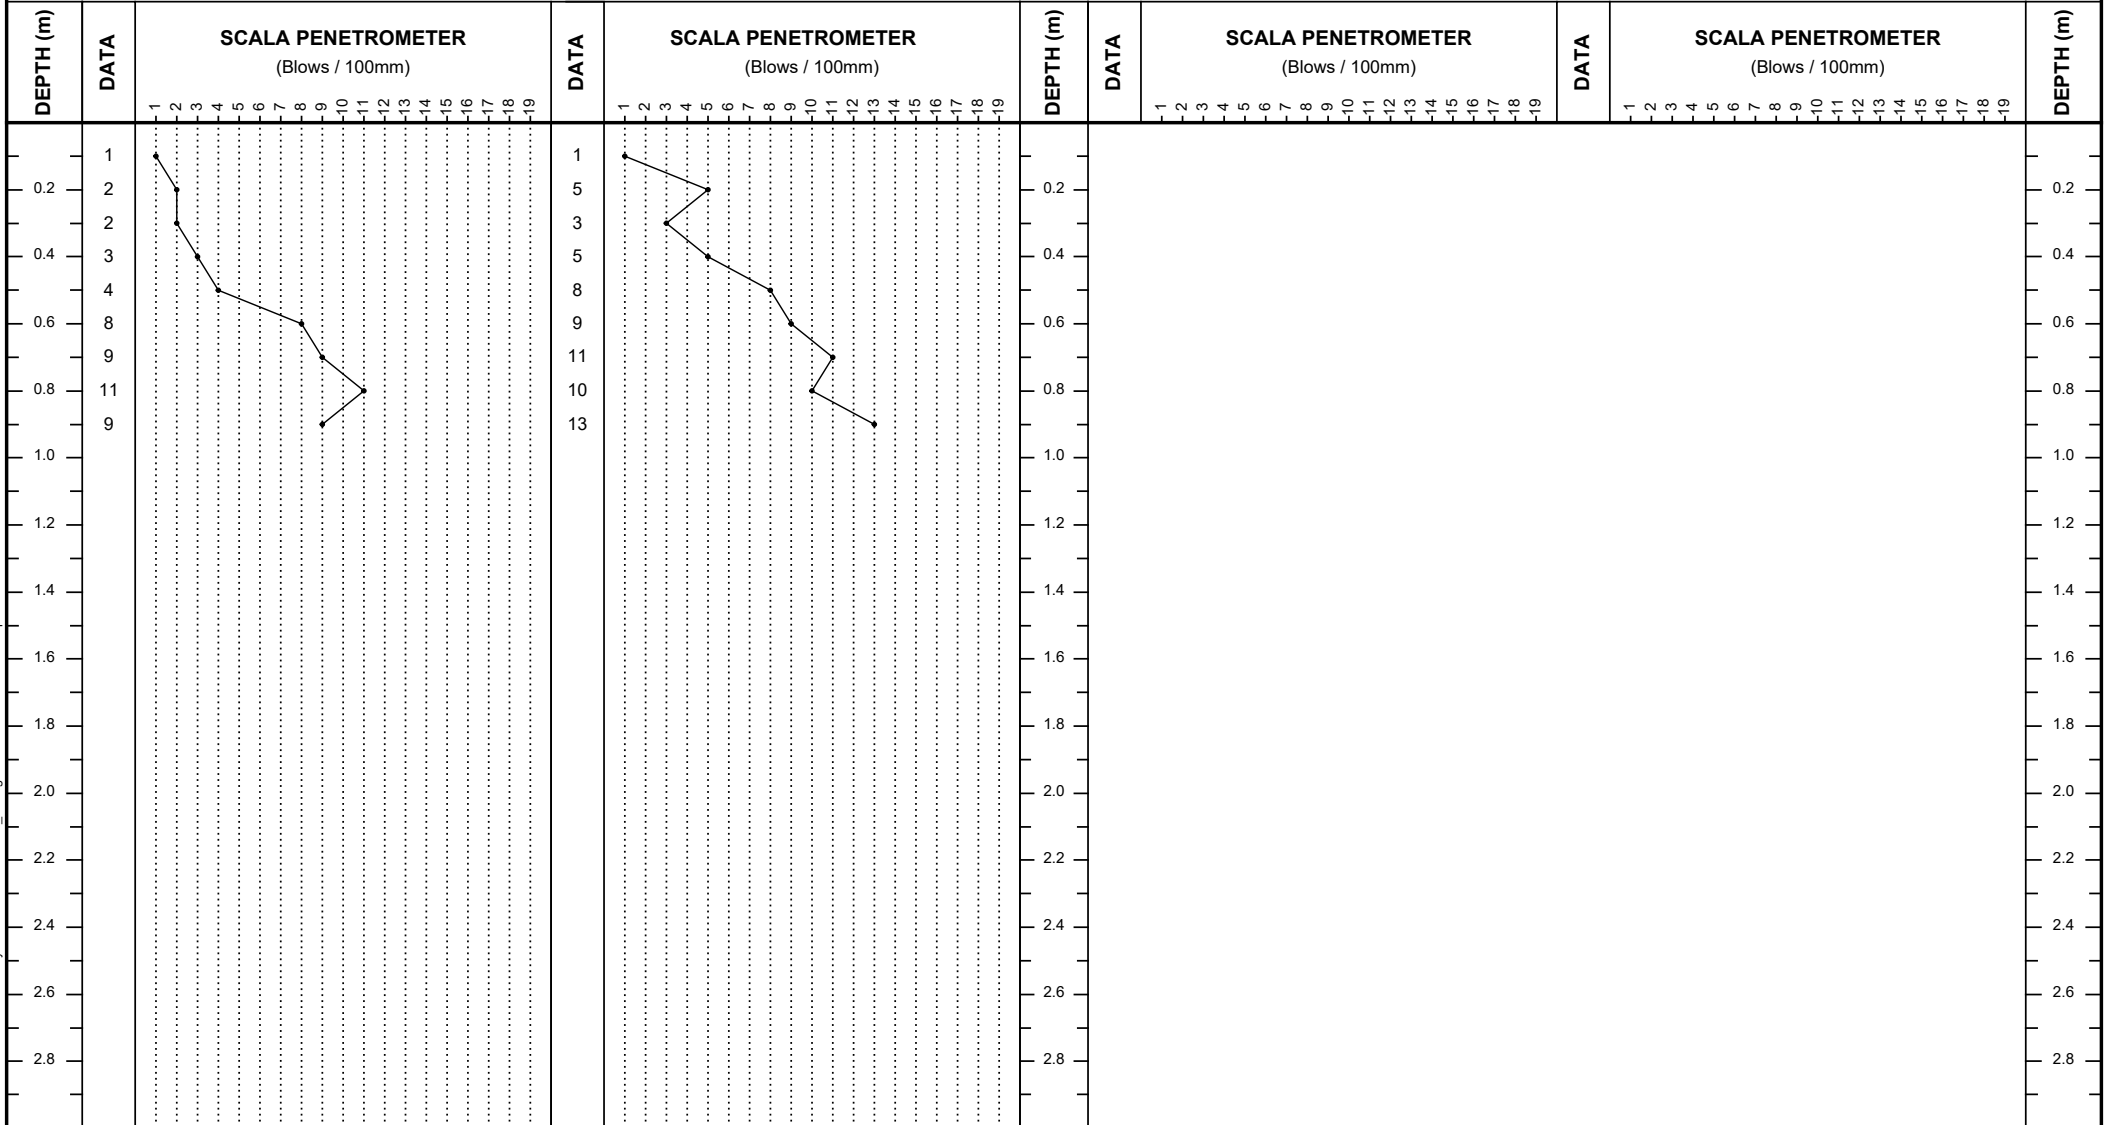
Tested By: KP
Ground Conditions: Near Level, Topsoil & Grass
Coordinates: NZTM2000 E 1576248.82
 N 5183000.43
Test Date: 27-Apr-23

Tested By: SS
Ground Conditions: Near Level, Topsoil & Grass
Coordinates: NZTM2000 E 1576256.56
 N 5183005.50
Test Date: 27-Apr-23

Our SP testing was carried out in accordance with NZS 4402:1988, Test 6.5.2, *Dynamic Cone Penetrometer*. The SP results are also attached.

SPs at each of the four locations returned results between 2 and 13 blows per 100mm penetration below the topsoil and within the engineered fill layer. SPs were terminated at 0.9m depth to confirm near surface bearing capacities, and to avoid damage to the geogrids and geotextile. In addition, the density of the engineered fill and bearing capacity of its underlying subgrade have been confirmed via extensive geotechnical inspection and fill compaction testing during subdivision earthworks.
