Date: 30 August 2023
Project No: LTC21220-A
Revision: B

**RE: SHALLOW SOIL TEST REPORT
FUTURE RESIDENTIAL FOUNDATIONS
LOT 8, 115 EUREKA STREET, ARANUI**

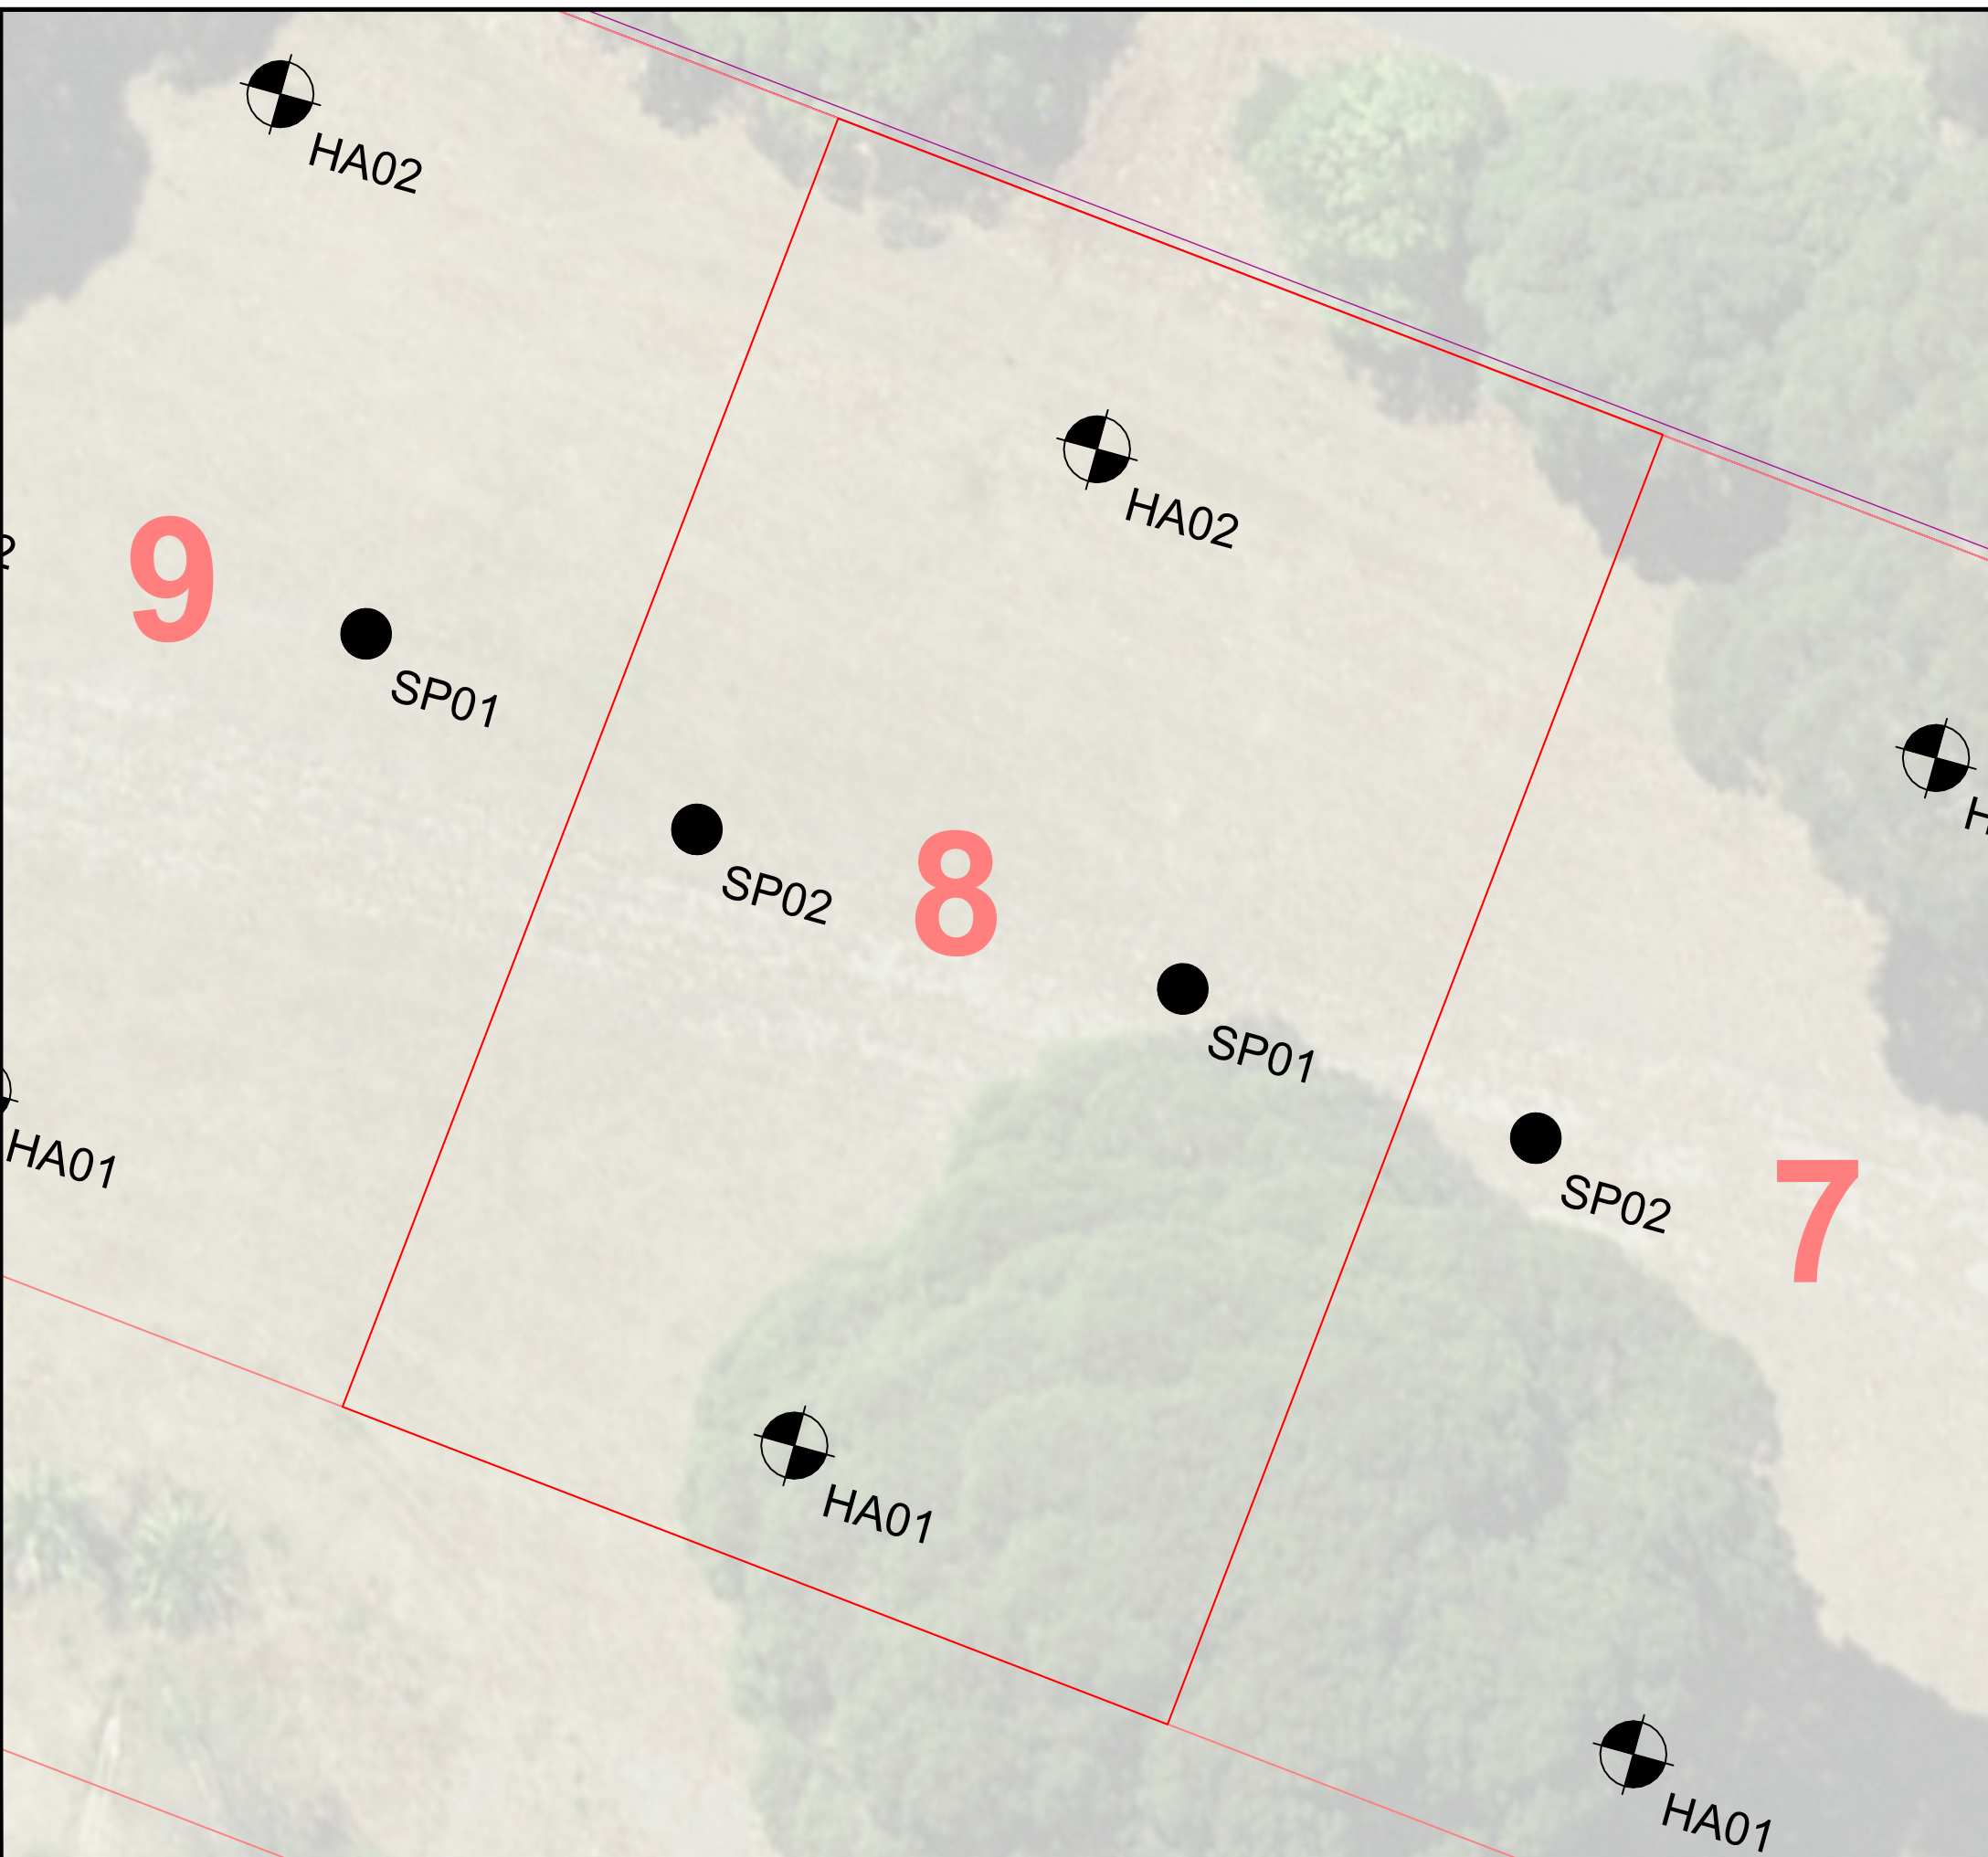
KEY:

Locations of features approximate only
 Original sheet size A3
 Boundary information on this *Test Location Plan* adapted from LINZ website: www.data.linz.govt.nz (accessed 23 March 2023)
 Location of proposed lot boundaries adapted from Davie Lovell-Smith drawing titled: Proposed Subdivision, dated May 2021

LandTech investigated the site on 24 May 2023, conducting two hand augers with corresponding Scala Penetrometer tests (SPs) and two additional SPs. The locations of the hand auger and SPs were measured using inferred lot boundaries and are approximate only. The test locations are shown on our LandTech *Test Location Plan*, Drawing No. Lot 8/ TLP, attached to this report.

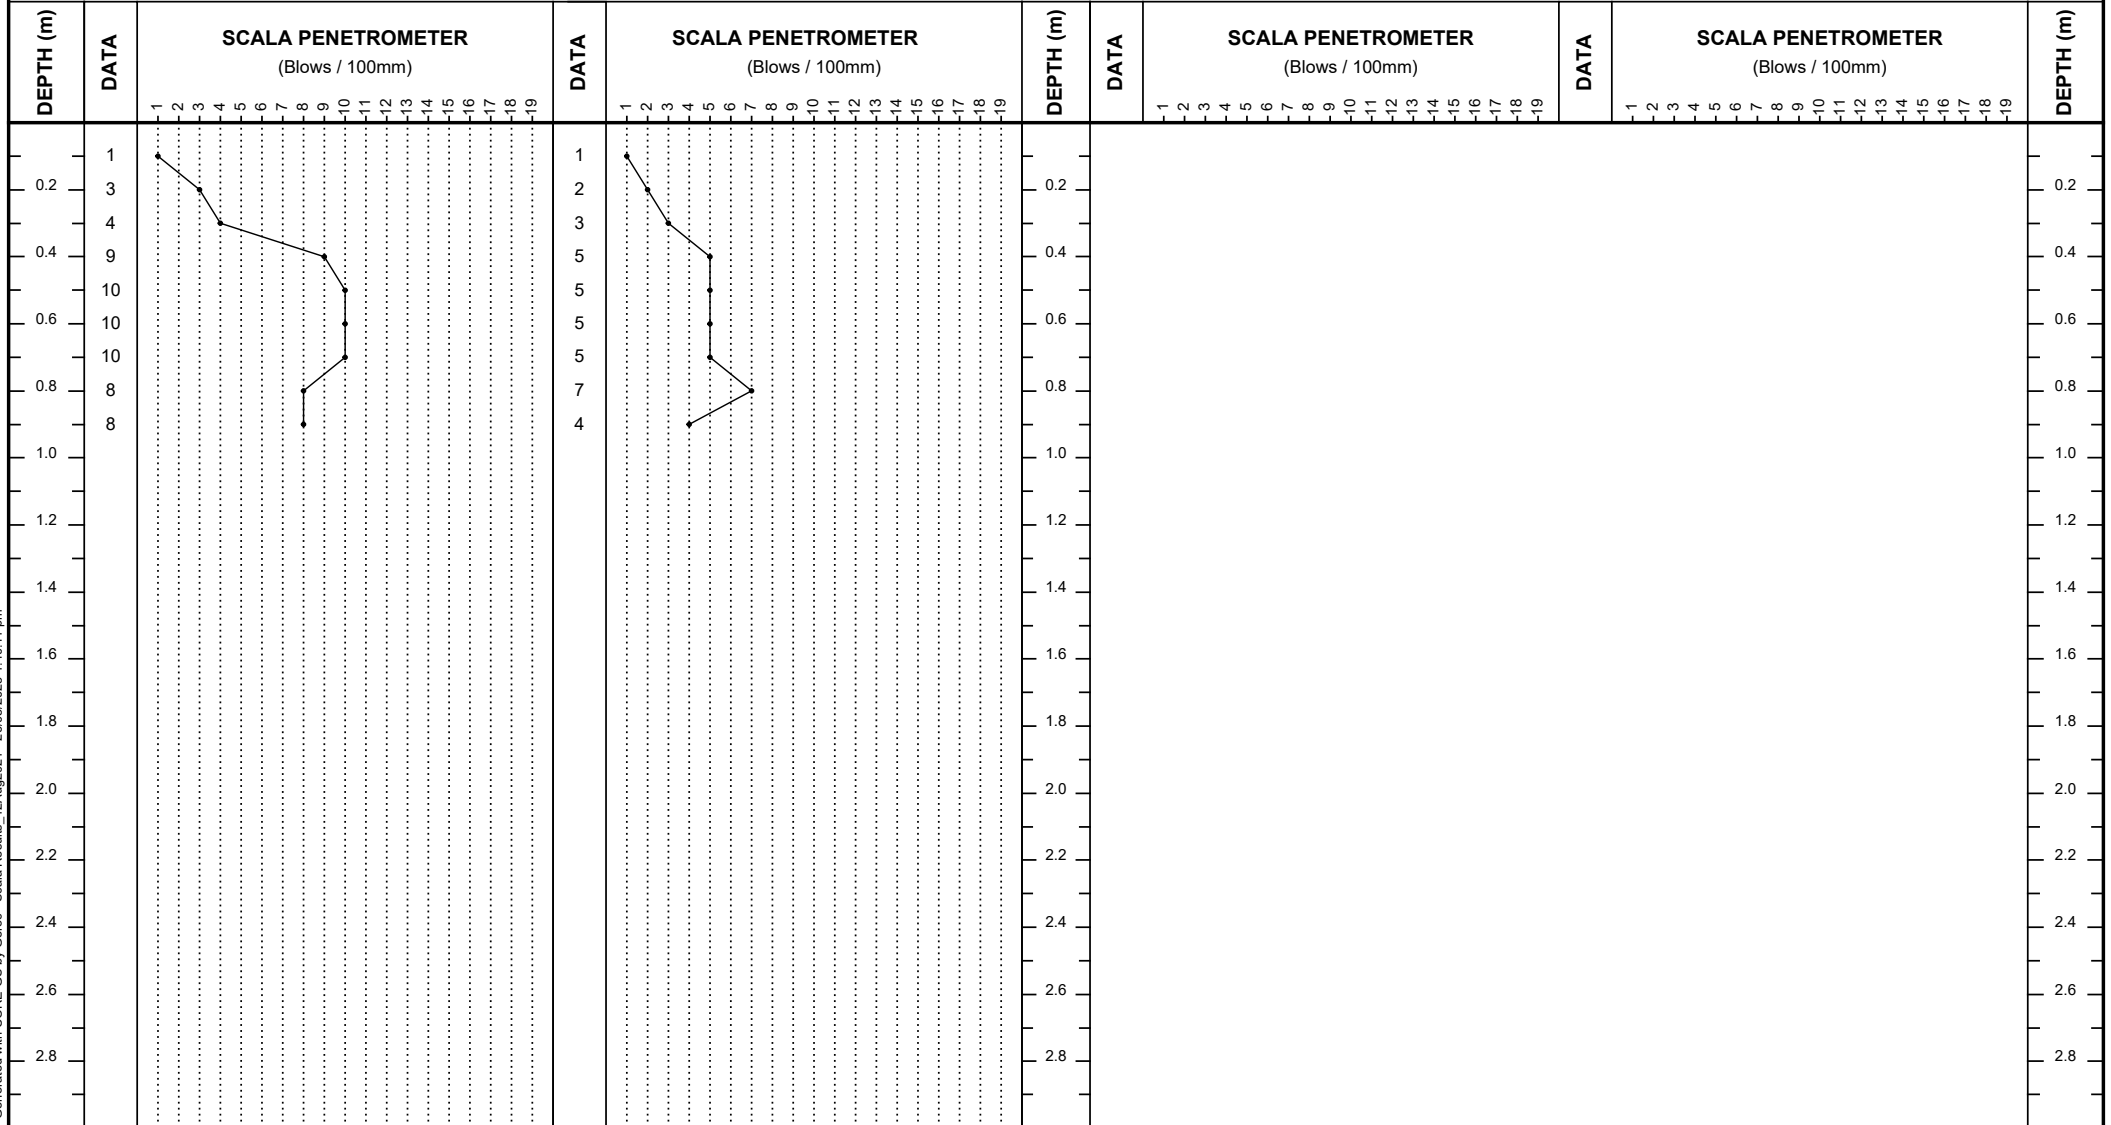
Tested By: KY
 Ground Conditions: Near level, Topsoil.
 Coordinates: NZTM2000 E 1576320.89
 N 5183027.59
 Test Date: 24-May-23

Tested By: KY
 Ground Conditions: Near level, Topsoil.
 Coordinates: NZTM2000 E 1576394.90
 N 5183030.48
 Test Date: 24-May-23

Our SP testing was carried out in accordance with NZS 4402:1988, Test 6.5.2, *Dynamic Cone Penetrometer*. The SP results are also attached.

SPs at each of the four locations returned results between 3 and 22 blows per 100mm penetration below the topsoil and within the engineered fill layer. SPs were terminated at 0.9m depth to confirm near surface bearing capacities, and to avoid damage to the geogrids and geotextile. In addition, the density of the engineered fill and bearing capacity of its underlying subgrade have been confirmed via extensive geotechnical inspection and fill compaction testing during subdivision earthworks.
